1984 - 1993 Corvette: Service Bulletin: Rear Lift Window Hard to Open/Hinge Loose to Glass

Model and Year: 1984-1993 Corvette

Source: Chevrolet Service Bulletin

Bulletin Number: 93-131-10

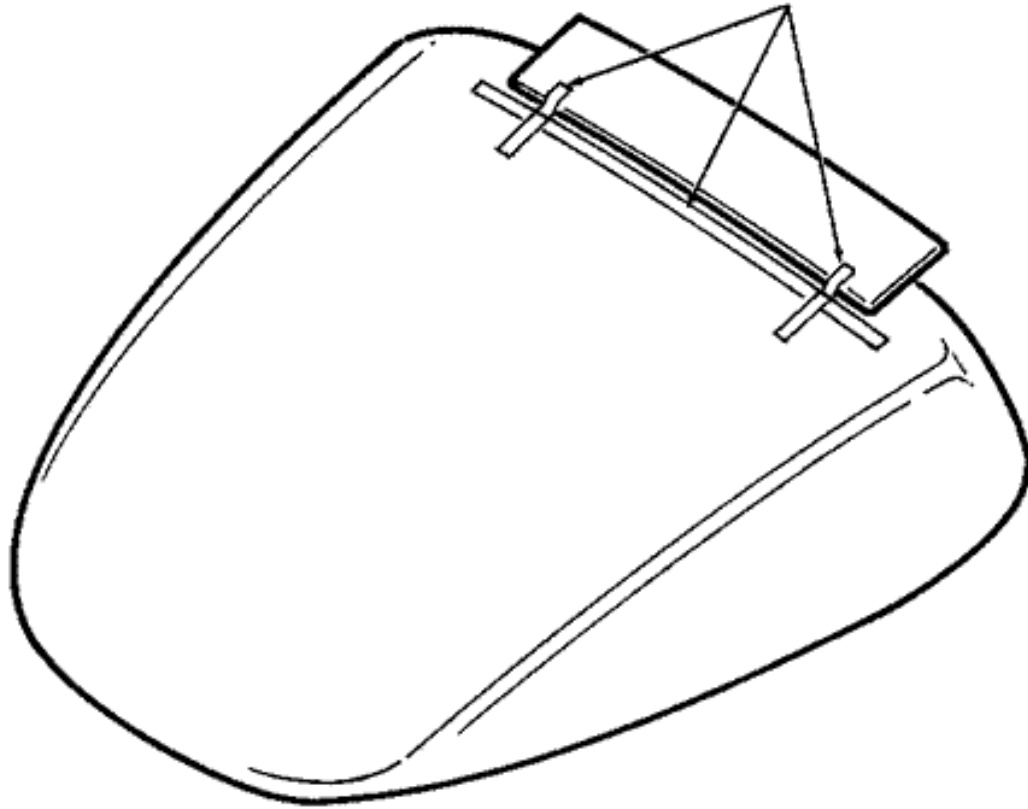
FIGURE 1

MASKING TAPE INSTALLED FOR ALIGNMENT

Apply three pieces of tape to the glass for alignment of the hinge plate to the glass after the glass is removed from the vehicle. Cut the tape spanning the glass and hinge plate as shown in Figure 1.
