## 1982 - 1991 Corvette: Service Bulletin: Checking Connector Terminal Contact - Metri-Pack

Subject: CHECKING CONNECTOR TERMINAL CONTACT - METRI -

Model and Year: 1982-91 PASSENGER CARS AND TRUCKS

**Bulletin Number:** 91-85-8A - (09/21/1990)

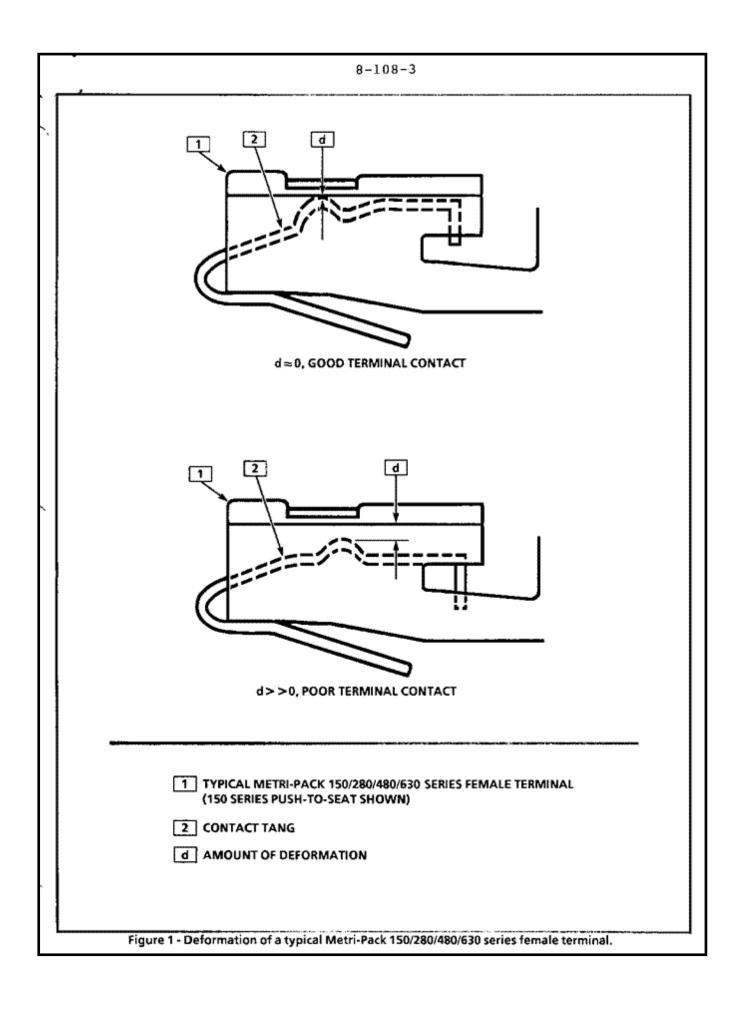
Deformation is caused by probing the mating side of a connector terminal without the proper adapter, improperly joining the connector halves or repeatedly separating and joining the connector halves. Deformation, usually

to the female terminal contact tang, can result in poor terminal contact, see Figure 1, causing an open or intermittently open circuit.

- 3. Using an equivalent male terminal from the Terminal Repair Kit J 38125-2, check the retention force of the female terminal in question by inserting and removing the male terminal to the female terminal in the connector body. Good terminal contact will require a certain amount of force to separate the terminals.

- 4. Using an equivalent female terminal from the Terminal Repair Kit J 38125-2, compare the retention force of this terminal to the female terminal in question by joining and separating the male terminal to the good female terminal, and then joining and separating the male terminal to the female terminal in question. If the retention force is significantly different between the two female terminals, replace the female terminal in question, refer to Terminal Repair Kit J 38125-2.
