# 1982 - 1991 Corvette: Service Bulletin: Transmission Stuck in First Gear

**Subject:** TRANSMISSION STUCK IN FIRST GEAR

**Bulletin Number:** 91-371-7A - (06/28/1991)

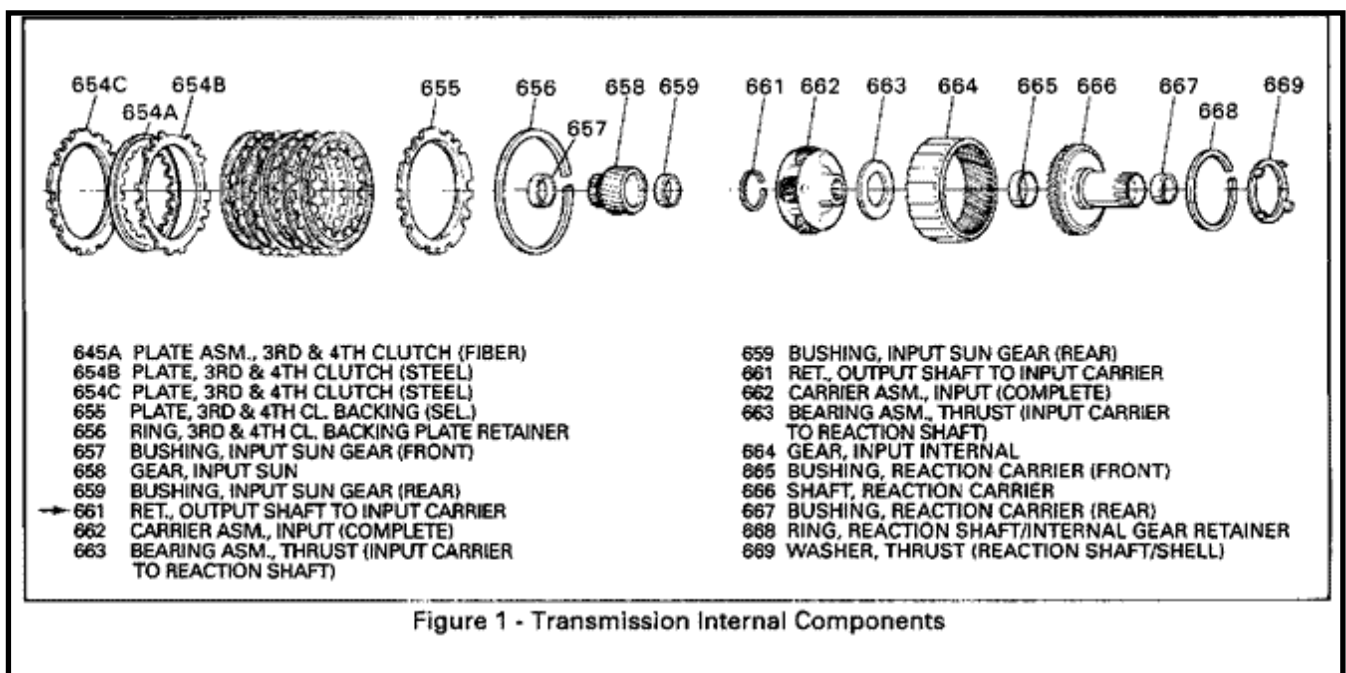
Figure 1 - Transmission Internal Components

Some HYDRA-MATIC 4L60/700-R4 transmissions may experience a "no upshift" or "stuck in first gear" condition. This may be caused by the input carrier to output shaft retaining ring coming unseated, or retaining ring omitted during assembly. This can allow the output shaft to move slightly, and cause wear on the governor gear (the governor gear ON THE GOVERNOR, not the governor drive gear on the output shaft). The governor gear wear may be described as an "apple cored" condition. If the governor gear is worn, the transmission cannot upshift out of first gear.

Remove the governor and inspect the governor gear. If it is "apple cored", disassemble the transmission and look for the presence of the input carrier to output shaft retaining ring.

- o If the retaining ring is missing, replace it, but make sure the original

retaining ring is not broken and stuck inside the transmission.

o If the retaining ring has become unseated, replace the retaining ring with a new one since the original has probably been over-expanded.

When installing a new retaining ring, be careful not to over-expand the retaining ring.
