# 1982 - 1991 Corvette: Service Bulletin: Transmission Stuck in First Gear

**Subject:** TRANSMISSION STUCK IN FIRST GEAR

**Source:** Chevrolet Service Bulletin

**Bulletin Number:** 91-371-7A - (06/28/1991)

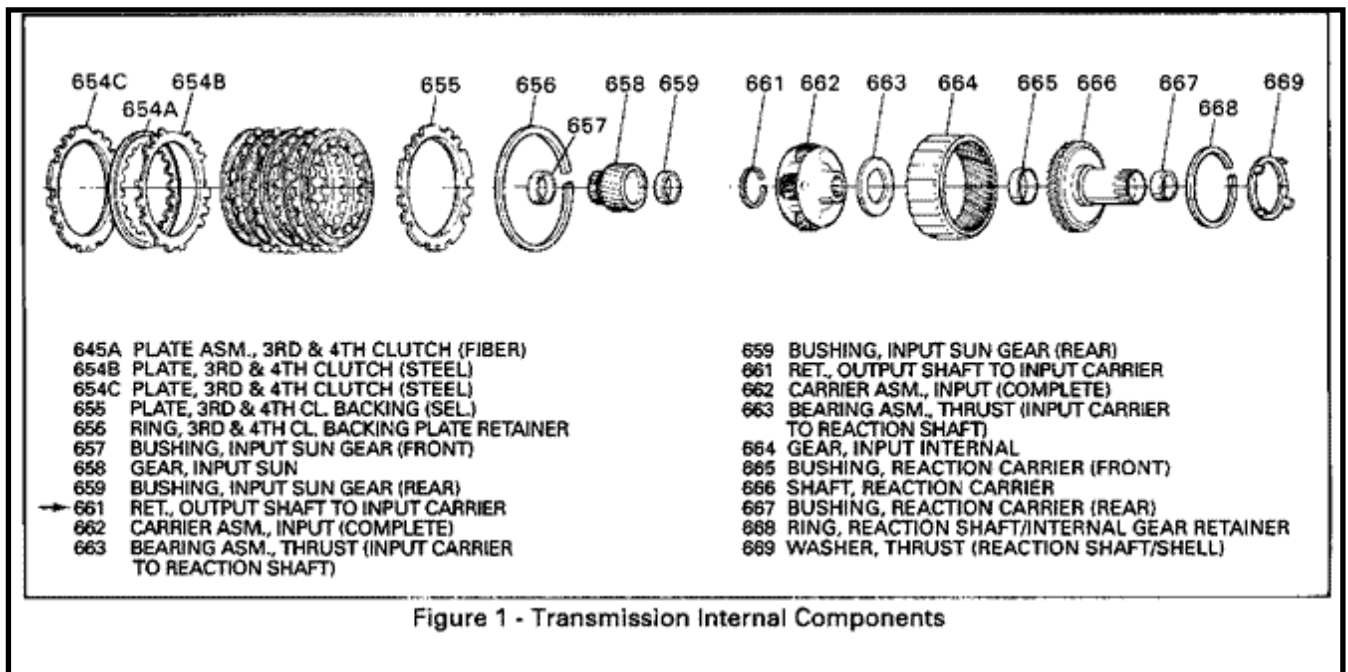
Figure 1 - Transmission Internal Components

Some HYDRA-MATIC 4L60/700-R4 transmissions may experience a "no upshift" or "stuck in first gear" condition. This may be caused by the input carrier to output shaft retaining ring coming unseated, or retaining ring omitted during assembly. This can allow the output shaft to move slightly, and cause wear on the governor gear (the governor gear ON THE GOVERNOR, not the governor drive gear on the output shaft). The governor gear wear may be described as an "apple cored" condition. If the governor gear is worn, the transmission cannot upshift out of first gear.

Remove the governor and inspect the governor gear. If it is "apple cored", disassemble the transmission and look for the presence of the input carrier to output shaft retaining ring.

o If the retaining ring has become unseated, replace the retaining ring with a new one since the original has probably been over-expanded.

When installing a new retaining ring, be careful not to over-expand the retaining ring.
