2014 Corvette: GM TechLink Article: Blank Touch Screen after Start-up and in Reverse

Source: GM TechLink

Date: January 23, 2014

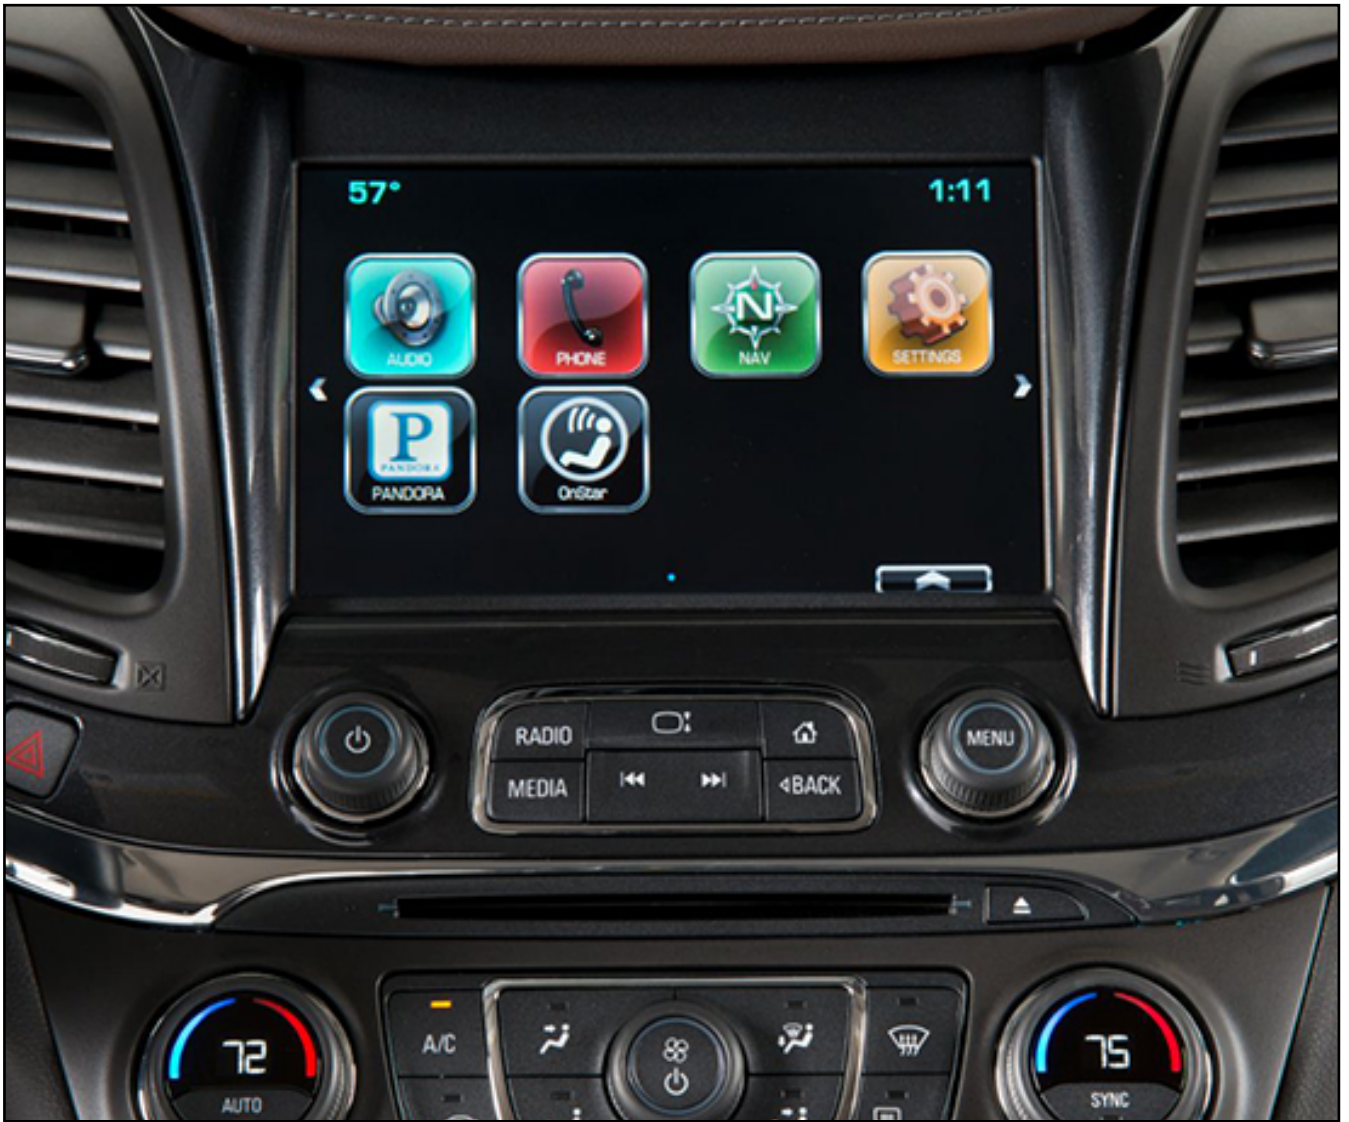
Fig. 9

The infotainment touch screen may be blank after start-up and in Reverse, a rearview camera message may be displayed, and there may be Bluetooth® and navigation system conditions on the following models equipped with radio-infotainment system RPOs IO4, IO5, IO6 or RAO (except with RPO UPF):

An updated software calibration has been released to address these conditions.

Update the Human Machine Interface (HMI) module using a USB flash drive and the Service Programming System with the files available on TIS2Web.

After USB programming has been completed, reprogram the HMI module using the Service Programming System with the latest calibrations available on TIS2Web and then clear any DTCs.
