# 1978 - 1979 Corvette: Service Bulletin: Glass Roof Panel Trim Separation

**Subject:** Glass Roof Panel Trim Molding Separation **Source:** Chevrolet Dealer Technical Service Bulletin

Number: 79-T-7 Date: April, 1979

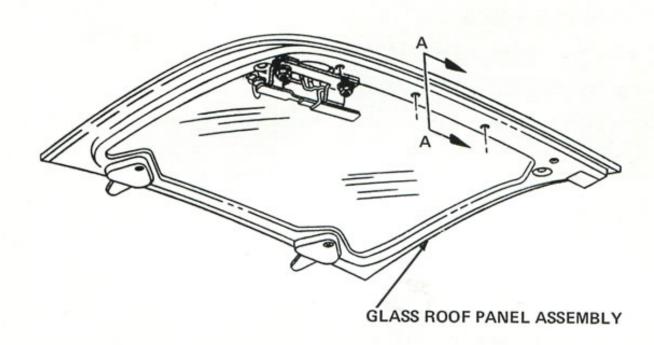
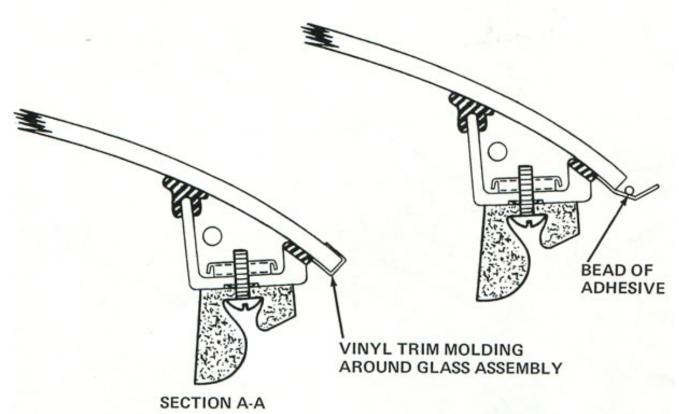
A few 1978-79 Corvettes equipped with the RPO CC1 glass roof panel may exhibit the condition of the vinyl trim molding separating from the glass panel.

The recommended service correction is application of a two part epoxy, such as 3M P/N 8640, or equivalent between the glass panel and the molding.

- 1. Remove the roof panel from the vehicle, but do not separate the glass from its frame.
- 2. In the area to be bonded, clean both the molding channel and glass thoroughly with a dry cloth to remove dirt and loose adhesive.
- 3. Mix epoxy as directed on package. Note cautions and curing time.
- 4. Transfer the adhesive into a small plastic bag ("baggie") and twist to push the adhesive into a corner. Cut off this corner to provide the proper bead size of approximately 1/16 inch diameter.
- 5. Apply a 1/16 inch diameter bead of adhesive into the molding channel, as illustrated, and place the channel firmly over the glass edge, allowing the excess adhesive to squeeze out.
- 6. After the "squeeze out" becomes firm, remove it carefully with a dull blade.
- 7. Allow approximately one hour cure time at room temperature before

reinstalling the roof panel.
