2006 - 2008 Corvette: GM TechLink: 6L80 or 6L90 Automatic Transmission Shift Conditions

Source: GM Techlink

Date: October 2011

Subject: 6L80 or 6L90 Automatic Transmission Shift Conditions

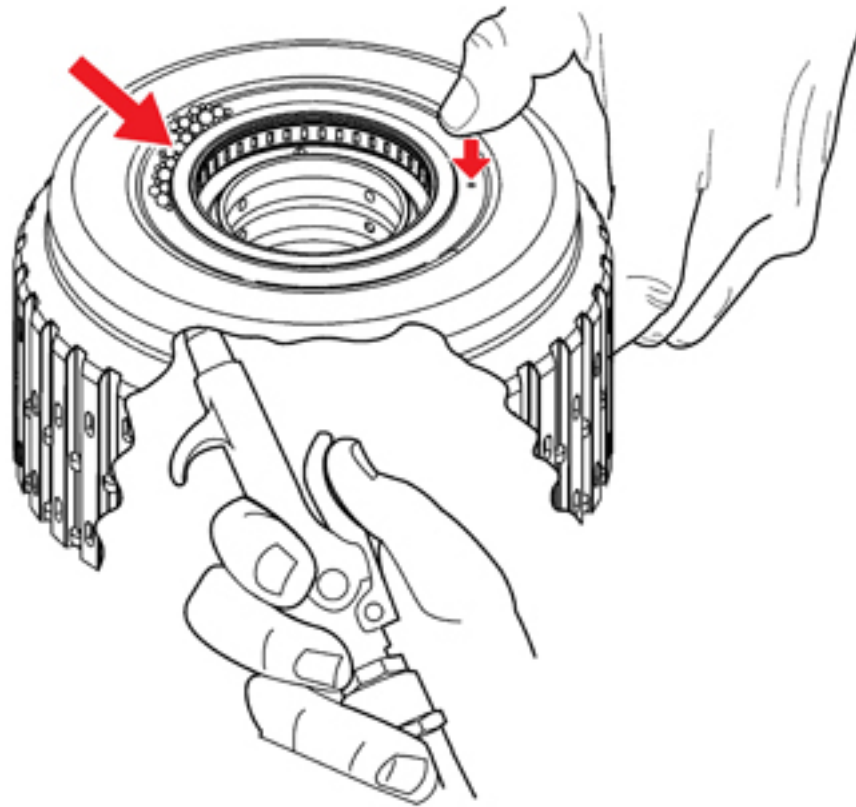
Fig. 14

A cracked 1-2-3-4/3-5-R clutch housing may cause any of the following conditions:

- Slip when Reverse is selected or no Reverse
- Delayed engagement into Reverse
- DTC P0776 set as an active or a history code in the Transmission Control Module, Malfunction Indicator Lamp (MIL) illuminated
- Harsh shifts from Second to Third

Inspect the 1-2-3-4 / 3-5-R clutch housing for a possible cracked weld by

applying soap compound to the weld area of the housing. Hold your thumb over the air bleed passage and spray compressed air into the piston housing. Inspect the weld area for bubbles. If bubbles are detected, a new housing is required. (Fig. 14)
