# 1976 Corvette: Service Bulletin: Heater Hose Clamp Interference with A/C Evaporator Inlet Pipe

**Model and Year:** 1976 Corvette with A/C

**Source:** Chevrolet Dealer Service Technical Bulletin

**Bulletin Number:** 76-T-43, Section Ia

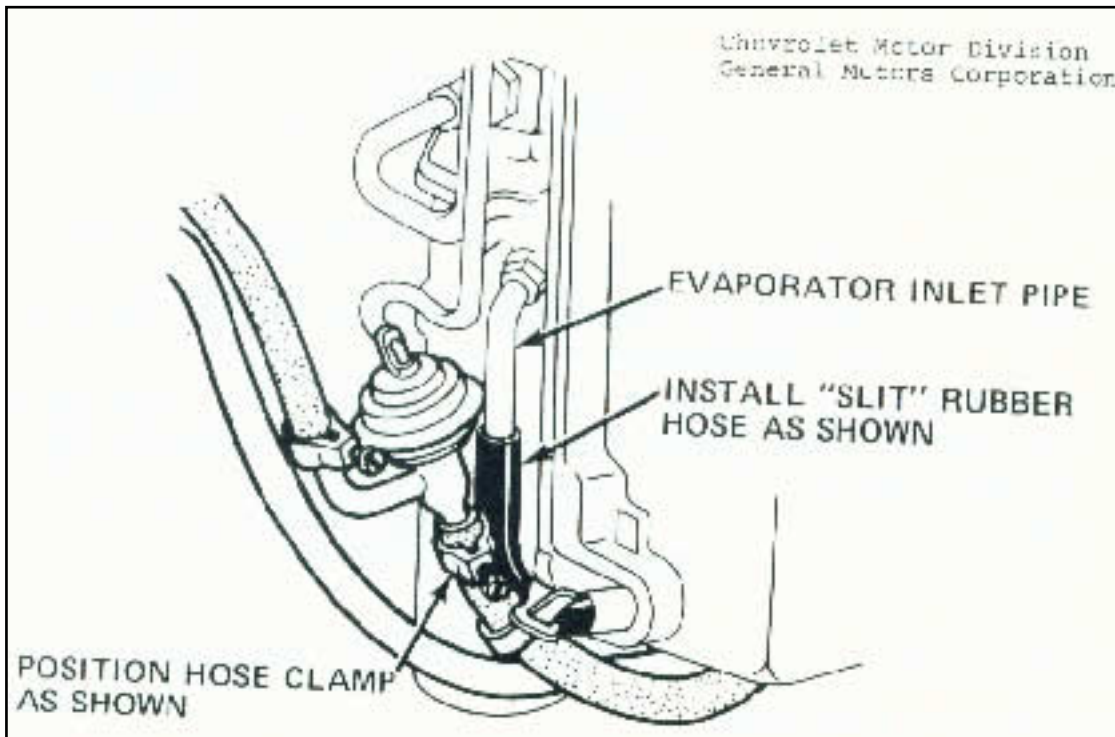
On some 1976 Corvettes, the heater hose clamp screw may rub against the evaporator inlet refrigeration pipe. This condition could cause a hole being worn through the evaporator pipe resulting in a loss of freon. For 1977 production models, this condition has been corrected by lengthening the heater hose.

1. Loosen hose clamp and rotate to provide maximum clearance to the evaporator pipe.
2. Insert a section of slit rubber hose over the evaporator inlet pipe in the area of the hose clamp. (See Figure 1)
3. In the event the clamp screw has worn through and a loss of freon has taken place, it will be necessary to replace the evaporator core.
