1954 - 1955 Corvette: Service Bulletin: Positioning Directional Signal Flasher Plastic Socket

Subject: Positioning Directional Signal Flasher Plastic Socket
Model and Year: 1955 Passenger Cars (applies to 1954 - 1955 Chevrolet Corvettes)
Source: Chevrolet Central Office, Technical Service Bulletin
Bulletin Number: DR-180, Section XII
Date: November 3, 1954

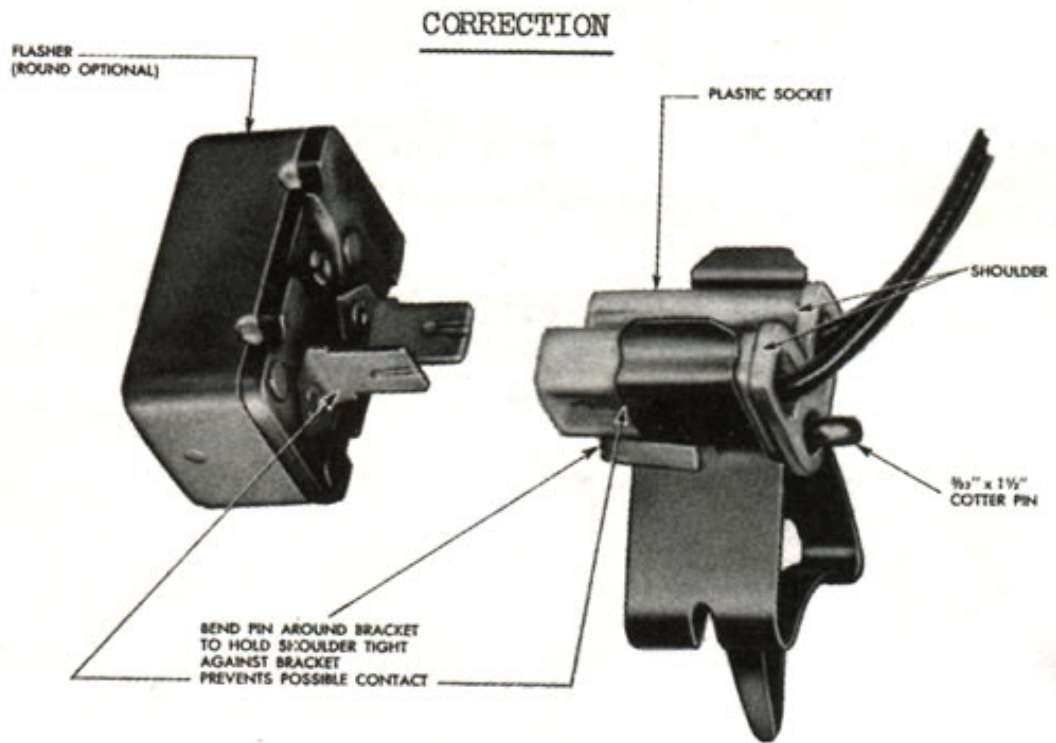
The shoulder on the plastic Directional Signal Flasher Socket should be up against its Mounting Clip to prevent contact between Flasher Terminal and Clip.

Flasher is located above parking brake handle back of instrument panel.

To prevent mis-positioning and shorting during future flasher replacement, a 3/32" x 1-1/2" cotter pin should be installed through the hole in the plastic socket and around the legs of clip, holding the plastic shoulder tight against the clip.
