1957 - 1958 Corvette: Service News: Corvette 4-Speed Transmission - Harsh Shift Into Third Speed

Source: Chevrolet Service News

Date: December, 1957

Subject: Corvette 4-Speed Transmission - Harsh Shift Into Third Speed

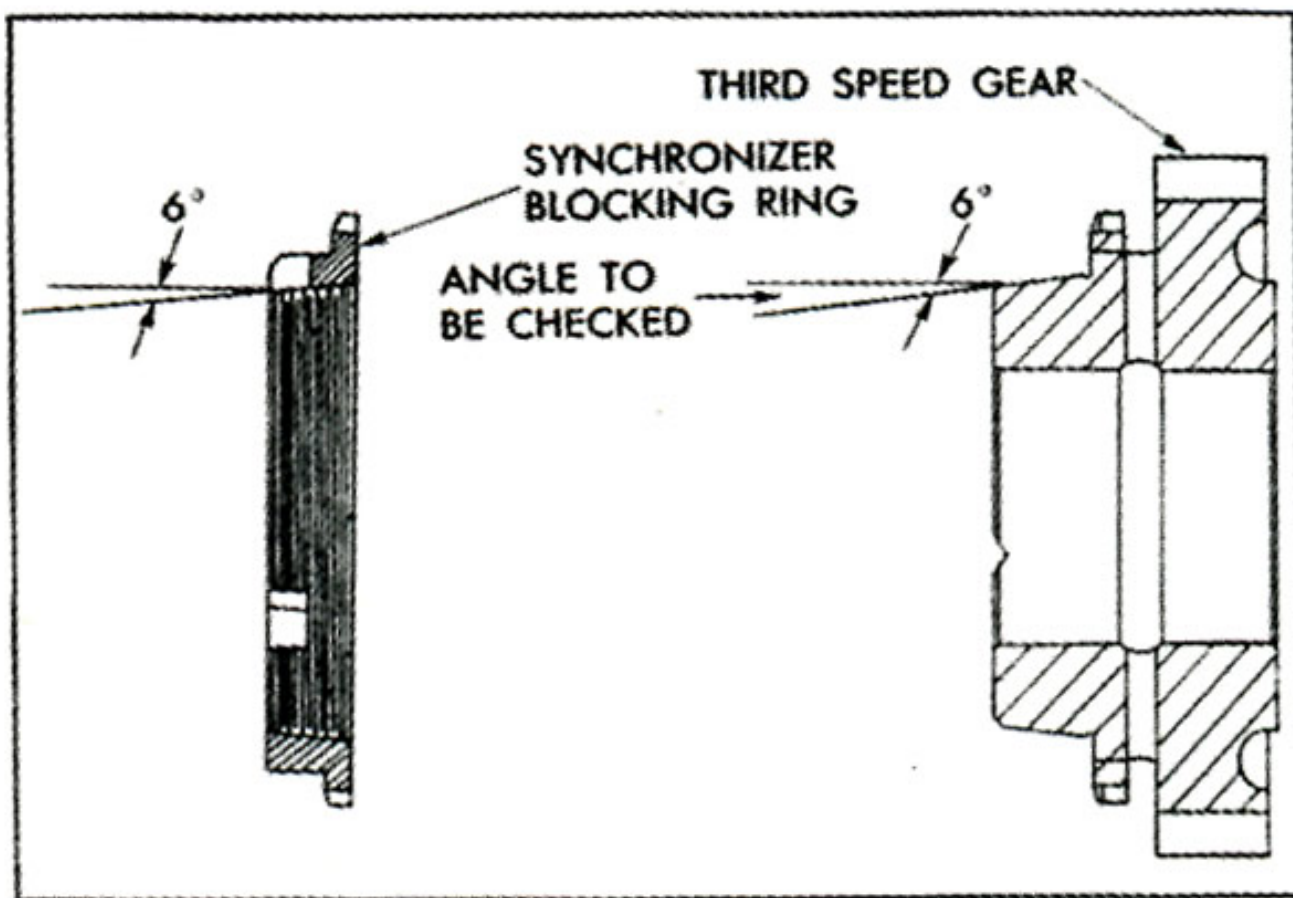
Some 1957 and 1958 Corvette four-speed transmissions have been built incorporating a third speed gear with 7° cone angle rather than the specified 6° , as illustrated in Figure 3. This may cause a harsh shift into third speed due to the resultant improper engagement of the synchronizer blocking ring and third speed gear cone.

Fig. 3--Checking Third Speed Gear

The suggested correction, if the harsh shift is encountered, is to replace the third speed gear assembly No. 3743452 and the synchronizer blocking ring No. 3709348.

1. Coat I.D. of blocking ring lightly with a dye such as Prussian Blue.
2. Carefully install the blocking ring on the third gear cone to obtain an engagement impression.
3. If the Prussian Blue impression on the cone is all at the rear (or predominantly at the rear) the cone angle can be assumed to be 7° and should not be used. If the Prussian Blue is more or less evenly distributed on the cone surface, the angle is correct.
