1968 Corvette: Service News: Tune-up Specification Change

Subject: Tune-up Specification Change

Model and Year: 1968 Corvette with 427 cu. in. Engine, Manual Transmission and Air Conditioning

Date: February 1968, Volume 40, Issue #2

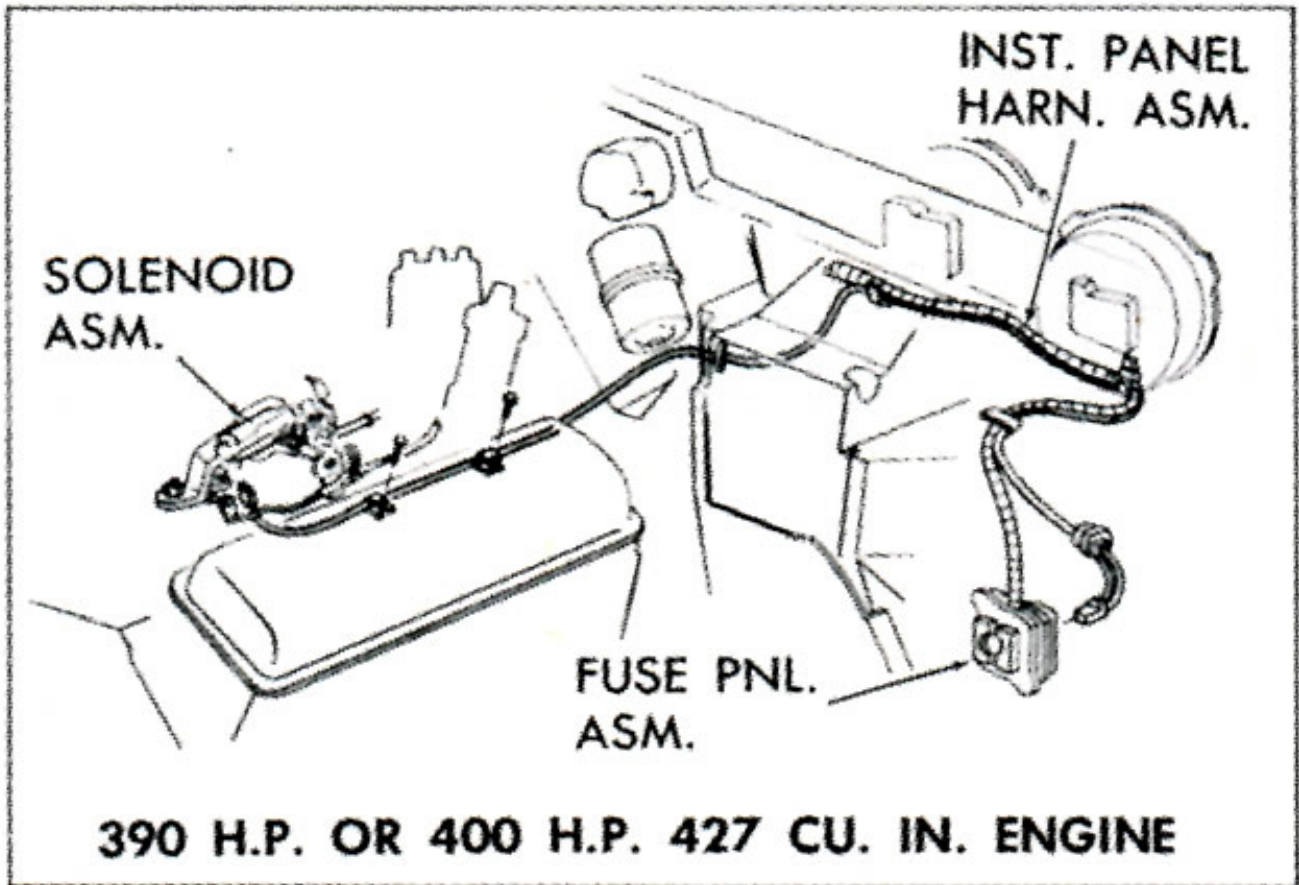
If the anti-dieseling solenoid on one of these vehicles requires replacement or adjustment, refer to the procedures given on Page 7 of this Service News issue. The 'Anti-Dieseling Solenoid Diagnosis Chart' on Page 7 of this issue should be of assistance in determining whether replacement is necessary. Figure 6 illustrates proper solenoid wire routing for either the 390 or 400 H.P. engine. The connector at the use panel should be inserted in the receptacle marked "IGN" for proper solenoid operation.

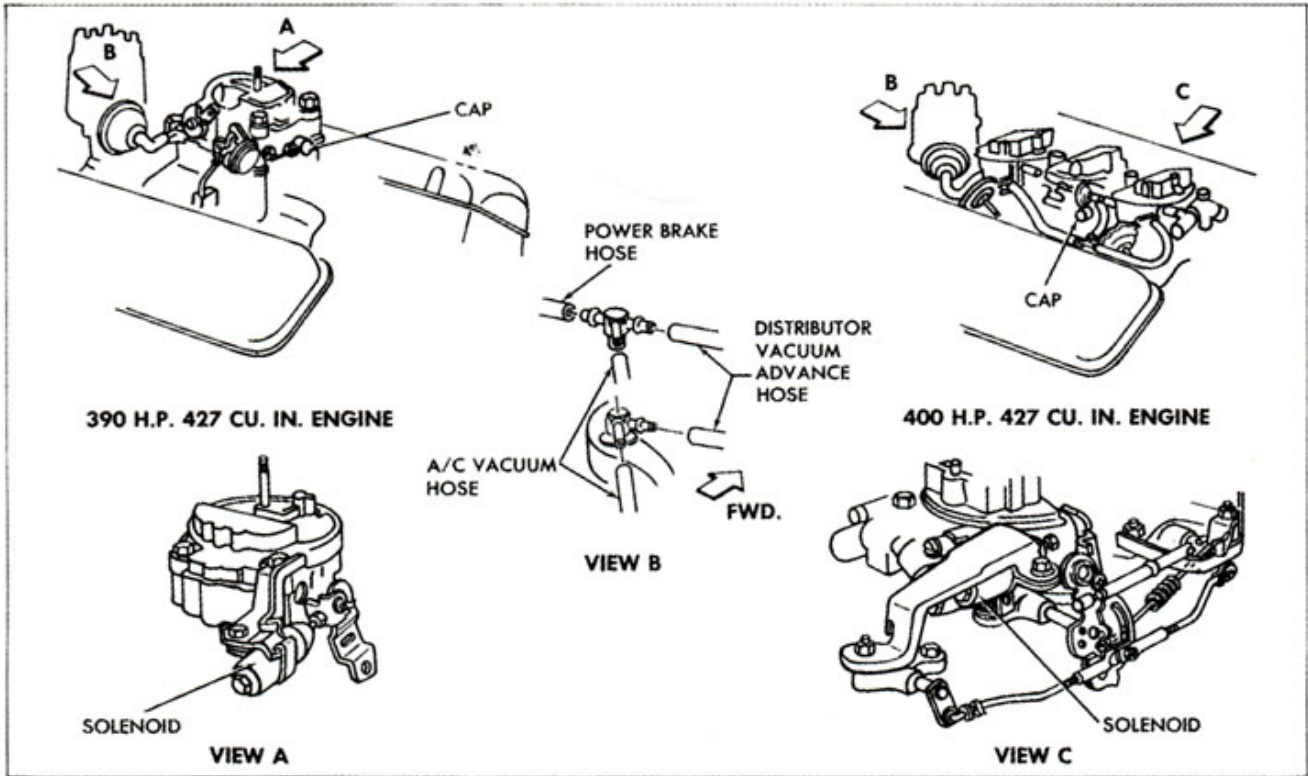
Fig. 7—Anti-Dieseling Solenoid Installation

Figure 7 illustrates proper solenoid installation on both the 390 and 400 H.P. versions of the 427 cu. in. engine and also illustrates the correct intake manifold vacuum fittings for the full manifold vacuum distributor advance arrangement.
