1986 Corvette: Recall Notice: Anti-Skid Brake System Master Cylinder Center Valve

Bulletin No: 86C12, Number 5

Date: September 1986

Subject: PRODUCT SAFETY CAMPAIGN 86C12
ANTI-SKID BRAKE SYSTEM
MASTER CYLINDER CENTER VALVE

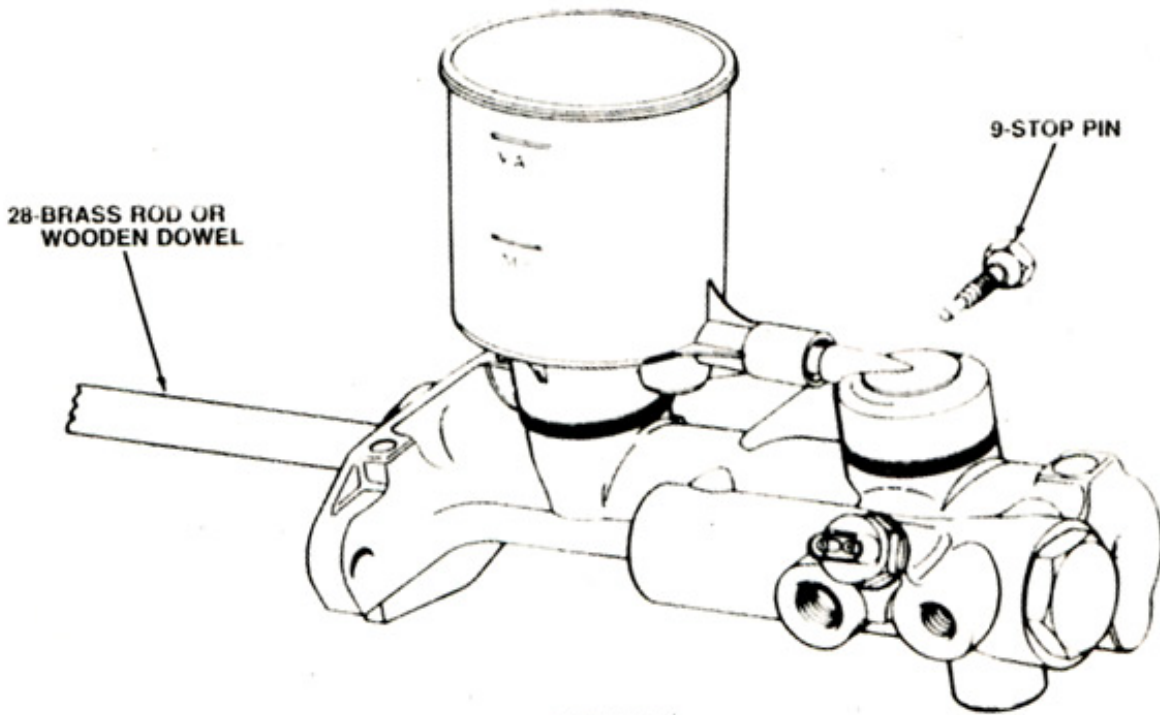
FIGURE 1

General Motors has determined that a defect which relates to motor vehicle safety exists in certain 1986 Corvettes. Certain severe and unusual braking conditions may cause damage to the brake master cylinder center valve. If sufficient damage accumulates, loss of front brakes may occur with accompanying increased pedal travel and reduced braking ability. A reduction of braking ability at a time when minimum stopping distance is required could result in a vehicle crash without prior warning.

1. Remove master cylinder from vehicle.
2. Drain and discard brake fluid from master cylinder reservoir and bore.
3. Fully depress the master cylinder pistons with a brass rod or wooden dowel (28) (as shown in Fig. 1) and remove stop bolt (9). Then remove snap ring (1) with suitable Truarc pliers.

Do not remove stop bolt (9) unless both
pistons are fully bottomed in bore.

4. Remove brass rod or wooden dowel (28) and gently bump open end of master cylinder body on a piece of wood to remove primary piston (3) secondary piston assembly (7) and center valve assembly (8).
5. Discard secondary piston assembly and center valve assembly (7 & 8).
6. Remove primary piston seal retainer (6) by carefully prying open the legs of the seal retainer with a small screwdriver. Discard the retainer.
7. Remove and discard the primary piston seals (2 & 5). Do not dismantle any other part of the master cylinder.
