1984 Corvette: Service Bulletin: Side Door Lateral Movement

Subject: Side Door Lateral Movement
Model Year: 1984 Corvette
Source: Chevrolet Dealer Service Bulletin
Bulletin No: 84-118, Section: 10 (I)
Date: April, 1984

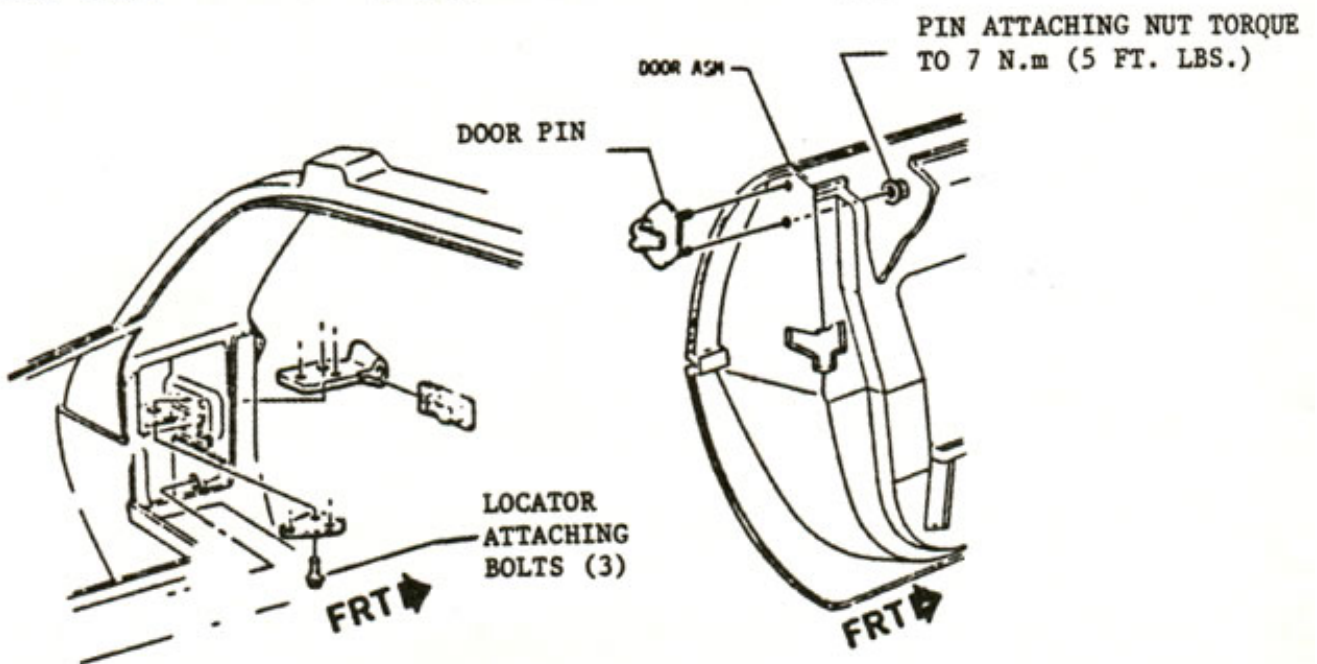
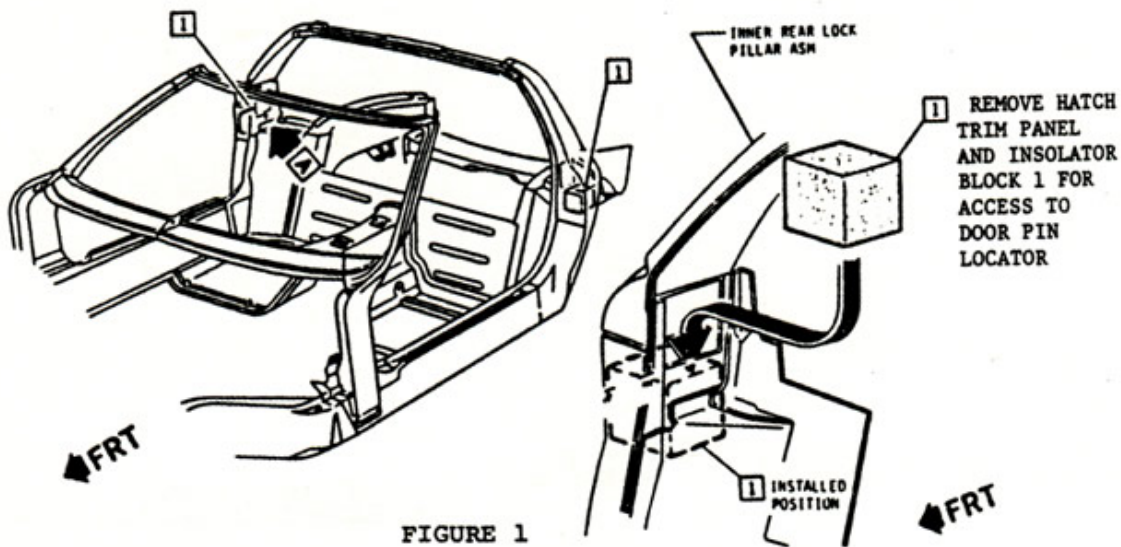
FIGURE 1

Some 1984 Corvettes may experience lateral side door movement with the side window rolled down.

Verify the plastic sleeve is installed in the pin locator assembly. With the vehicle door closed, loosen the locator three (3) attaching bolts (see Figure 1). The locator assembly is to be centered fore-aft and vertically on the door pin. Push the locator outboard to fully engage the door pin and tighten the locator attaching bolts to 11 N.m (8 ft. lbs.)

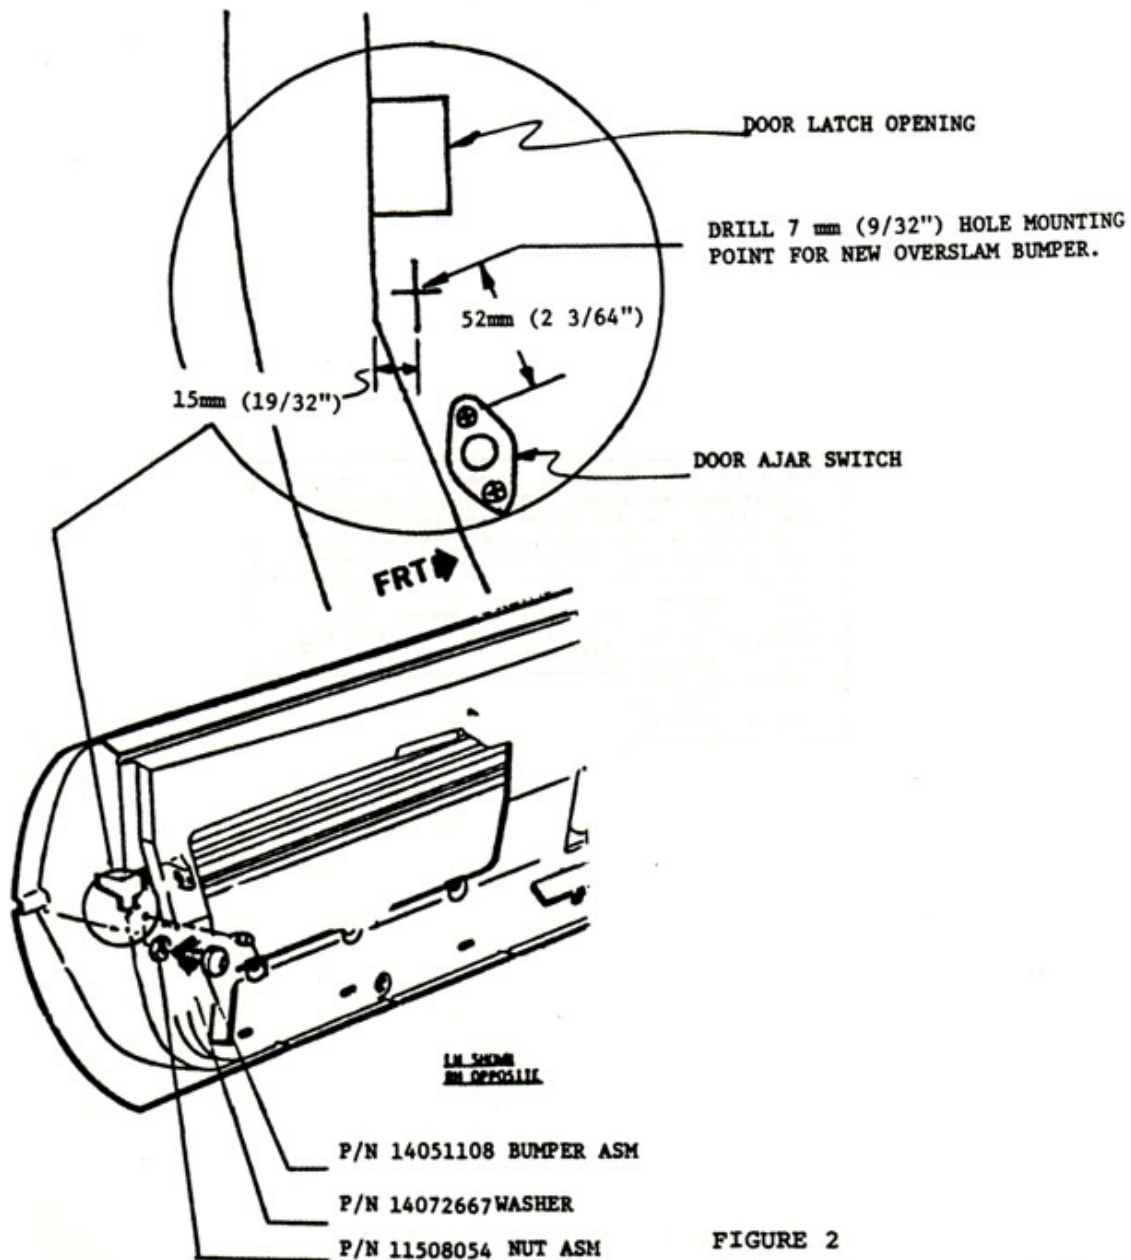
FIGURE 2

Some early built vehicles did not have overslam bumpers. If this is the case, it will be necessary to drill a 7mm (9/32") hole in the door (see Figure 2).

Replace the discarded production bumper(s) with bumper, P/N 14051108, attaching nut, P/N 11508276, and P/N 14072667, flat washers, which are to be used as bumper shims. The number of shims required will vary from vehicle to vehicle depending on "Build stacks".

Add shims (washers) between bumper and door, as required, to eliminate lateral door movement (see Figure 2). DO NOT "OVERSHIM" BUMPER.

Once shim pack has been established, tighten bumper retaining nut to 12 N.m (9 ft. lbs.) and check the door ajar lamp for proper operation. The door ajar switch is self-adjusting and cannot be reset.
