# 1962 Corvette: Service Bulletin: Excessive Idle Speed

SUBJECT: EXCESSIVE IDLE SPEED -  
1962 PASSENGER CARS

BULLETIN NO. DR #522

DATE February 14, 1962

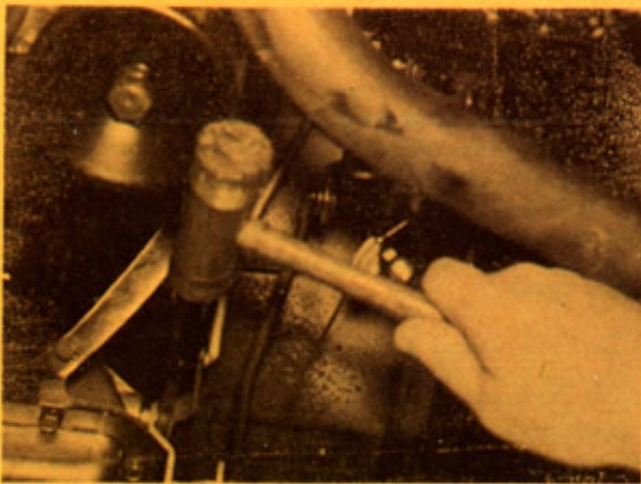
FIGURE 1

Excessive idle speed due mainly to poor return to idle on 1962 Passenger Cars equipped with 327 cu. in. engines and Powerglide transmissions, may be due to a bind in the transmission throttle valve linkage at the throttle valve rod to throttle valve lever clip and/or between the throttle valve control inner lever and the range selector shaft. Either of these conditions combined with the carburetor throttle valve return spring being marginal, may prevent the throttle linkage from returning completely to idle. This results in excessive idle speed.

2. Remove the transmission throttle valve rod to throttle lever clip and replace with plain washer #120392 and 3/32" x 5/8" cotter pin.
3. Position a screwdriver having a blade width of 3/8" between the transmission throttle lever and manual lever as shown in Figure 1.
4. Gently tap screwdriver wedging the throttle lever outboard until .010" - .015" clearance may be measured with a feeler gauge between the throttle lever and the washer which is between the two levers as shown in Figure 2.
