1963 - 1964 Corvette: Service News: Air Conditioning Changes

Subject: Air Conditioning Changes
Model and Year: 1963 - 1964 Corvette
Source: Chevrolet Service News
Date: March 1964 - Volume 36 - Number 3

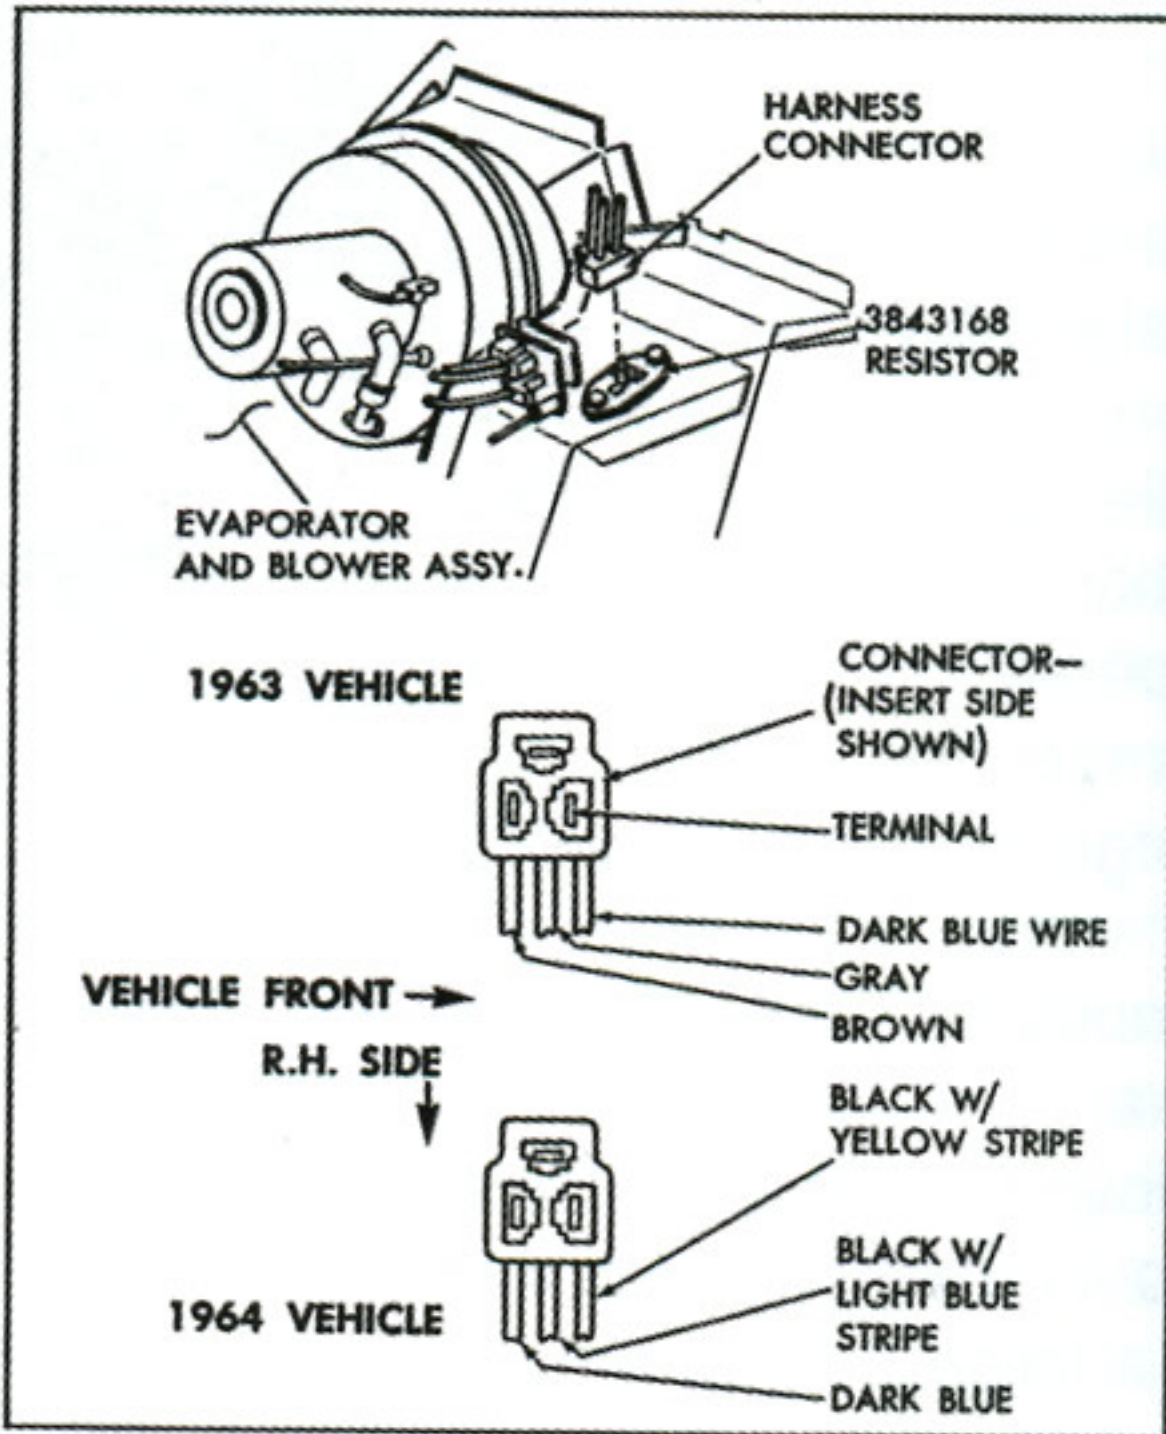
Fig. 1—Rework of Blower Motor Circuit

On all 1963 and early 1964 Corvettes equipped with Air Conditioner RPO C60, it would be necessary to slightly modify the electrical circuit to provide a true medium blower speed for the heater. In these RPO C60 installations, the resistor that was used in the blower motor circuit to establish blower medium and low speeds, unfortunately, during heater operation provides blower "low" RPM at the MEDIUM as well as at the LOW speed setting of the operator's control lever.

1. Replace the installed blower motor resistor with Resistor Part No. 3843168.
2. Reverse the location of two leads in the multiple connector that plugs into the blower motor resistor assembly; reinstalling the color coded leads in the connector body at the locations show in Fig. 1.

NOTE: To remove the terminals from the connector body, insert a small screwdriver along the inboard side of the terminal and move the end of the screwdriver outboard to disengage the terminal from the locking ledge in the connector. Before reinstalling the terminals in the connector, spread the

terminals to insure that they lock securely when installed.
