## 1968 - 1970 Corvette: Service Bulletin: Depressed Park Windshield Wipers Unable to Park

**Source:** Chevrolet Dealer Service Technical Service Bulletin

**Bulletin No:** 70-T-59

**Date:** May 5, 1971

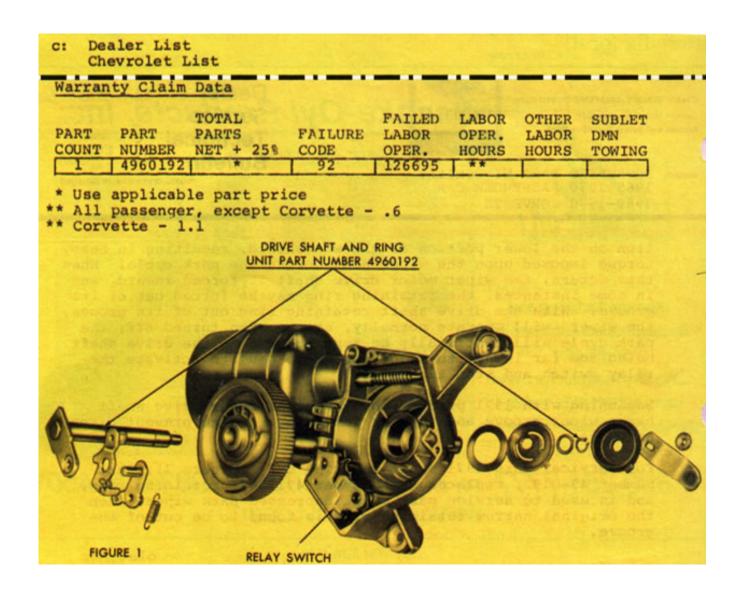
This problem usually is a result of heavy snow or ice accumulation on the lower portion of the windshield, resulting in heavy torque imposed upon the wiper arms during the park cycle. When this occurs, the wiper motor drive shaft is forced inward, and in some instances, the retaining ring may be forced out of its groove. With the drive shaft retaining ring out of its groove, the wipers will operate normally, except when turned off, the park cycle will continually be repeated due to the drive shaft being too far inward to allow the drive pawl to activate the relay switch and stop the motor.

Beginning with 1971 production, the wiper motor drive shaft has a wider groove and thicker retaining ring to prevent disengagement.

For service, this 1971 shaft and ring unit (Figure 1), Part Number 4960192, replaces Part Number 4911264, retaining ring, and is used to service past model depressed park wipers when the original narrow retaining ring is found to be out of the groove.
