1959 Corvette: Service News: Fuel Injection Pump Leakage

Subject: Fuel Injection Pump Leakage

Model and Year: 1959 Corvette

Date: March 1959 - Volume 31 - Number 3

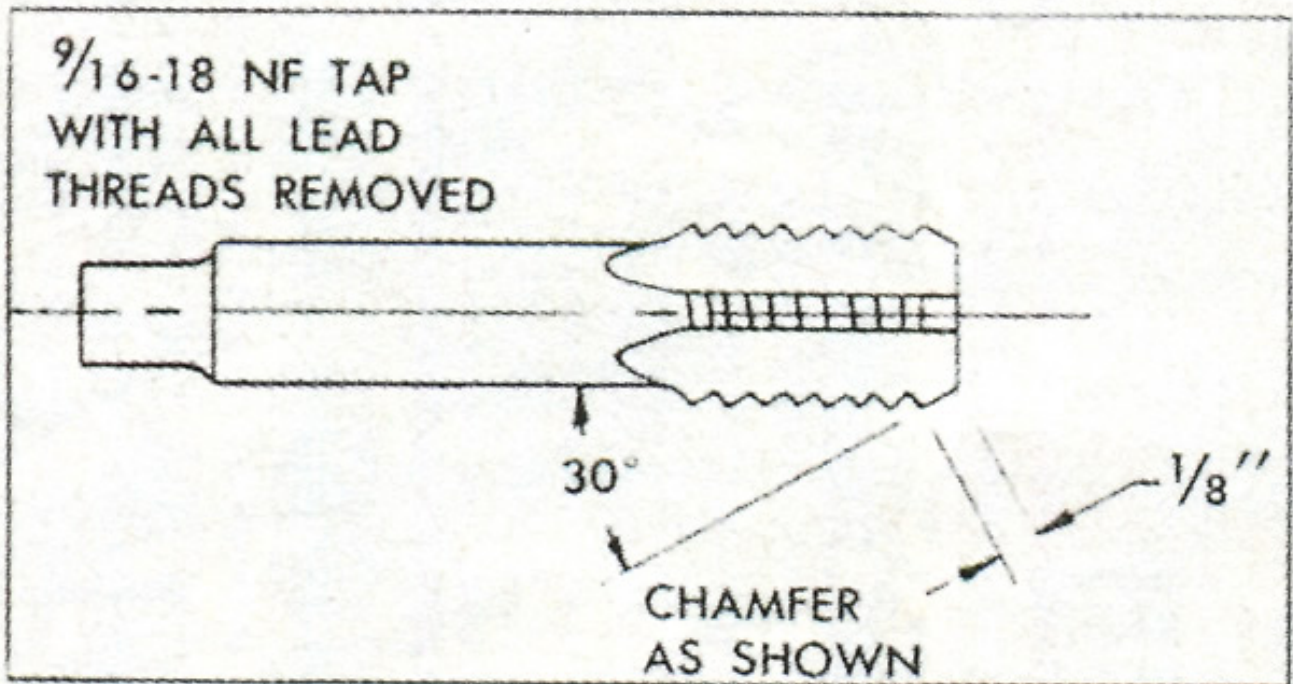
Fig. 6--Seal Remover

Gasoline leakage observed at rear of the fuel injection fuel meter may result from a worn drive shaft seal on the high pressure fuel pump. The pump mounts on the rear face of the meter housing.

1. Remove high pressure fuel pump from fuel meter.
2. Mark relationship of pump body, gear housing, and front cover.
3. Remove four Allen head screws and remove front cover.
4. Using china marking pencil, mark relationship of idler gear to drive gear.
5. Remove gear housing and idler gear.
6. Remove drive gear by extending shaft beyond gear so that drive pin may be removed.
7. Screw reworked tap (Fig. 6) into seal.

CAUTION: Tap must be seated in seal in no more than 2 or 3 turns or damage to the rear busing will occur.
8. Drive seal and tap out of pump housing using old drive shaft inserted from bearing end.
9. Slide drive shaft through the pump body and remove through seal end to avoid the possibility of burrs scratching the bushing.
10. Place a new seal in position in pump body with open end of seal downward. To satisfactorily replace the seal, it will be necessary to first make a seal remover (Fig. 6) and seal installer (Fig. 7), then perform the replacement exactly as described in the following.
