1963 - 1964 Corvette: Service Bulletin: 3-Speed Transmission Problems

Subject: 3-Speed Transmission Problems

Source: Chevrolet Technical Service Bulletin

Bulletin No: TSB #1008 DR #676

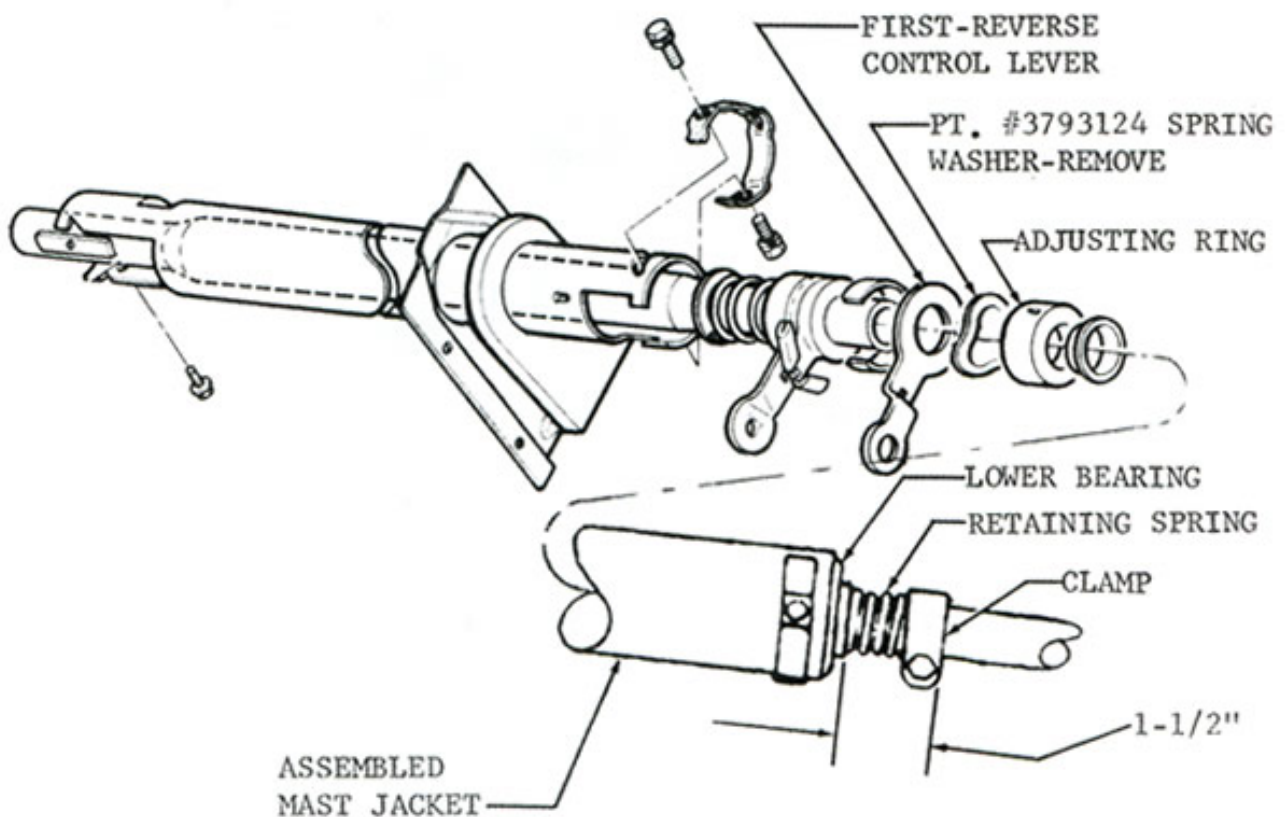
FIGURE 2 - MAST JACKET ASSEMBLY

The major sources of difficulty in shifting are the clearance adjustment between the transmission control levers located at the lower end of the mast jacket and the adjustment of the selector rods at the control levers for neutral cross-over. Excessive clearance between the levers or incorrect neutral cross-over may result in block-out.

To provide a more positive shift on truck models, Part No. 3793124, transmission control 1st and reverse lever spring washer is being omitted in production and should be removed from units in service. The procedure to remove this spring washer and to readjust lever clearance is as follows:

1. Refer to Figure 2 for parts identification. Place shift lever in neutral; remove access cover from fender skirt.

2. Remove cap screws retaining adjusting ring to mast jacket.
3. Loosen steering shaft lower bearing retaining spring clamp.
4. Slide adjusting ring downward along steering shaft until Part No. 3793124, spring washer, is exposed. Cut and remove spring washer from steering shaft.
5. Apply lubriplate to thrust surfaces of control levers, relay lever and adjusting ring.
6. Position adjusting ring in mast jacket; align holes in ring with slots in mast jacket and install cap screws, but do not tighten.
7. Rotate adjusting ring upward until clearance of .005" exists between first-reverse control lever and ring as shown in Figure 3. Tighten cap screws.

8. Force lower bearing retaining spring clamp upward against spring tension until a dimension of 1-1/2" exists between lower bearing and clamp as shown in Figure 2. Tighten clamp bolt.
9. With transmission side cover selector levers in neutral position, adjust selector rod lengths per instructions in the appropriate shop manual to provide proper neutral cross-over. Replace access cover when adjustments are completed.

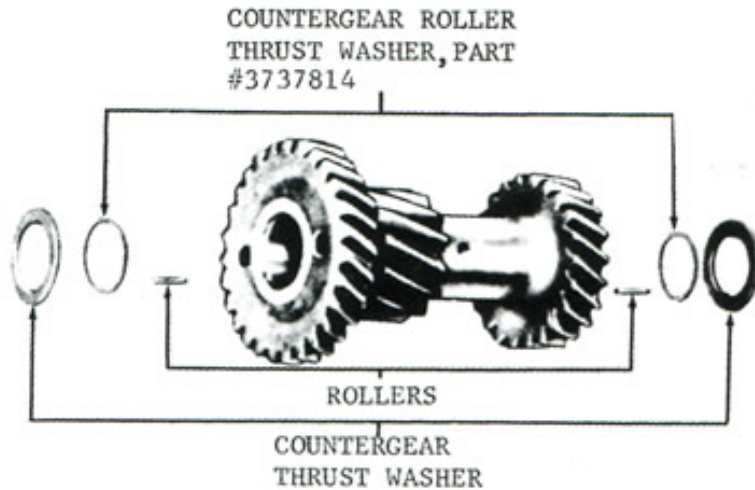
FIGURE 4 - INSTALLATION OF THRUST WASHERS IN CHEVY VAN

On Chevy Van models with three-speed transmissions, a small steel thrust washer is used between the countergear thrust washer and the countergear roller bearings at each end of the countergear. Since the 1964 Chevy Van Shop Manual is supplemented to the 1963 Truck Shop Manual in this area, reference to this part is omitted in error.

Figure 4 illustrates installed location of this thrust washer in Chevy Van transmissions.

NOTE: For service replacement procure (1) 3740819 Countergear Thrust Washer & (1) 3737814 Countergear Roller Thrust Washer for each steel thrust washer replaced. The roller thrust washer is installed between the countergear rollers and the countergear thrust washer.

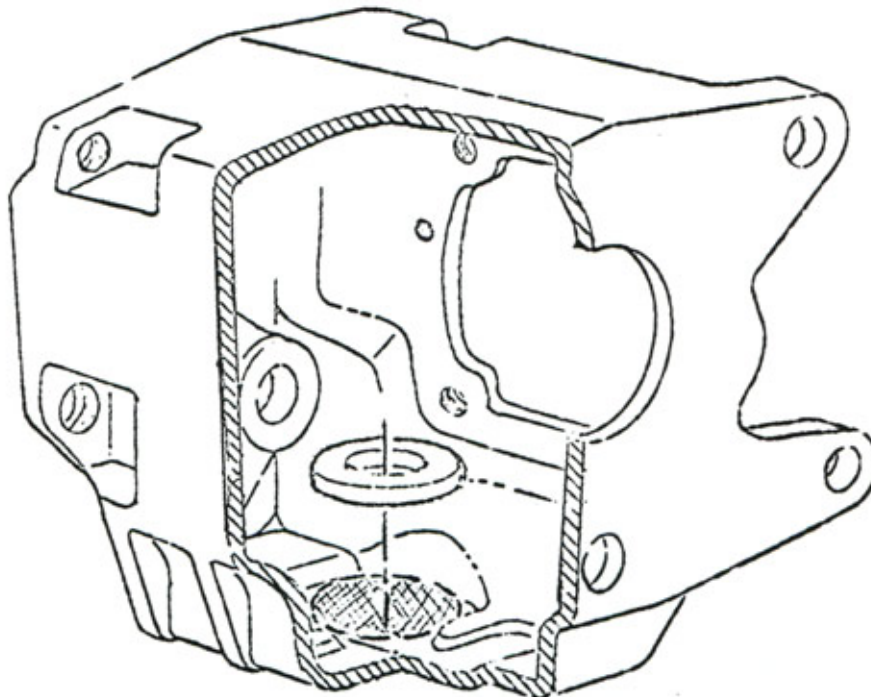
FIGURE 5 - INSTALLATION OF MAGNETIC CHIP COLLECTOR

Gear clash will cause rounding of the chamfers on the first and reverse gear, countergear and reverse idler gear and possibly break loose some fine chips. These fine particles are a major contributor to bearing noise.

To reduce bearing noise and increase bearing durability, two changes have been released for production. First is the installation of a magnetic chip collector which went into effect on June 5, 1964. Second is the use of a new clutch gear and mainshaft bearing that incorporates a slinger ring on the inner race. This change went into effect on transmissions for use on 327 cu. in. engines on June 11, 1964, and is estimated to go into effect the week of June 22, 1964, on remaining transmissions.

Service Kit #3869240 has been released for field installation of the chip collector on 1963 and 1964 3-speed transmissions built prior to the above dates. The kit includes the magnet, cement, and instruction sheet. It also contains a 3/8 inch high pedal bumper for increasing clutch release on all except Chevy Van (Reference - Gear Clash - First and Reverse Shift). It is recommended that whenever a 1963 or 1964 3-speed transmission is disassembled for any reason, that the magnet be installed using the following procedure.

3. Wipe magnet and area in case where magnet is to be installed with Acetone or Toluol (available at most drugstores). Area where magnet is to be installed must be clean, dry and free from oil and grease film. When Acetone or Toluol is applied, be sure to use in ample quantity to neutralize grease and oil which may be in pores of casting surface. Do not touch cleaned area with hands.

4. Using cement supplied in kit, apply about a 1/16 inch thick film over entire bottom surface of magnet and immediately place in case as shown in sketch. Press straight down - do not twist while pressing in position. Note: If cement from tube appears to be thick, discard thick or hardened chunks and use cement from middle or bottom of tube.

5. To cure cement, place a trouble light with a 100 watt lamp inside of case as close to magnet as possible, and allow to stand for a minimum of 30 minutes. Use care not to touch magnet or knock it out of position. A heat lamp, if available, may be used in place of 100 watt lamp.

6. Reassemble transmission. Note: First and reverse sliding gears, counter gears and reverse idler gears which display normal wear and slight rounding at ends of gear teeth due to gear clash need not be replaced. If tooth marks from partial engagement are visible on gear teeth or if the teeth are chipped or have been partially or fully broken off, replace only the gears so affected.
