# 1963 - 1964 Corvette: Service Bulletin: 3-Speed Transmission Problems

**Subject:** 3-Speed Transmission Problems

**Source:** Chevrolet Technical Service Bulletin

**Bulletin No:** TSB #1008 DR #676

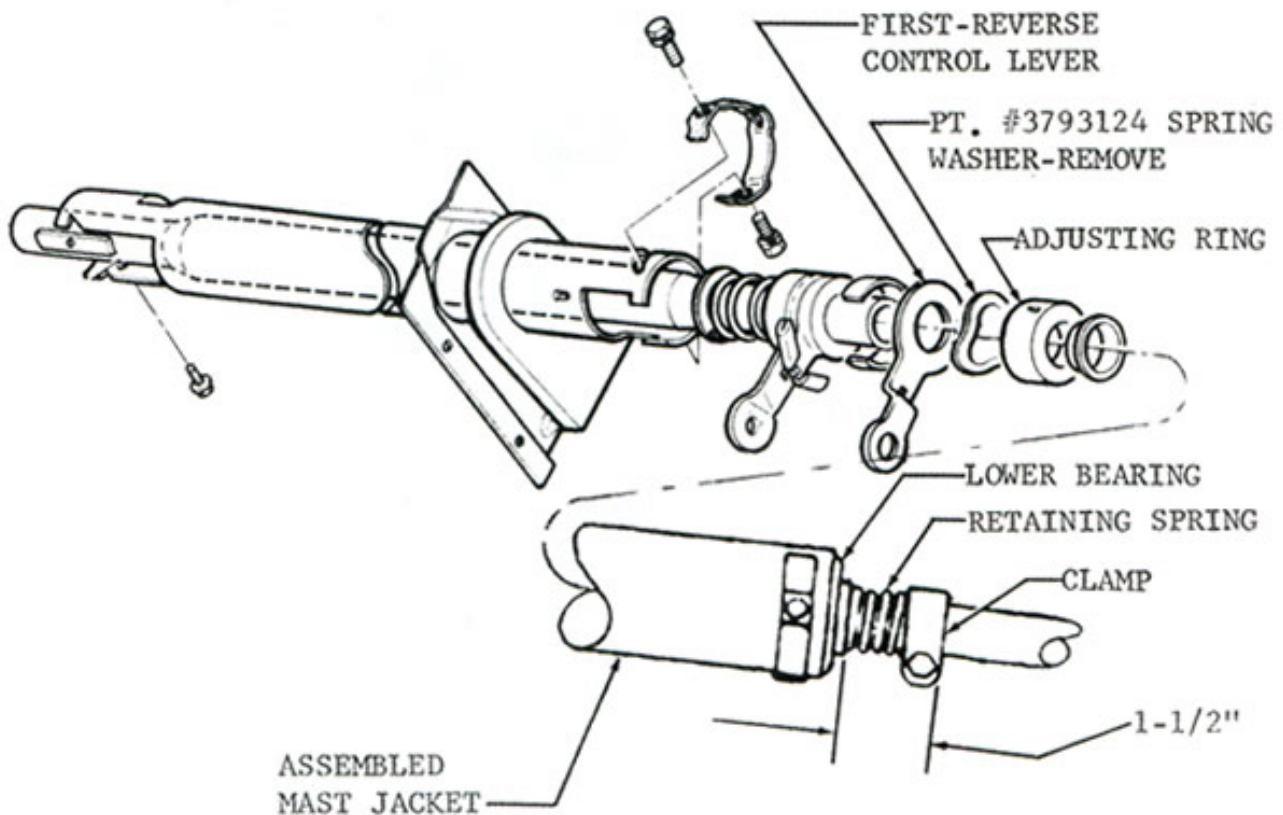
FIGURE 2 - MAST JACKET ASSEMBLY

The major sources of difficulty in shifting are the clearance adjustment between the transmission control levers located at the lower end of the mast jacket and the adjustment of the selector rods at the control levers for neutral cross-over. Excessive clearance between the levers or incorrect neutral cross-over may result in block-out.

To provide a more positive shift on truck models, Part No. 3793124, transmission control 1st and reverse lever spring washer is being omitted in production and should be removed from units in service. The procedure to remove this spring washer and to readjust lever clearance is as follows:

1. Refer to Figure 2 for parts identification. Place shift lever in neutral; remove access cover from fender skirt.

2. Remove cap screws retaining adjusting ring to mast jacket.
3. Loosen steering shaft lower bearing retaining spring clamp.
4. Slide adjusting ring downward along steering shaft until Part No. 3793124, spring washer, is exposed. Cut and remove spring washer from steering shaft.
5. Apply lubriplate to thrust surfaces of control levers, relay lever and adjusting ring.
6. Position adjusting ring in mast jacket; align holes in ring with slots in mast jacket and install cap screws, but do not tighten.
7. Rotate adjusting ring upward until clearance of .005" exists between first-reverse control lever and ring as shown in Figure 3. Tighten cap screws.

8. Force lower bearing retaining spring clamp upward against spring tension until a dimension of 1-1/2" exists between lower bearing and clamp as shown in Figure 2. Tighten clamp bolt.
9. With transmission side cover selector levers in neutral position, adjust selector rod lengths per instructions in the appropriate shop manual to provide proper neutral cross-over. Replace access cover when adjustments are completed.

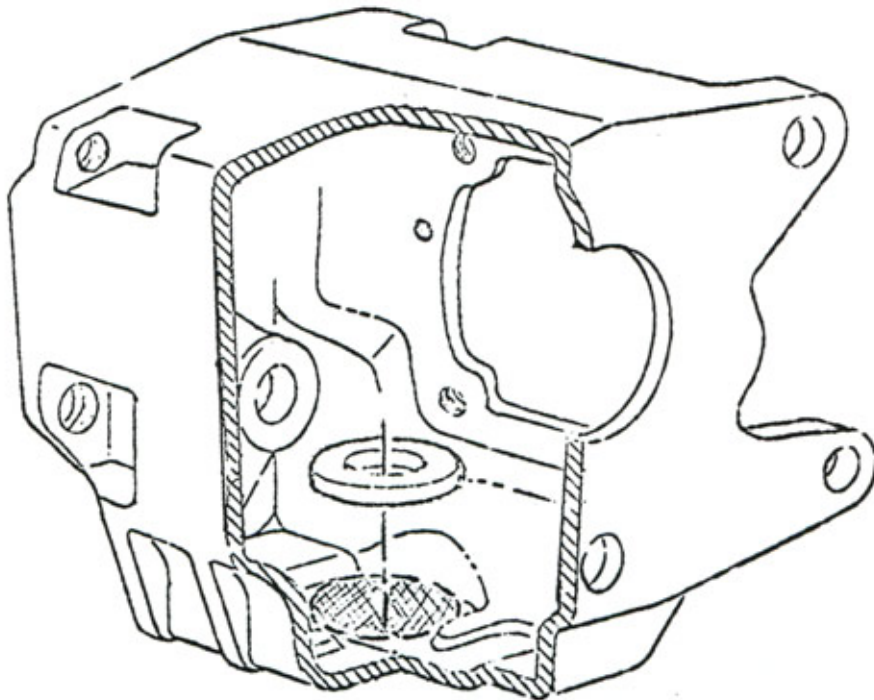
FIGURE 5 - INSTALLATION OF MAGNETIC CHIP COLLECTOR

To reduce bearing noise and increase bearing durability, two changes have been released for production. First is the installation of a magnetic chip collector which went into effect on June 5, 1964. Second is the use of a new clutch gear and mainshaft bearing that incorporates a slinger ring on the inner race. This change went into effect on transmissions for use on 327 cu. in. engines on June 11, 1964, and is estimated to go into effect the week of June 22, 1964, on remaining transmissions.

3. Wipe magnet and area in case where magnet is to be installed with Acetone or Toluol (available at most drugstores). Area where magnet is to be installed must be clean, dry and free from oil and grease film. When Acetone or Toluol is applied, be sure to use in ample quantity to neutralize grease and oil which may be in pores of casting surface. Do not touch cleaned area with hands.

4. Using cement supplied in kit, apply about a 1/16 inch thick film over entire bottom surface of magnet and immediately place in case as shown in sketch. Press straight down - do not twist while pressing in position. Note: If cement from tube appears to be thick, discard thick or hardened chunks and use cement from middle or bottom of tube.
