1968 Corvette: Service Bulletin: Choke and Hot Restart Problems

Model and Year: 1968 Corvette with 427 cu. in. Engine

Bulletin No: 68-T-23 Re-Issue

Date: Apr. 24, 1968

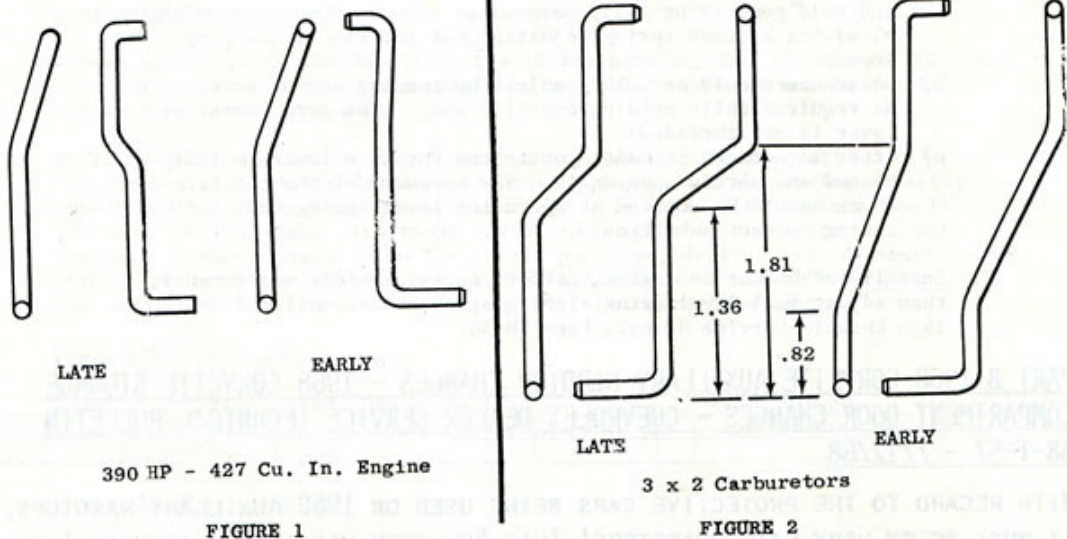
The hard cold starting problem may be due to interference or bind conditions of the choke rod, resulting in failure of the choke to move fully closed. Choke rod revisions corrected this possible condition with early October production vehicles. Field correction of this condition is outlined on Page2.

Install new choke rod (Part No. 3919899) which has a greater off-set leg length and check for interference between choke thermostat coil and the manifold pocket as shown in Figure 3. If interference exists in this area, adjust the coil as much as possible on its mounting location, and if necessary, grind the pocket area or the choke rod end to gain clearance needed.

Install new choke rod (Part No. 3937738) which has a greater off-set and a reverse entry direction at the choke lever end. Adjust to one rod diameter interference by bending at the off-set as necessary.
