# 1968 Corvette: Service Bulletin: Choke and Hot Restart Problems

**Model and Year:** 1968 Corvette with 427 cu. in. Engine

**Bulletin No:** 68-T-23 Re-Issue

**Date:** Apr. 24, 1968

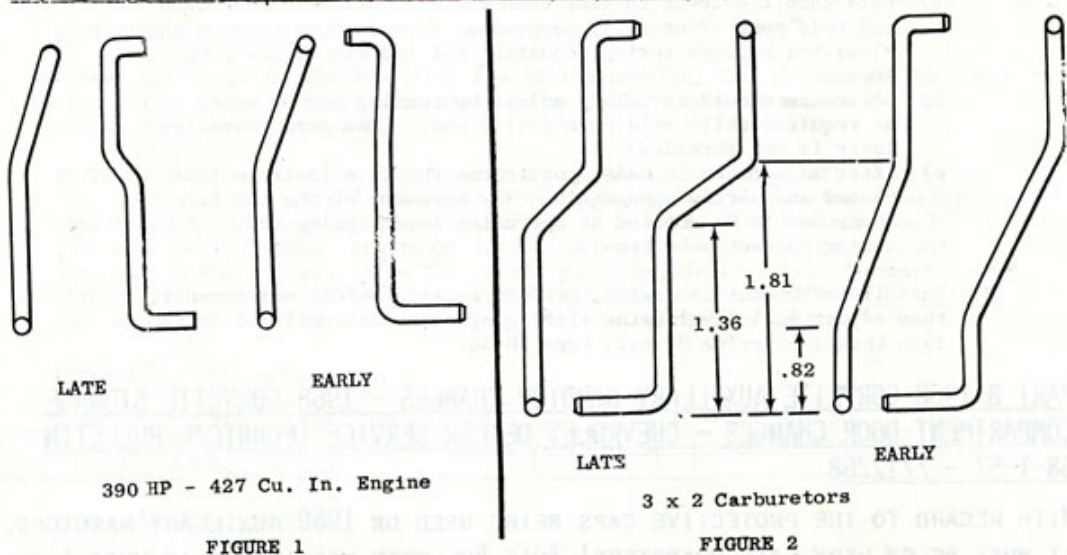
FIGURE 1

The hard cold starting problem may be due to interference or bind conditions of the choke rod, resulting in failure of the choke to move fully closed. Choke rod revisions corrected this possible condition with early October production vehicles. Field correction of this condition is outlined on Page2.

Install new choke rod (Part No. 3937738) which has a greater off-set and a reverse entry direction at the choke lever end. Adjust to one rod diameter interference by bending at the off-set as necessary.

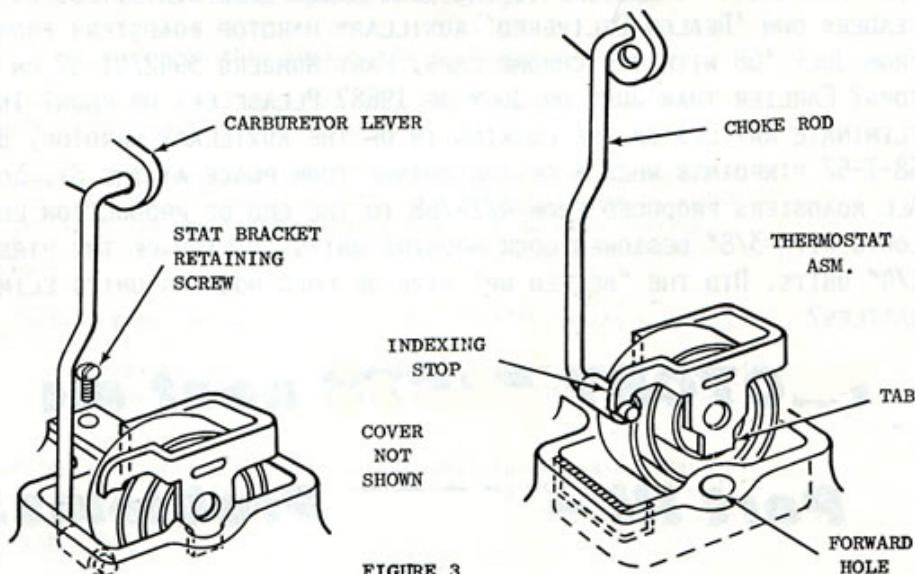
FIGURE 3

Install new choke rod (Part No. 3919899) which has a greater off-set leg length and check for interference between choke thermostat coil and the manifold pocket as shown in Figure 3. If interference exists in this area, adjust the coil as much as possible on its mounting location, and if necessary, grind the pocket area or the choke rod end to gain clearance needed.
