1968 Corvette: Service Bulletin: Heat Damage to Engine Wiring Harness

Subject: Heat Damage to Engine Wiring Harness
Model and Year: 1968 Passenger Vehicles with 396 or 427 Cubic Inch Engine
Source: Chevrolet Dealer Service Technical Bulletin
Bulletin No: 68-T-25
Section: VIy
Date: Feb. 19, 1968

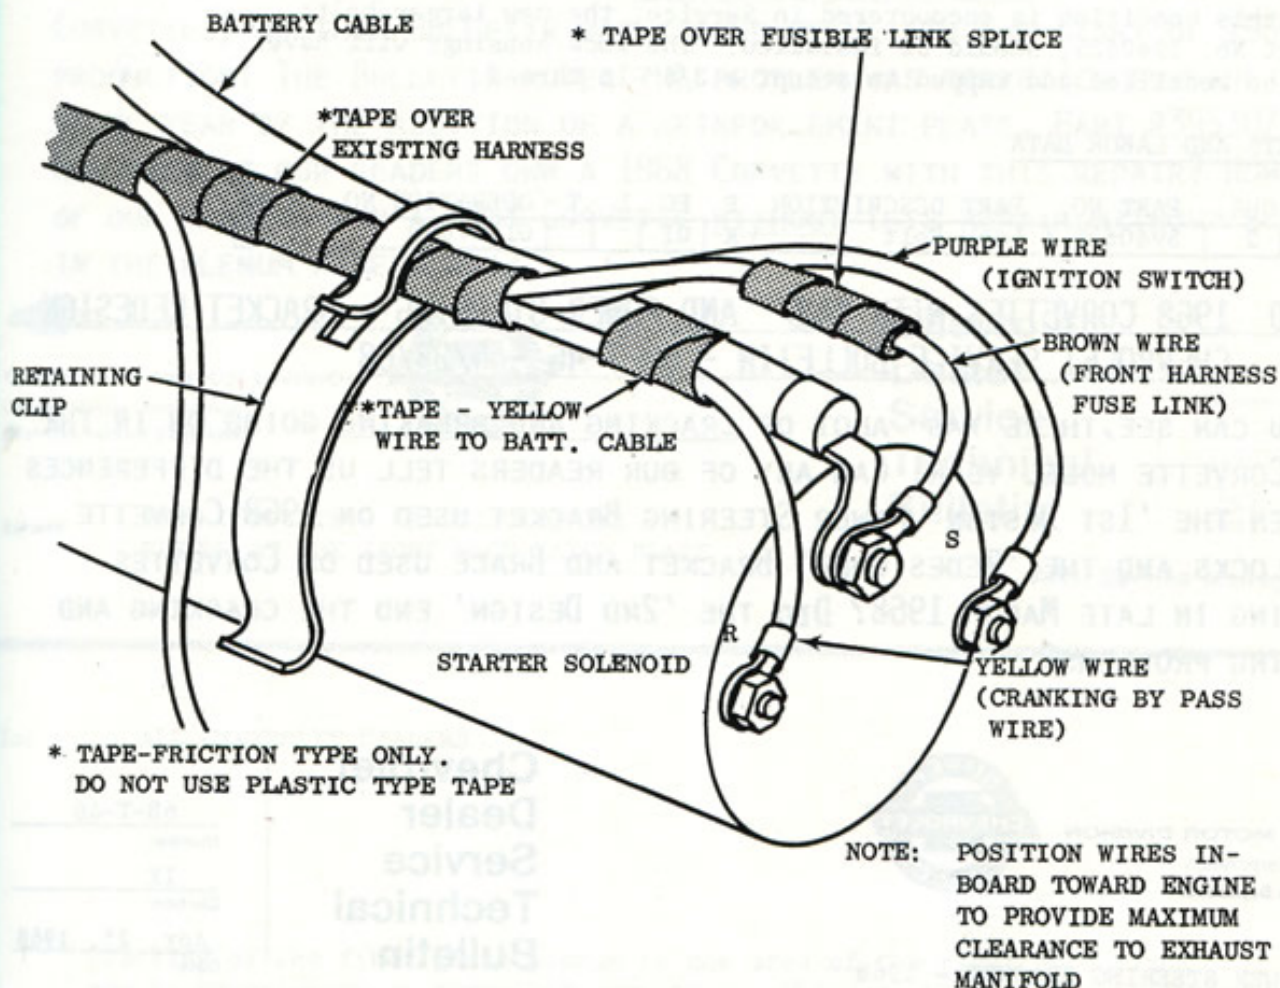
FIGURE 1

The engine wiring harness on some early production 1968 passenger vehicles equipped with either the 396 or 427 cubic inch engine may be subject to exhaust manifold heat damage harness wires are not properly routed through the retaining clip located on the starter solenoid. Reports have indicated that the yellow colored ignition or cranking by-pass wire, which attaches to the solenoid terminal closest to the exhaust manifold, is the wire most often damaged by exhaust manifold heat. To prevent damage, the wire must be routed "loop-free" through the solenoid retaining clip to the solenoid terminal.

ENGINE WIRING HARNESS ROUTING
FOR 1968 CORVETTE
396 AND 427 CUBIC INCH ENGINE

Effective November 27, 1967, the assembly plant is repositioning and taping the wiring harness on all Corvettes with either the 396 or 427 cubic inch engine as shown in figure 1. Proper routing of the engine wiring harness through the retaining clip on all other passenger vehicles with the 396 or 427 engine is being more closely maintained at all assembly plants.

If heat damage to the engine wiring harness is encountered on subject 1968 Corvette models in the field, the harness should be taped as shown in figure 1. If harness replacement is necessary, the new harness should be similarly taped at the time of installation. All other 396 or 427 cubic inch engine passenger cars require only proper wire routing to avoid heat damage from the manifold. This wiring should be checked for proper routing at the time of new car preparation.
