# 1968 Corvette: Service Bulletin: Heat Damage to Engine Wiring Harness

**Subject:** Heat Damage to Engine Wiring Harness  
**Model and Year:** 1968 Passenger Vehicles with 396 or 427 Cubic Inch Engine  
**Source:** Chevrolet Dealer Service Technical Bulletin  
**Bulletin No:** 68-T-25  
**Section:** VIy  
**Date:** Feb. 19, 1968

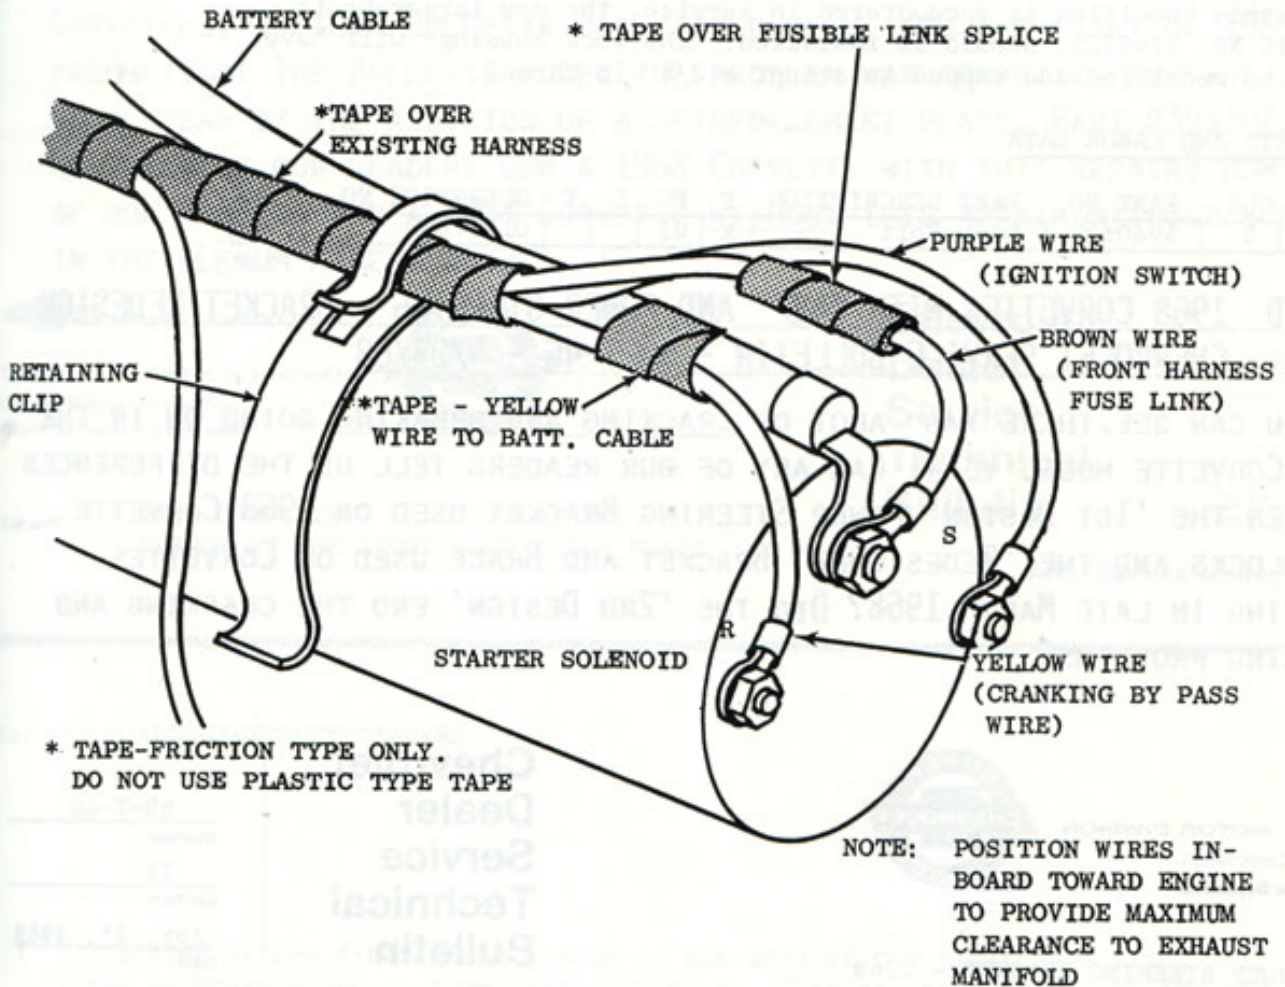
FIGURE 1

The engine wiring harness on some early production 1968 passenger vehicles equipped with either the 396 or 427 cubic inch engine may be subject to exhaust manifold heat damage harness wires are not properly routed through the retaining clip located on the starter solenoid. Reports have indicated that the yellow colored ignition or cranking by-pass wire, which attaches to the solenoid terminal closest to the exhaust manifold, is the wire most often damaged by exhaust manifold heat. To prevent damage, the wire must be routed "loop-free" through the solenoid retaining clip to the solenoid terminal.

ENGINE WIRING HARNESS ROUTING  
FOR 1968 CORVETTE  
396 AND 427 CUBIC INCH ENGINE

Effective November 27, 1967, the assembly plant is repositioning and taping the wiring harness on all Corvettes with either the 396 or 427 cubic inch engine as shown in figure 1. Proper routing of the engine wiring harness through the retaining clip on all other passenger vehicles with the 396 or 427 engine is being more closely maintained at all assembly plants.

If heat damage to the engine wiring harness is encountered on subject 1968 Corvette models in the field, the harness should be taped as shown in figure 1. If harness replacement is necessary, the new harness should be similarly taped at the time of installation. All other 396 or 427 cubic inch engine passenger cars require only proper wire routing to avoid heat damage from the manifold. This wiring should be checked for proper routing at the time of new car preparation.
