1968 Corvette: Service Bulletin: Cracking of the Plenum at the Right Hood Latch Plate

Subject: Cracking of the Plenum at the Right Hood Latch Plate

Model and Year: 1968 Corvette

Bulletin No: 68-T-68

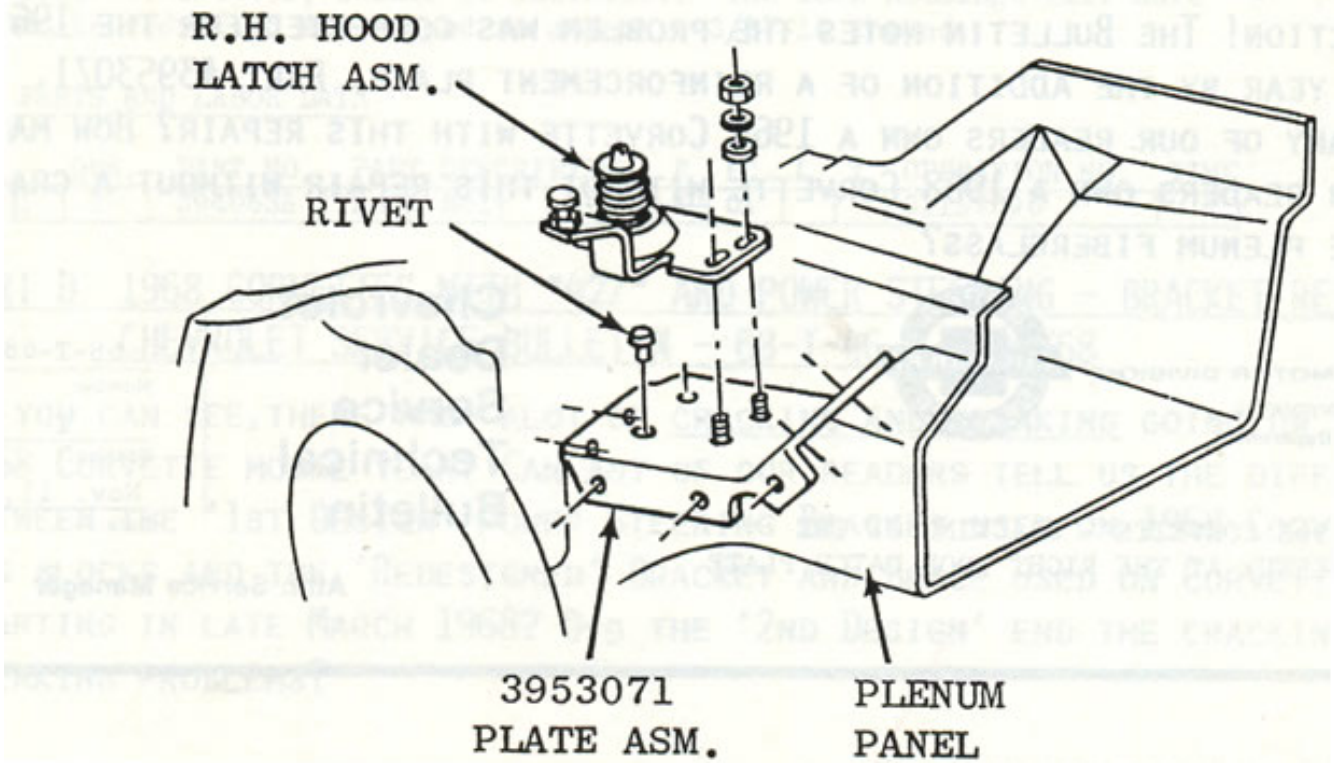
RIGHT HOOD LATCH REINFORCEMENT PLATE INSTALLATION
1968 CORVETTE

Cracking of the fiber glass plenum in the area of the right hood latch may be experienced on some 1968 Corvettes. This cracking is due to the manufacturing process of the plenum causing a glass rich condition in this area. This condition was corrected at the start of the 1969 production by the addition of a reinforcement plate to the area.

Whenever this cracking condition is encountered in the field, it may be corrected by riveting a reinforcement plate Part No. 3953071 to the outer surface of the plenum as outlined under Service Procedure.

1. Remove right hood latch assembly from the plenum panel and remove cowl vent grille.
2. Drill out two rivets retaining existing stud plate to plenum using a 7/32" dia. drill bit. Remove stud plate through cowl vent opening.
3. Position reinforcement plate on plenum as shown in sketch and drill seven (7) holes 7/32" dia. at hole locations in plate. The two (2) outboard holes are not accessible for drilling.
4. Attach the reinforcement plate to the plenum using 3/16" x 5/8" "Pop" Rivets.
5. Install and adjust right hood latch assembly as outlined in the August 1968 issue of "Chevrolet Service News." Install cowl vent grille.
