# 1966 - 1967 Corvette: Service Bulletin: Crankshaft to Water Pump Drive Belt Failure

**Subject:** Crankshaft to Water Pump Drive Belt Failure  
**Model and Year:** 1966 - 1967 Corvettes with 427 CU. IN. Engine and Air Conditioning  
**Source:** Chevrolet Service Technical Bulletin  
**Bulletin No:** 67-T-26  
**Section:** VI  
**Date:** Sept. 26, 1967

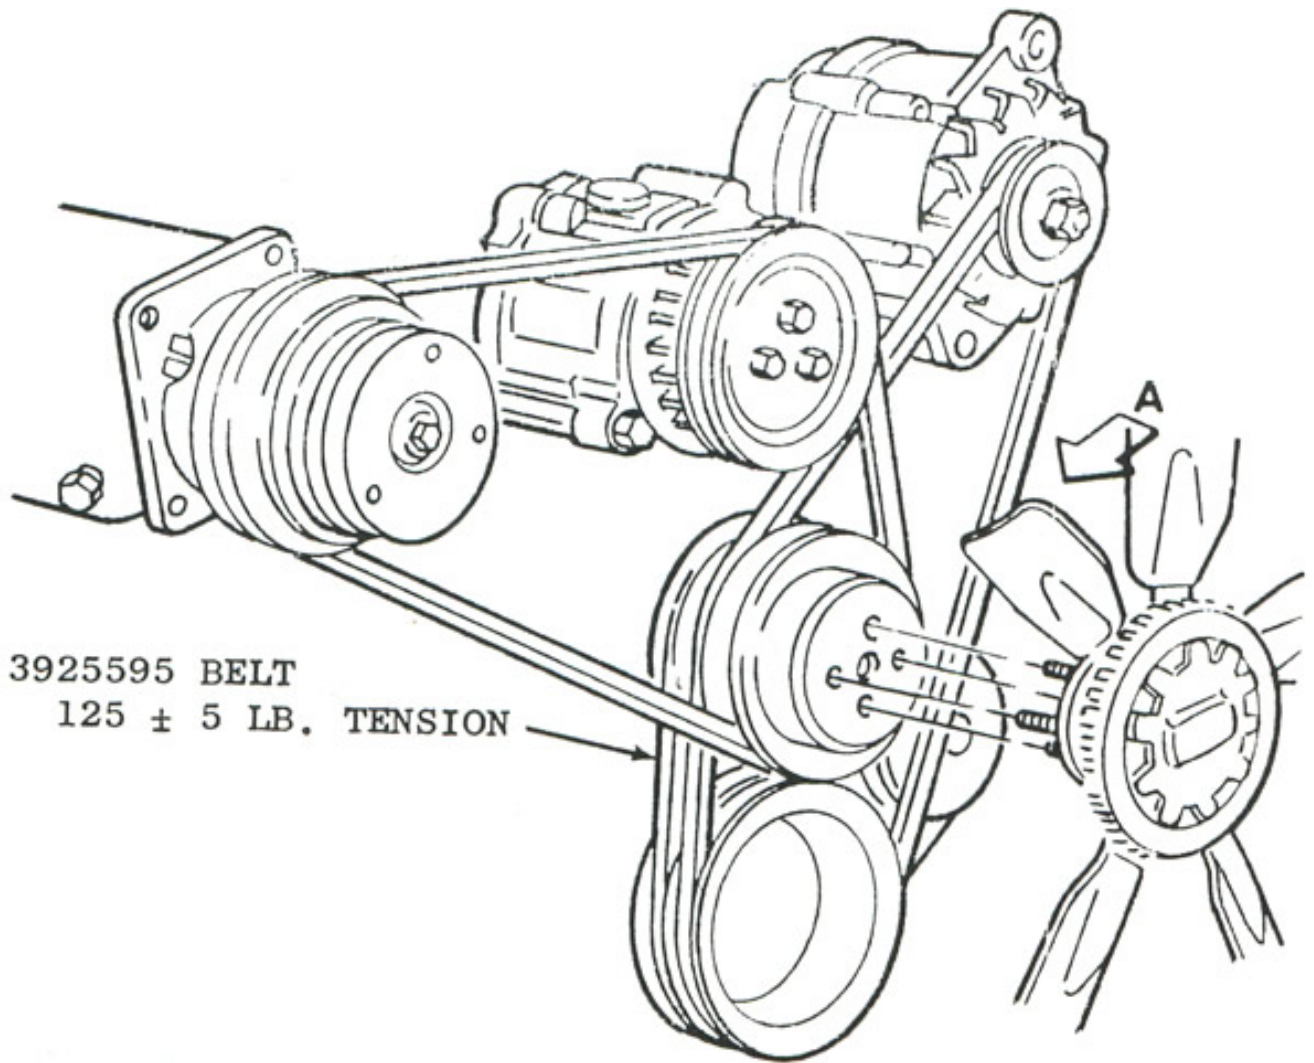
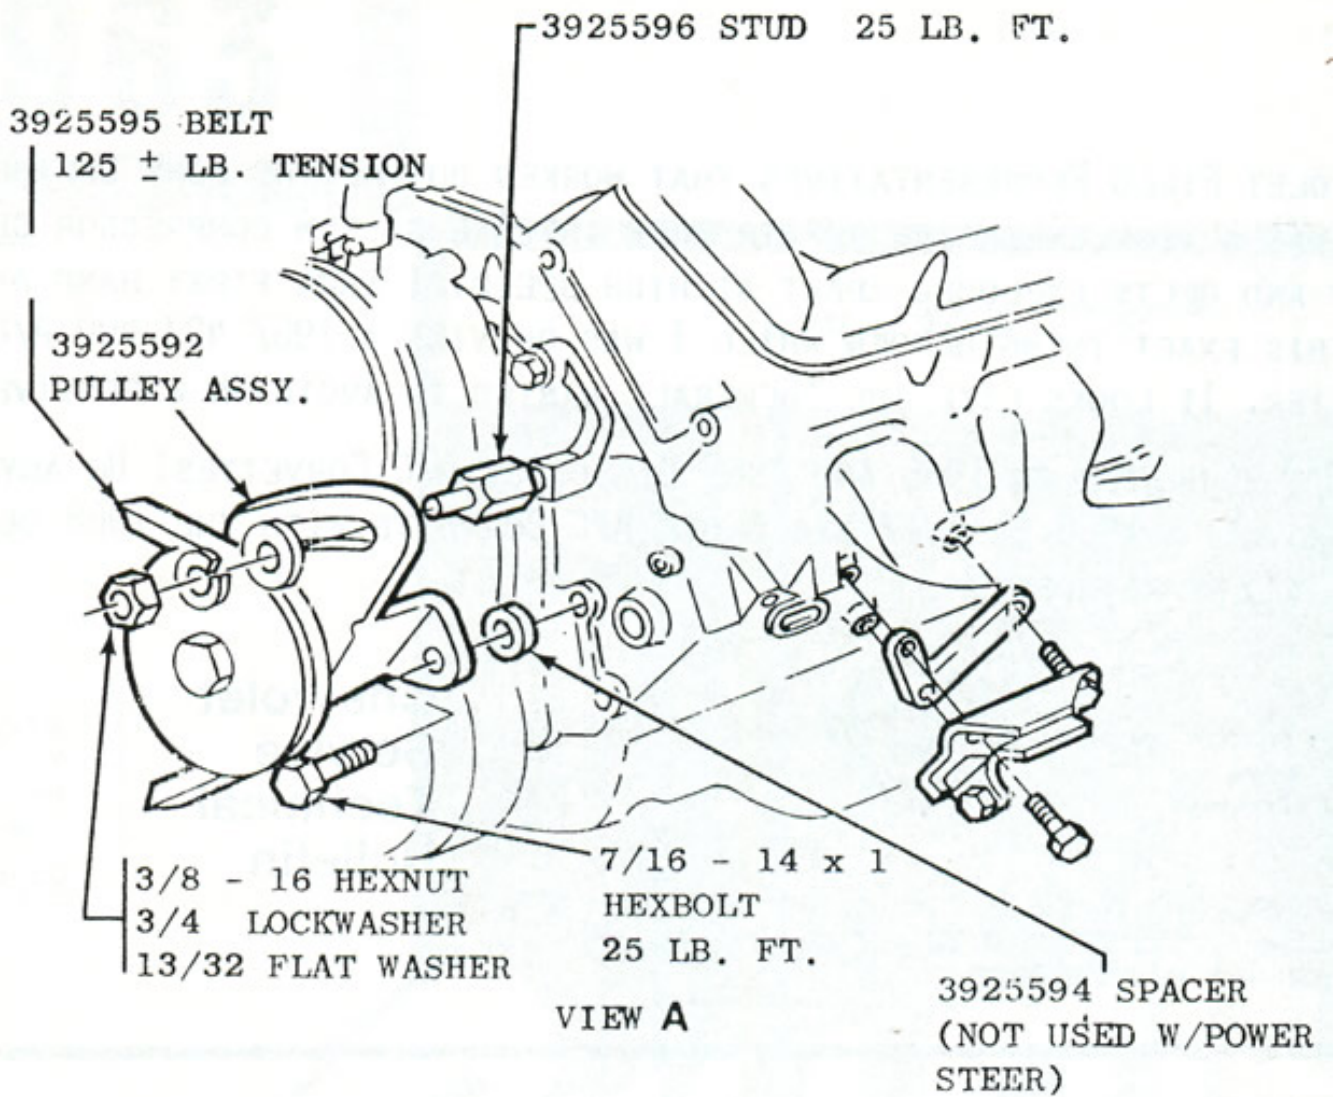
FIG. 1

Reports have been received of crankshaft to water pump drive belt failures on 1966 and 1967 Corvettes equipped with 427 cubic inch engine and air conditioning. The belt failure occurs when the air conditioning compressor stalls under high head pressure after extreme hot soak conditions. With the compressor stalled, the water pump and the drive belt between the crankshaft and water pump also stall. As the crankshaft pulley continues to rotate, the crankshaft to water pump drive belt fails due to overheating and wear.

3925595 BELT  
125 ± 5 LB. TENSION

To permit belt tension adjustment between the crankshaft and water pump, 1968 Corvettes equipped with 427 cubic inch engine and air conditioning will incorporate an idler pulley shown in Figure 1.

In service, a similar idler pulley and longer drive belt can be installed to permit belt tension adjustment and correct the condition of belt slippage and wear. Parts information and installation instructions are illustrated in Figure 1
