1978 Corvette: Service Bulletin: Air Conditioning Compressor Noise

Subject: Air Conditioning Compressor Noise
Model and Year: 1978 Corvette with RPO L48 Engine and M38 Automatic Transmission
Source: Chevrolet Dealer Service Technical Bulletin
Bulletin No: 78-T-76
Section: Ia
Date: February 1979

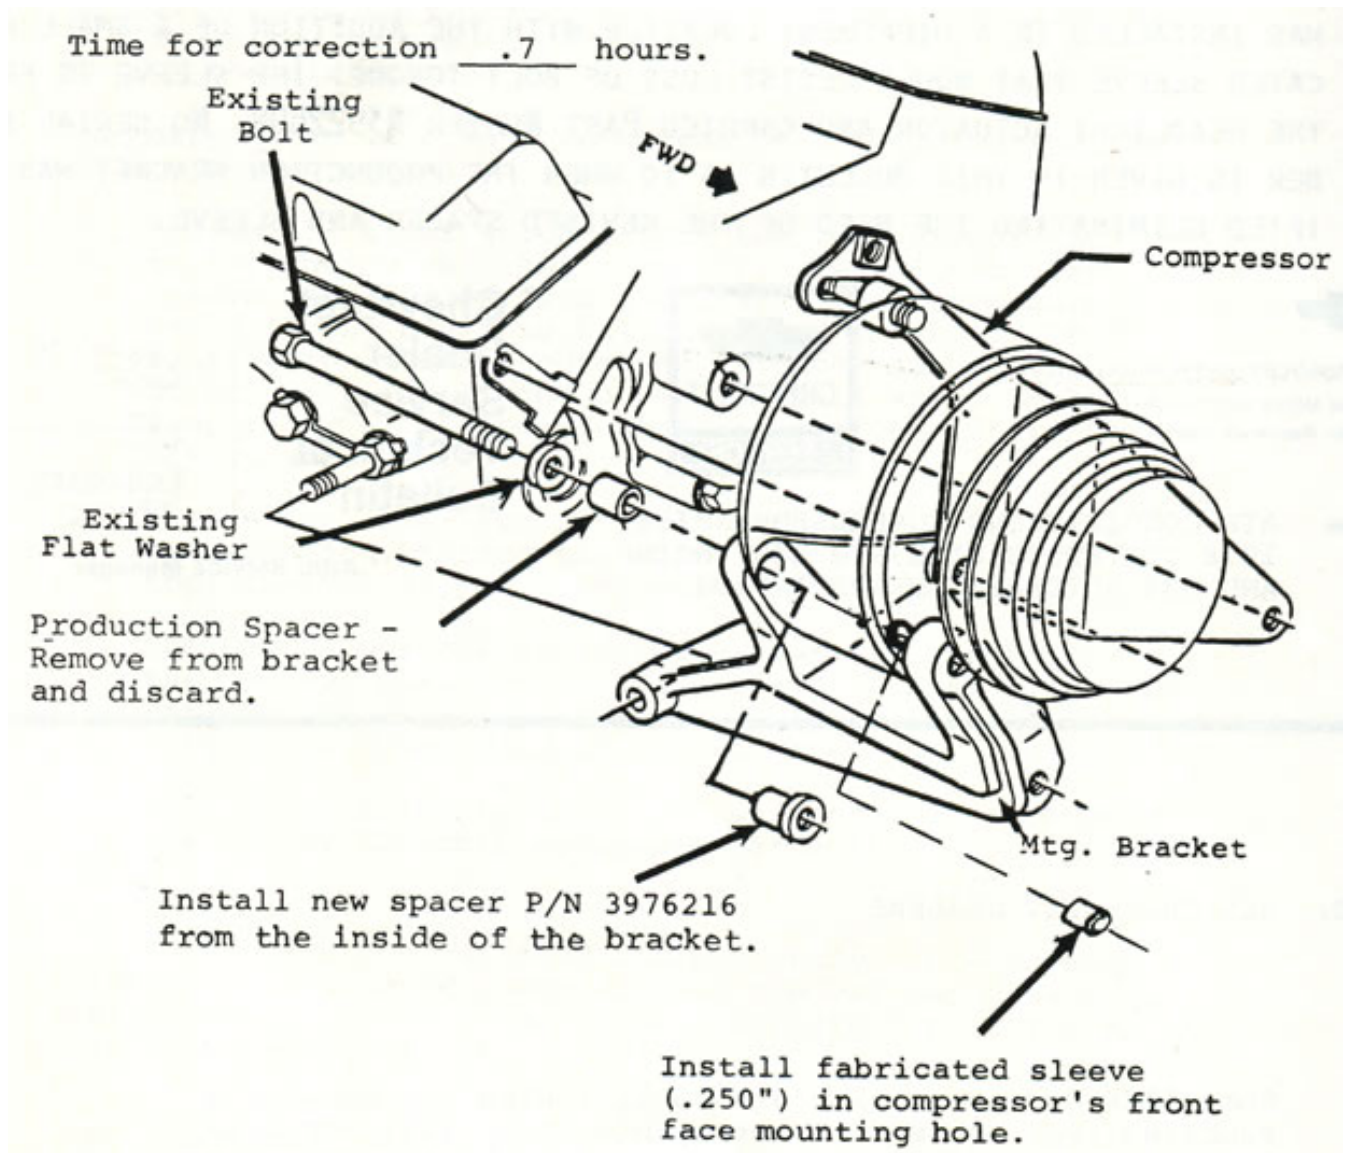
Some 1978 Corvettes with air conditioning may exhibit a rumbling type noise most noticeable at or just off idle RPM, with the air conditioning on, and the transmission in drive.

This condition usually occurs under high ambient temperatures and high head pressured and is caused by a reduction of compressor mounting bolt torque which results in compressor "wobble" and subsequent abnormal deflection of the compressor belt.

In production, the compressor mounting has been revised for 1979 Corvettes. Complaint vehicles can be corrected by using a new mounting bracket spacer, P/N 3976216, and the addition of a sleeve fabricated from a Corvette headlamp actuator sleeve, P/N 3922498, as outlined on page 2.

1. Obtain P/N 3976216 spacer and P/N 3922498 sleeve from stock.

2. Cut the P/N 3922498 plastic sleeve in half, resulting in two .250" long sleeves of which one will be used.
3. Remove the compressor belt and disassemble the compressor from the mounting brackets.
4. Lift compressor from bracket to allow access to both the original spacer in the mounting bracket hole and the mounting hole in the front face of the compressor where the feed-through bolt will exit.
5. Remove original spacer and install new spacer, P/N 3976216 in its place and the fabricated sleeve (.250") in the compressor face mounting hole as shown in Figure 1.
6. Reinstall compressor and belt.
7. Finalize the repair by tightening the compressor belt to 100 +/- 5 lbs. and torquing the compressor mounting bolts to 30 ft. lbs.
