1978 Corvette: Service Bulletin: Air Conditioning Compressor Noise

Source: Chevrolet Dealer Service Technical Bulletin

Bulletin No: 78-T-76

Date: February 1979

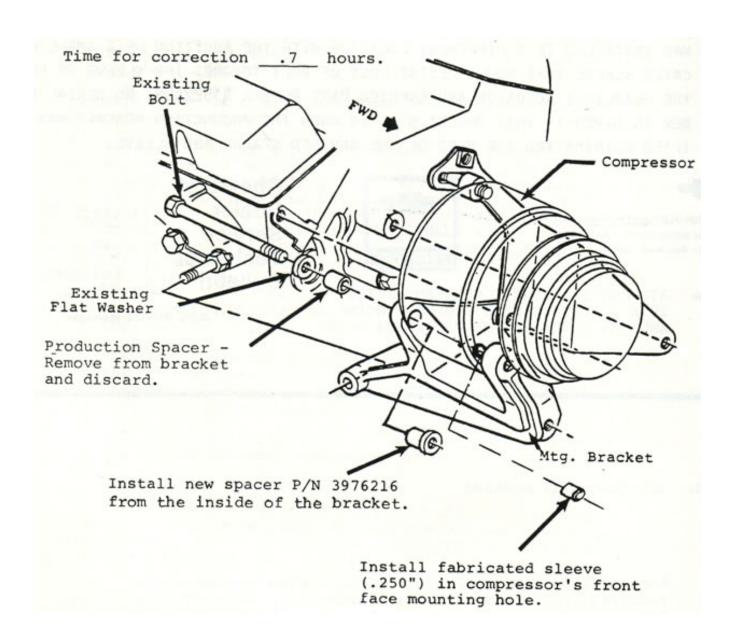
Some 1978 Corvettes with air conditioning may exhibit a rumbling type noise most noticeable at or just off idle RPM, with the air conditioning on, and the transmission in drive.

This condition usually occurs under high ambient temperatures and high head pressured and is caused by a reduction of compressor mounting bolt torque which results in compressor "wobble" and subsequent abnormal deflection of the compressor belt.

In production, the compressor mounting has been revised for 1979 Corvettes. Complaint vehicles can be corrected by using a new mounting bracket spacer, P/N 3976216, and the addition of a sleeve fabricated from a Corvette headlamp actuator sleeve, P/N 3922498, as outlined on page 2.

1. Obtain P/N 3976216 spacer and P/N 3922498 sleeve from stock.

- 2. Cut the P/N 3922498 plastic sleeve in half, resulting in two .250" long sleeves of which one will be used.
- 3. Remove the compressor belt and disassemble the compressor from the mounting brackets.
- 4. Lift compressor from bracket to allow access to both the original spacer in the mounting bracket hole and the mounting hole in the front face of the compressor where the feed-through bolt will exit.
- 5. Remove original spacer and install new spacer, P/N 3976216 in its place and the fabricated sleeve (.250") in the compressor face mounting hole as shown in Figure 1.
- 6. Reinstall compressor and belt.
- 7. Finalize the repair by tightening the compressor belt to 100 +/- 5 lbs. and torquing the compressor mounting bolts to 30 ft. lbs.
