1978 Corvette: Service Bulletin: Air Conditioning Compressor Noise

Subject: Air Conditioning Compressor Noise
Model and Year: 1978 Corvette with RPO L48 Engine and M38
Automatic Transmission
Source: Chevrolet Dealer Service Technical Bulletin
Bulletin No: 78-T-76
Section: Ia
Date: February 1979

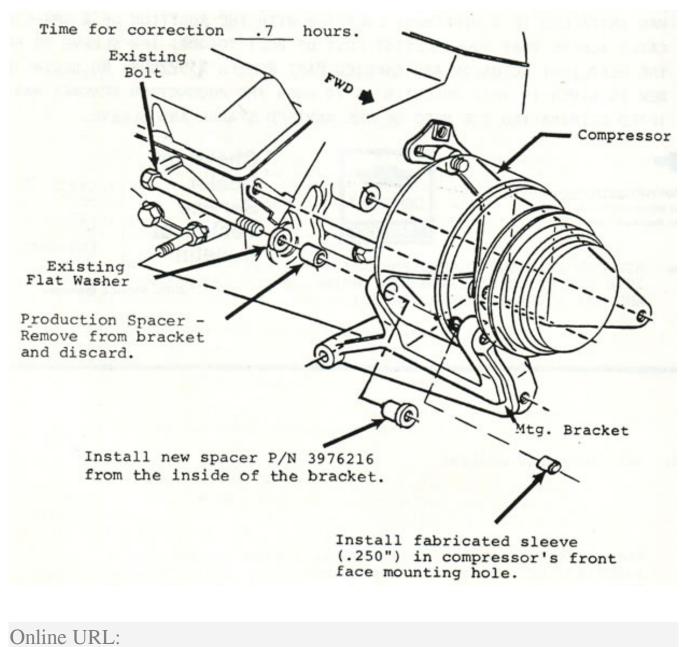
Some 1978 Corvettes with air conditioning may exhibit a rumbling type noise most noticeable at or just off idle RPM, with the air conditioning on, and the transmission in drive.

This condition usually occurs under high ambient temperatures and high head pressured and is caused by a reduction of compressor mounting bolt torque which results in compressor "wobble" and subsequent abnormal deflection of the compressor belt.

In production, the compressor mounting has been revised for 1979 Corvettes. Complaint vehicles can be corrected by using a new mounting bracket spacer, P/N 3976216, and the addition of a sleeve fabricated from a Corvette headlamp actuator sleeve, P/N 3922498, as outlined on page 2.

1. Obtain P/N 3976216 spacer and P/N 3922498 sleeve from stock.

- 2. Cut the P/N 3922498 plastic sleeve in half, resulting in two .250" long sleeves of which one will be used.
- 3. Remove the compressor belt and disassemble the compressor from the mounting brackets.
- 4. Lift compressor from bracket to allow access to both the original spacer in the mounting bracket hole and the mounting hole in the front face of the compressor where the feed-through bolt will exit.
- 5. Remove original spacer and install new spacer, P/N 3976216 in its place and the fabricated sleeve (.250") in the compressor face mounting hole as shown in Figure 1.
- 6. Reinstall compressor and belt.
- 7. Finalize the repair by tightening the compressor belt to 100 +/- 5 lbs. and torquing the compressor mounting bolts to 30 ft. lbs.
