# 1960 Corvette: Service Bulletin: Accelerator Pedal Falls Off Retaining Studs

**Subject:** Accelerator Pedal Falls Off Retaining Studs

**Model and Year:** 1960 Corvette Models

**Date:** June 15th, 1960

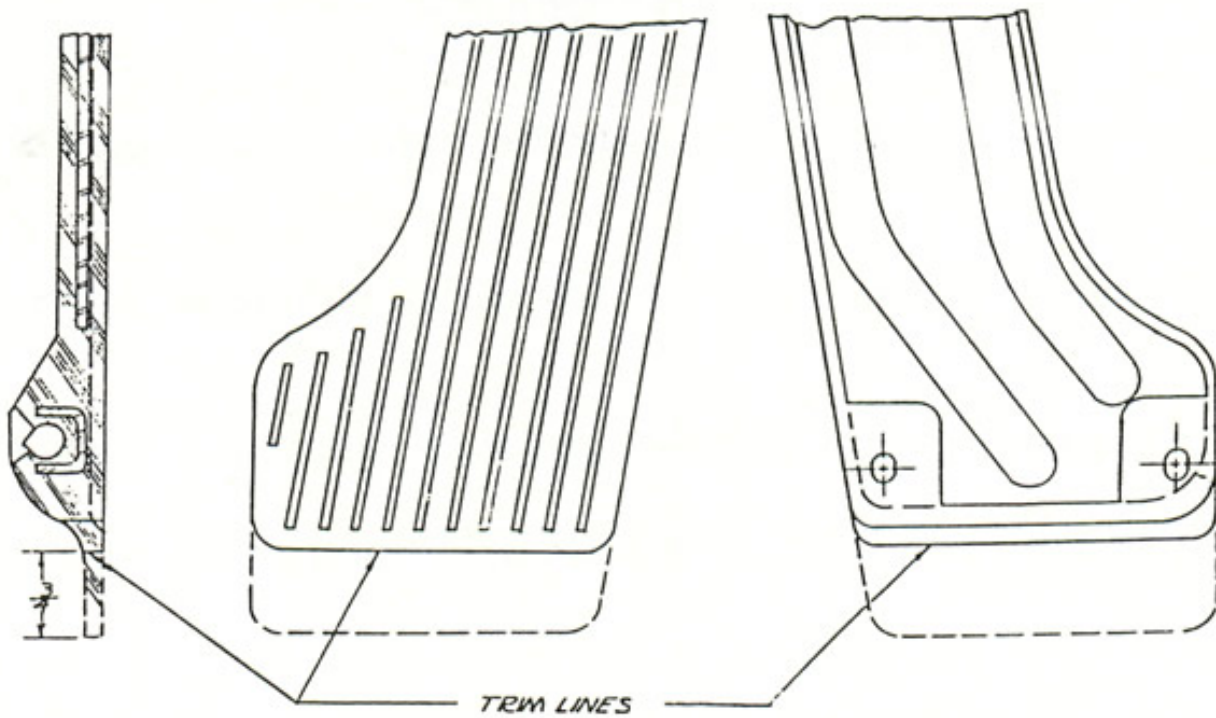
Fig. 31.

There has been a few complaints that the 1960 Corvette accelerator pedal snaps off of the two retaining studs at the heel end of the pedal, due to an interference condition between the floor mat material and the heel flap of the pedal.

REWORK INSTRUCTION DRAWING TO COVER THE MODIFICATION OF  
THE 1960 CORVETTE ACCELERATOR PEDAL # 3771749

As a Production correction, the assembly plant will revert to the 1959 design pedal, part #3760271, which does not incorporate the heel flap.
