1963 Corvette: Service Bulletin: Transmission Shift Lever Vibration

Subject: Transmission Shift Lever Vibration
Model and Year: 1963 1000 Series, Chevy II and Corvette with Floor Mounted Shift Lever
Source: Chevrolet Technical Service Bulletin
Bulletin No: DR #595
Section: VII
Date: June 24, 1963

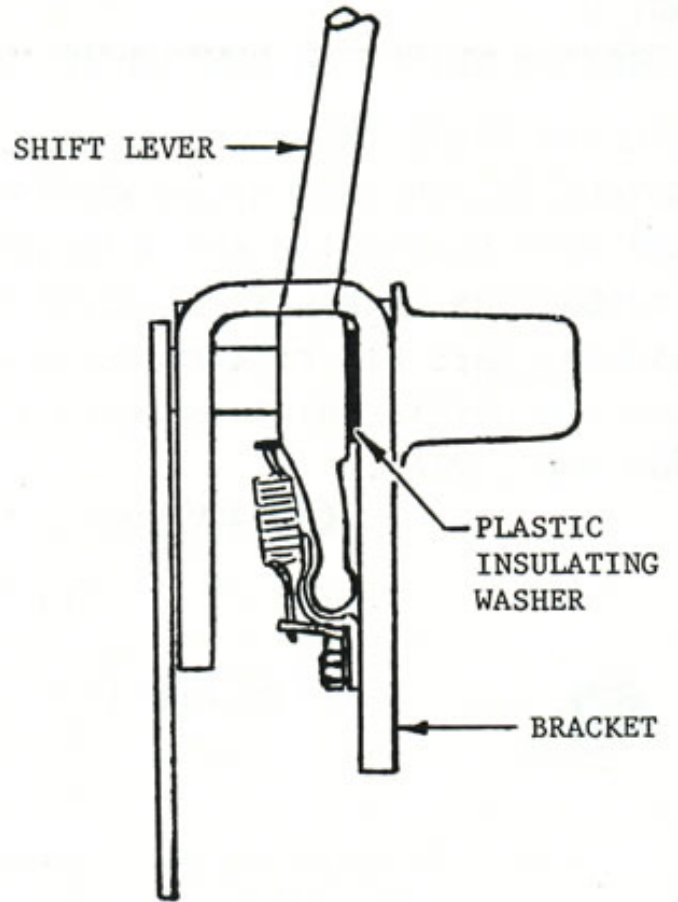
Vehicles equipped with a Powerglide or 4-speed transmission which incorporates the floor mounted shift lever may be subject to a "buzzing" type noise as a result of shift lever-to-mounting bracket vibration and/or excessive shift lever-to-guide plate clearance.

With the shift lever assembly removed from the vehicle, insert the above fabricated insulator washer on the shaft between the lever and bracket. (See Figure 2, below)
