# 1970 Corvette: Service Bulletin: 1970 Corvette Folding Top Material Interference with Lid Pin Support

**Source:** Chevrolet Dealer Service Technical Bulletin

**Bulletin No:** 70-T-46

**Date:** Oct. 27, 1970

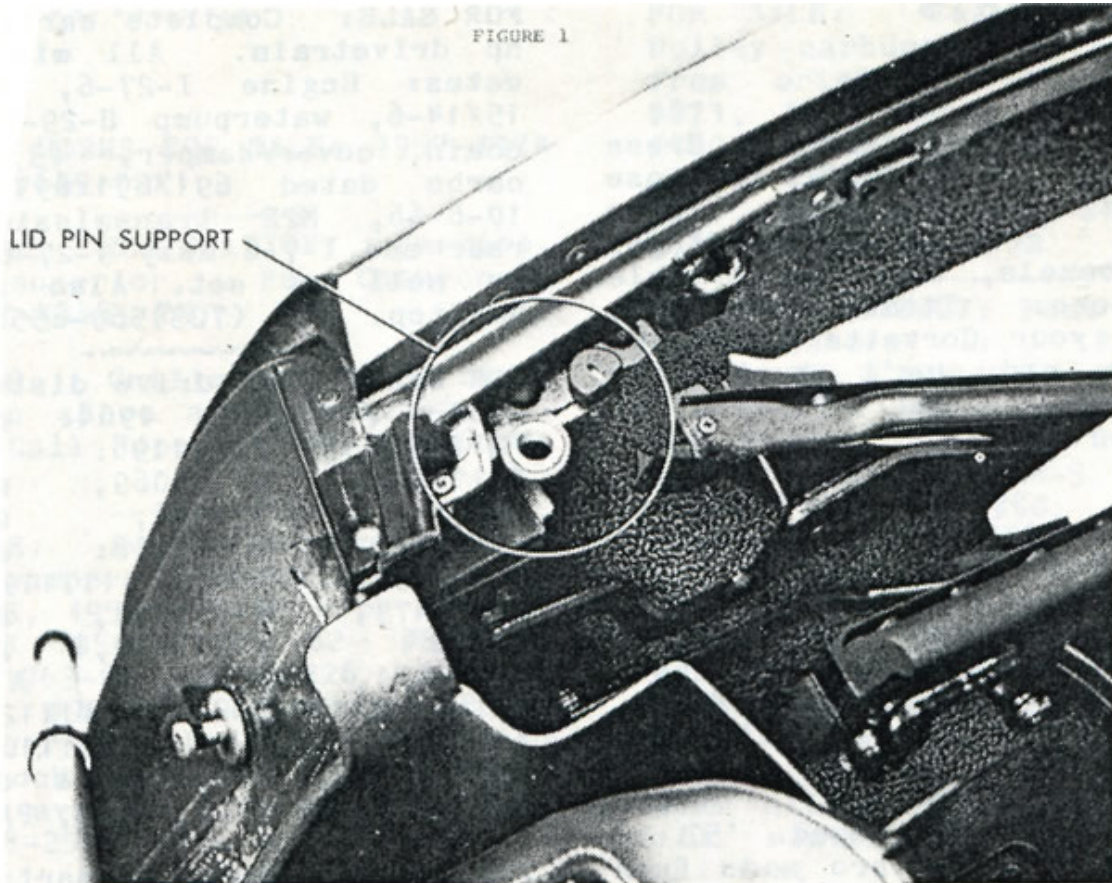
FIGURE 1

1970 Corvettes assembled prior to Serial Number S400748 may have interference between the folding top material and the top compartment lid pin support. This interference may result in damage to the folding top material.

LID PIN SUPPORT

1. Remove the lid pin support. (See Figure 1).
2. Grind 3/8" x 3/4" off the inboard edge of the support. (See Figure 2).
3. Reinstall the lid pin support and inspect to insure adequate clearance exists between the folding top material and the support.
