1970 Corvette: Service Bulletin: 1970 Corvette Folding Top Material Interference with Lid Pin Support

Source: Chevrolet Dealer Service Technical Bulletin

Bulletin No: 70-T-46

Date: Oct. 27, 1970

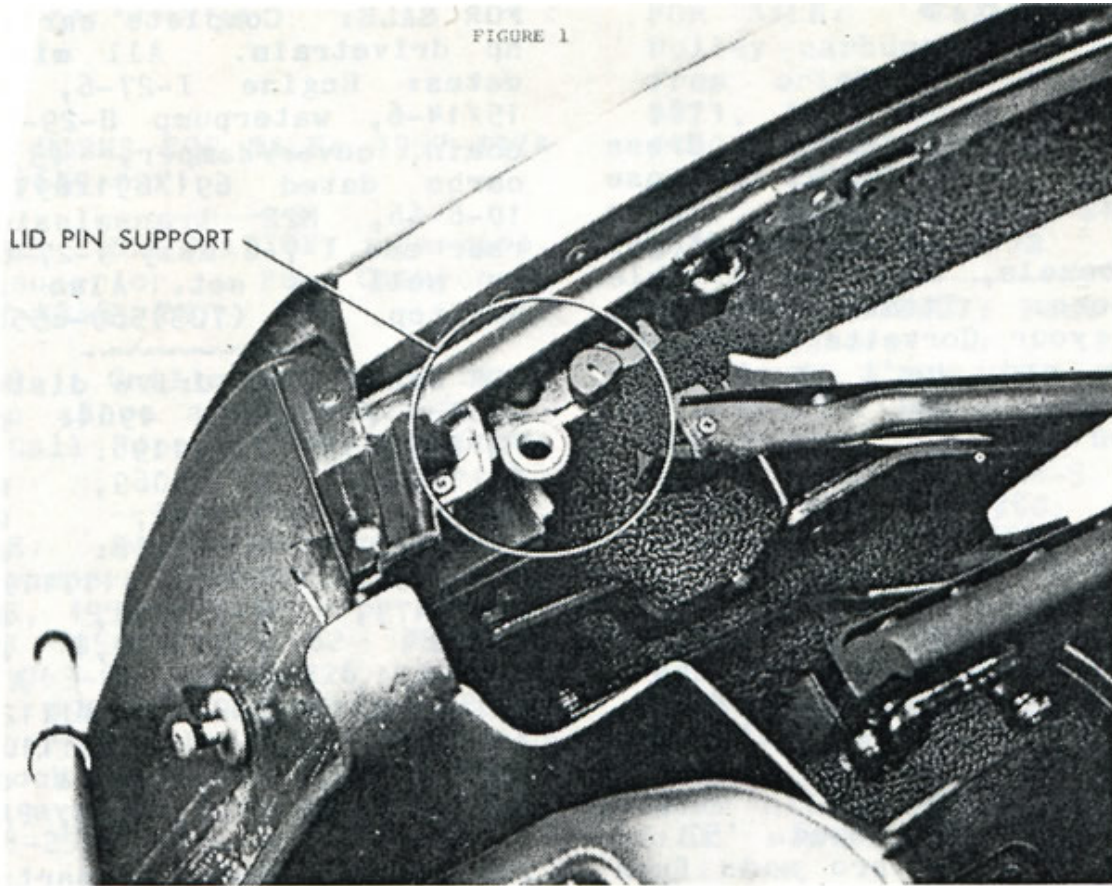
FIGURE 1

1970 Corvettes assembled prior to Serial Number S400748 may have interference between the folding top material and the top compartment lid pin support. This interference may result in damage to the folding top material.

LID PIN SUPPORT

1. Remove the lid pin support. (See Figure 1).
2. Grind 3/8" x 3/4" off the inboard edge of the support. (See Figure 2).
3. Reinstall the lid pin support and inspect to insure adequate clearance exists between the folding top material and the support.
