1984 Corvette: Service Bulletin: Broken Window Regulator Tapes

Source: Chevrolet Dealer Service Bulletin

Bulletin No: 84-3

Date: Oct., 1983

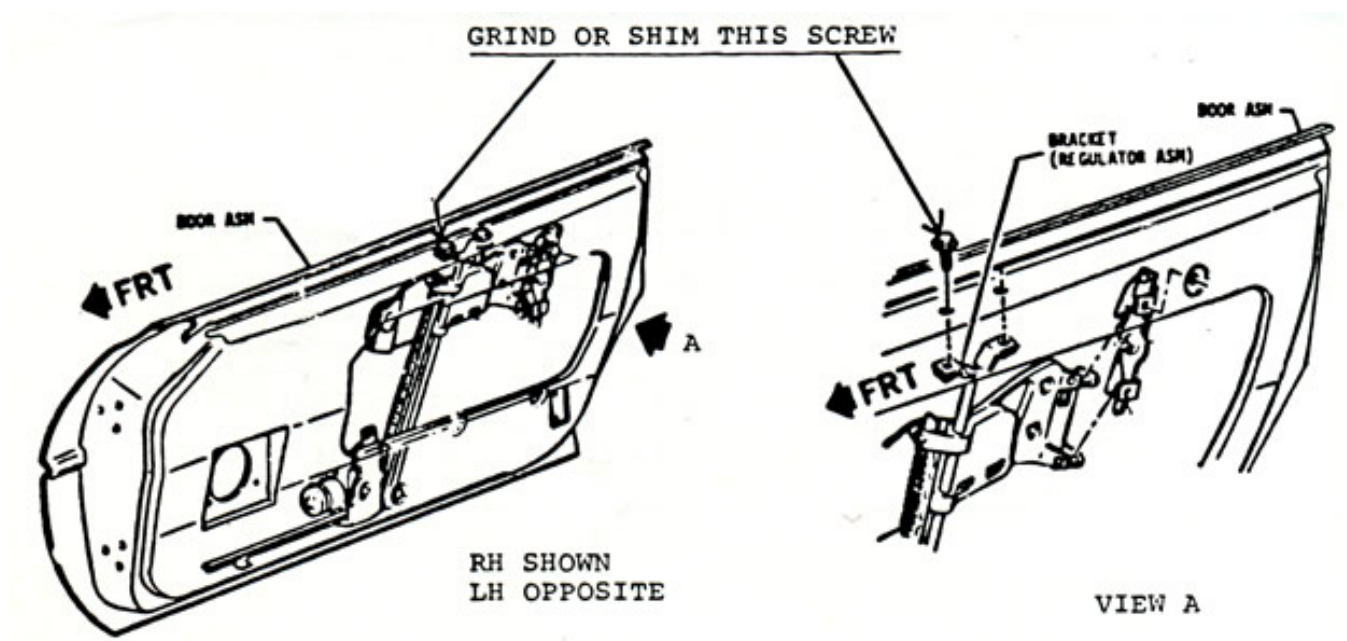
Whenever a vehicle requires service of door components, inspect for interference between the forward upper attaching screw and the upper end of the tape drive. If interference exists, one of the following options should be performed:

This is to prevent contact between the bottom of the screw and the upper end of the tape drive. If this contact exists, excessive stress is created in the tape and could cause a failure.

1. Add a washer (P/N 14038397), or equivalent, under the upper forward attaching screw (See Illustration).
2. Remove the forward attaching screw (P/N 11503800) and grind approximately 3mm from the threaded end.
