1978 - 1980 Corvette: Service Bulletin: Instrument Cluster Area Squeak

Model and Year: 1978 - 1980 Corvette

Bulletin No: 80-T-37

Date: May, 1980

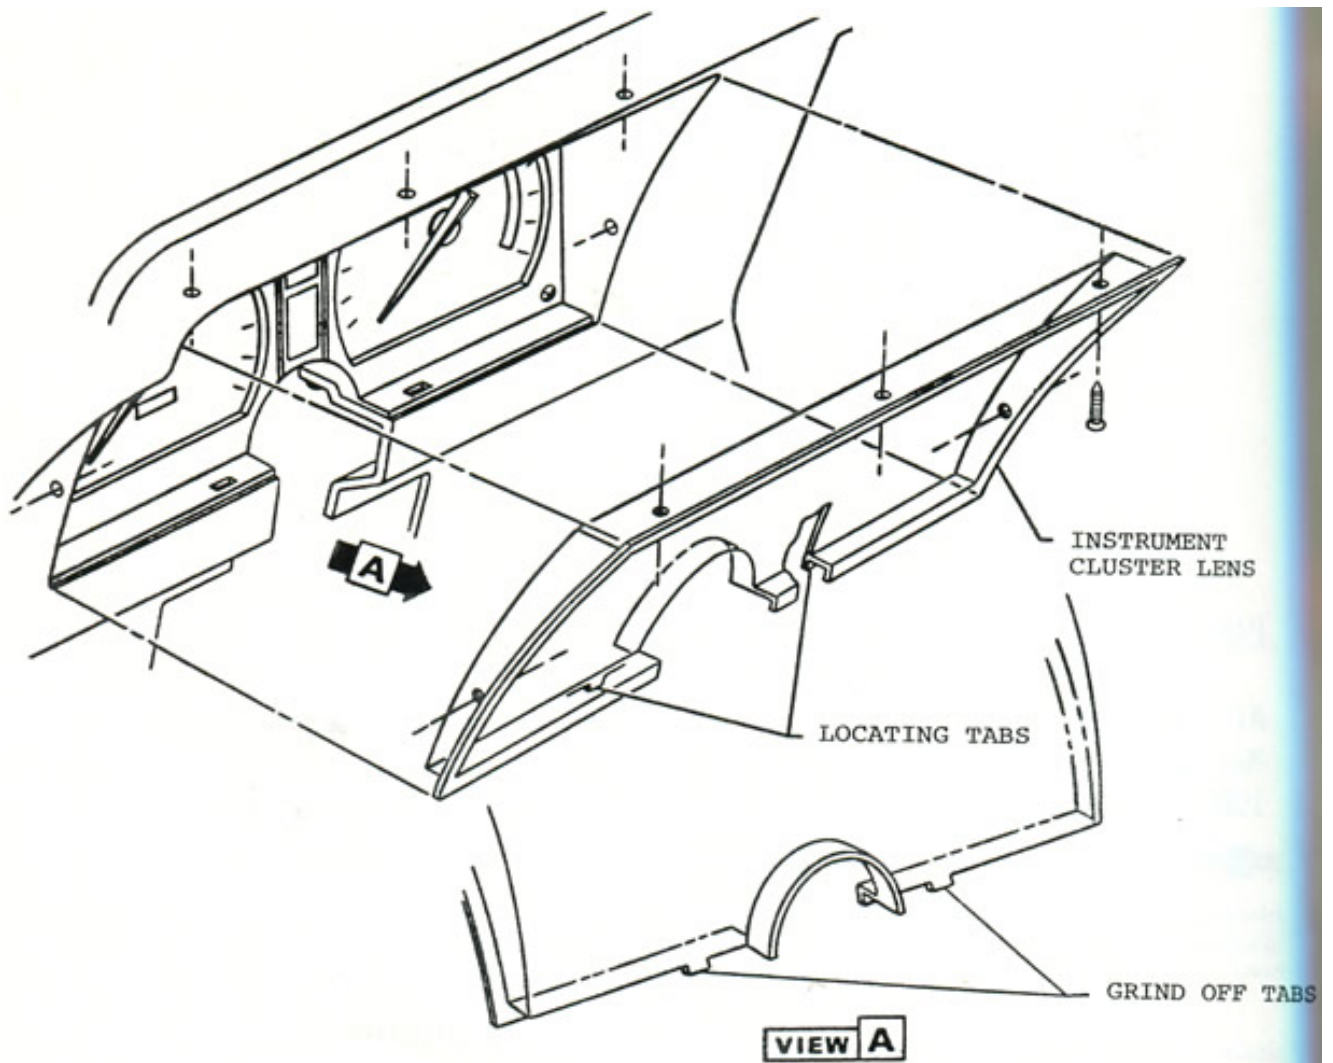
CORVETTE INSTRUMENT CLUSTER LENS
LOCATING TABS

Lower tabs on cluster lens may rub against side of case locating holes. To verify this source, apply light hand pressure to lens.

1. Remove five (5) lens to case attaching screws and remove lens.
2. Grind off and file to a smooth surface the two (2) plastic locating tabs at bottom of lens, as illustrated on Page 2. CAUTION : The plastic lens is brittle and may crack if the tabs are snapped off rather than ground.
3. Reinstall lens to case with five (5) screws.
