# 2020 - 2021 Corvette: GM TechLink: Tips for Over-The-Air Software Programming

## 2020 - 2021 Corvette: Tips for Over-The-Air Software Programming

March 12, 2021

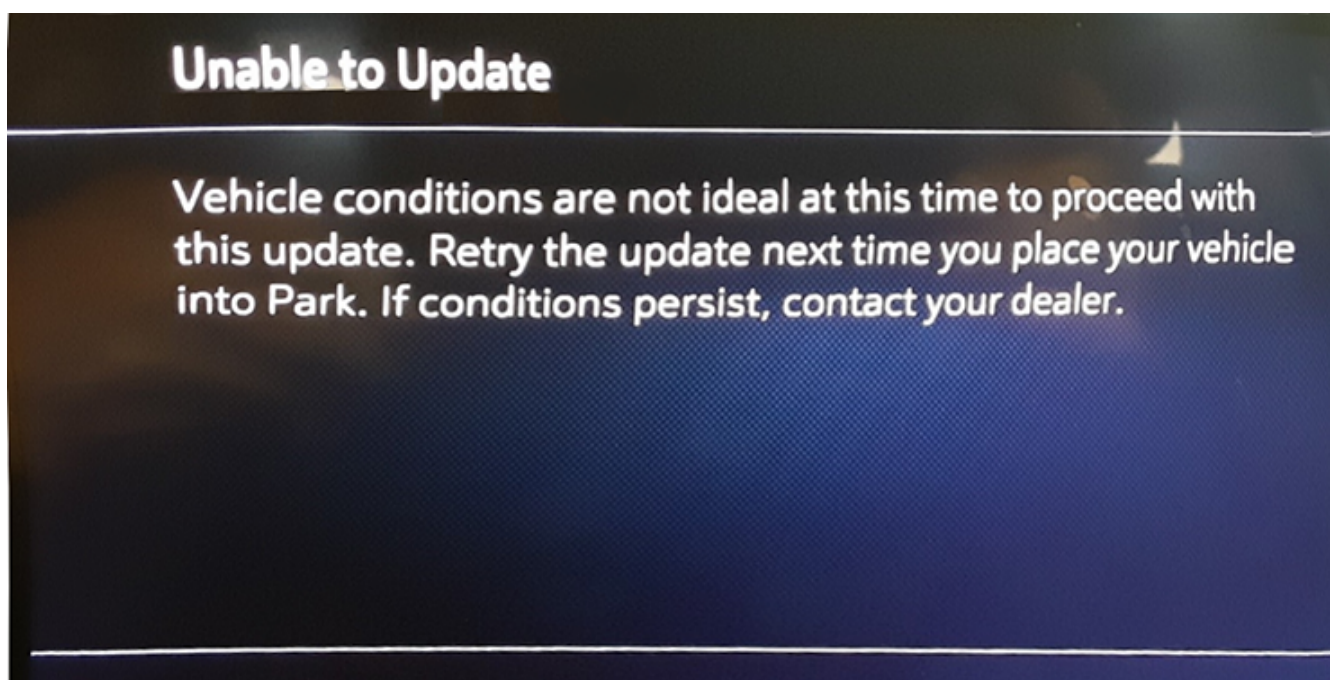
**Fig. 4**

There are a number of criteria that must be met in order to successfully complete the software update installation on a vehicle. The most common cause of being unable to complete an installation is the State of Charge (SOC) of the 12V battery. If the 12V battery does not meet the minimum SOC requirement of 70 percent or greater along with an Outside Ambient Temperature

(OAT) greater than 14°F (-10°C), the OTA update installation will not occur. The colder the ambient air temperature is, the higher the target SOC becomes. To determine the battery SOC for VIP vehicles, go to BCM / 12V Battery / Battery Sensor Module – State of Charge in GDS 2.

There may be other conditions that will affect an OTA update installation. If any of these conditions are present, a “Vehicle Conditions Not Ideal” message may display on the infotainment screen stating that conditions are not ideal to proceed with the update installation. These conditions do not indicate a failure; only that the vehicle does not meet all the criteria necessary to complete the OTA update installation. (Fig. 4)

If a low battery SOC is preventing the OTA update installation, the 12V battery should be charged to meet the target SOC of 70 percent.

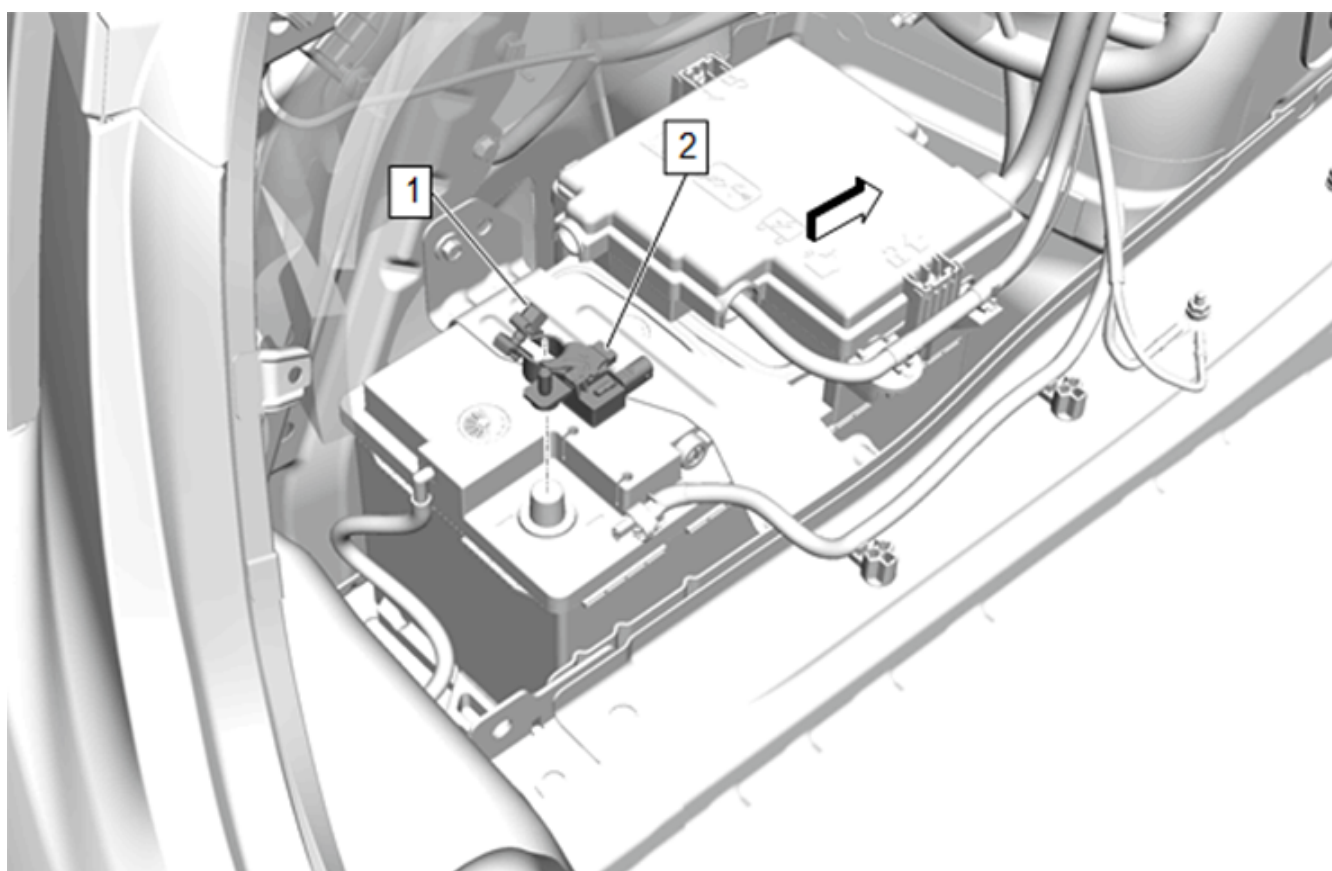
**Fig. 5**

On some GM models, connecting the battery charger directly to the 12V battery posts will bypass

the Battery Sensor Module, resulting in a default SOC value of 65 percent and a “Conditions Not Met” message.

**TIP:** The Battery Sensor Module (Fig. 5) is attached directly to the battery negative terminal. It determines the battery condition by calculating the battery SOC, functions, and state of health, which is used to help determine if the 12V Stop/Start system will allow an Auto Stop when the vehicle has come to a stop. To properly charge the battery, the negative lead of the charger must be connected to chassis ground, and not directly to the negative battery post. Connecting to chassis ground allows current to flow through the Battery Sensor Module during charging as well as be monitored. Connecting directly to the negative battery post charges the battery, but the current cannot be monitored by the Battery Sensor Module.

If a battery is improperly charged, the Battery Sensor Learn will be required to calibrate the Battery Sensor Module. With the ignition off, let the vehicle rest for a minimum of four hours

without any interruptions (opening a door, using the key fob, etc.). Verify if the battery SOC is 70 percent or greater using GDS 2 before attempting to continue with an OTA update.
