2014 - 2020 Corvette: Service Bulletin: #17-NA-271: Clicking Noise from Front Wheels While Turning at Slow Speeds

#17-NA-271: Clicking Noise from Front Wheels While Turning at Slow Speeds - (Oct 13, 2020)

Subject: Clicking Noise from Front
Wheels While Turning at Slow
Speeds

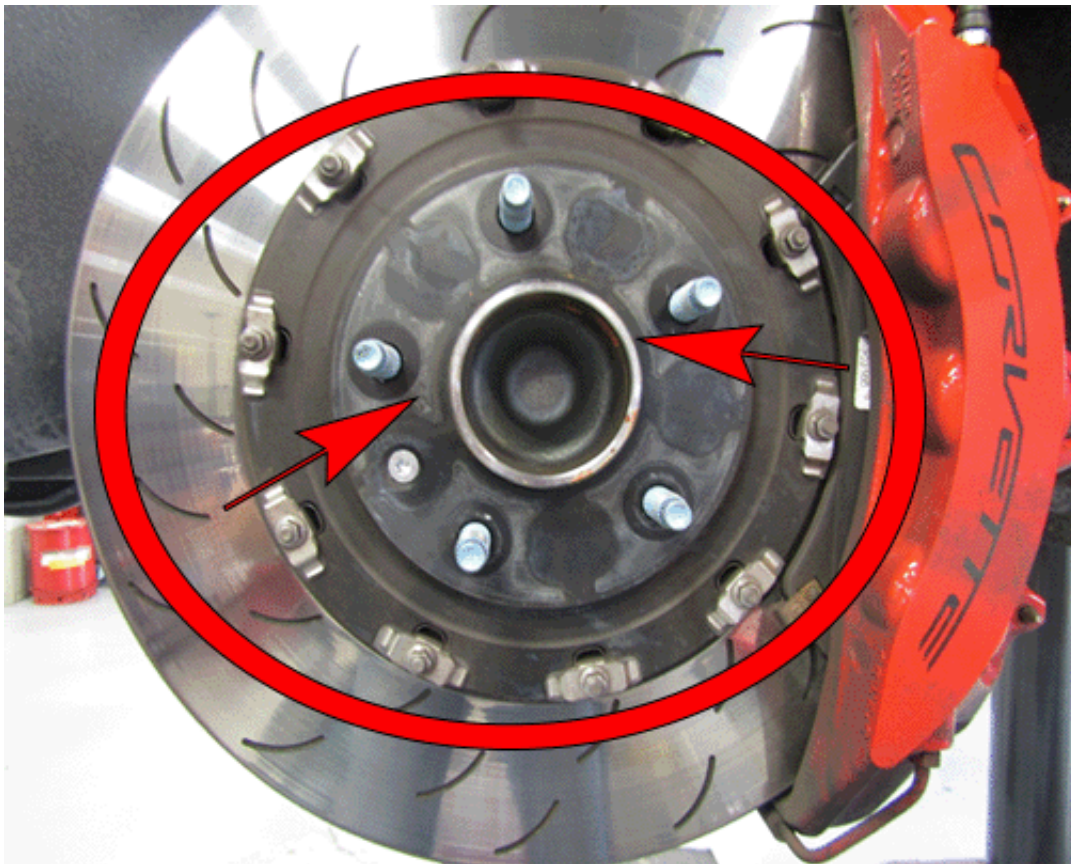
- Clean the wheel mounting surface of the brake rotors, or sometimes referred to as the brake rotor top hats, as follows:

- Using 3M red Scotch-Brite 7447 pad or equivalent with approved brake cleaner (ex. Part number 19370705 (U.S.), 88901247 (Canada)), wipe the wheel mounting surface of the rotor (brake rotor top hat) and the wheel pilot at the center of the

rotor, removing any residual grey or black material that has accumulated on the rotors.

Note: All cleaning must be done by hand. *DO NOT* use pneumatic or power tools.

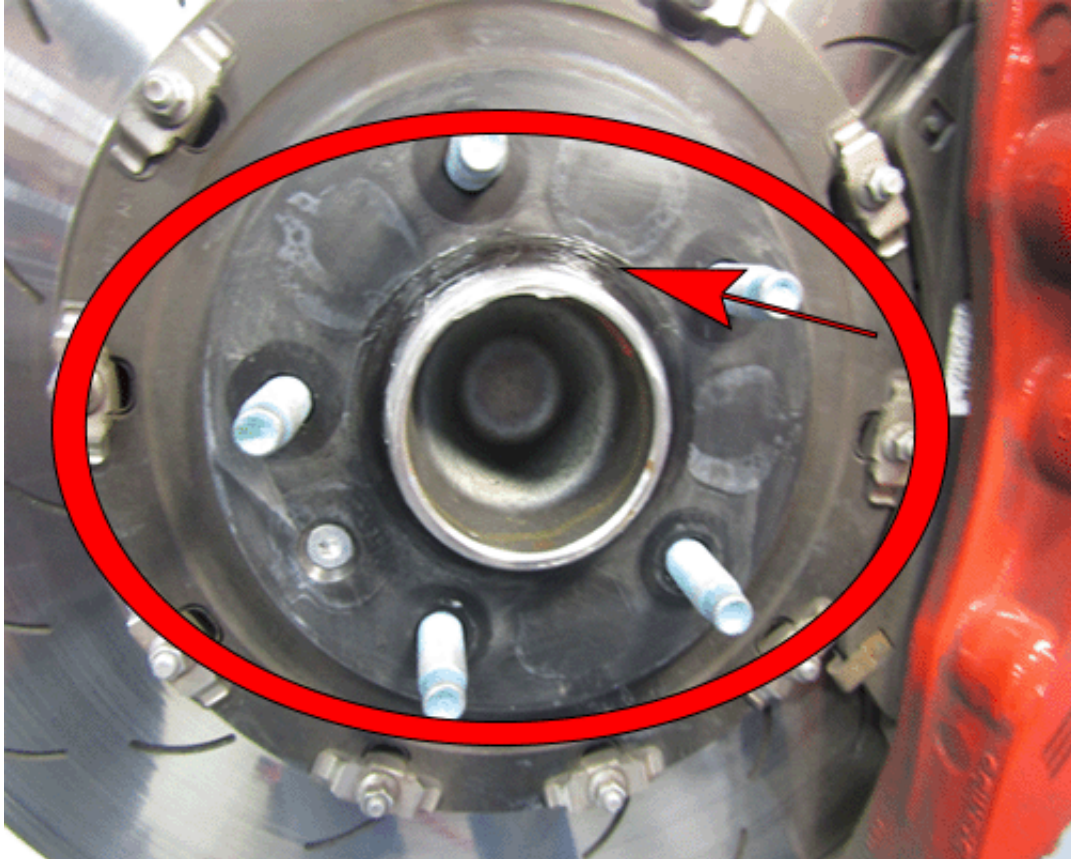
- Using Super Lube paste, P/N 12371287 (in Canada, 10953437) or equivalent, apply a light coat around the center pilot of the hub *ONLY*.
- Reinstall both of the wheels using the original wheel nuts. Refer to *Tire and Wheel Removal and Installation* in SI.

Important: Be sure the wheels and rotors are thoroughly dry prior to installation.
