## **#PI0754D: Rear and Side Tempered Glass Spots (Quench Marks) - (Nov 6, 2020)**

**Subject**: Rear and Side Tempered Glass Spots (Quench Marks)

Models: 2021 and Prior GM Passenger Cars and Trucks

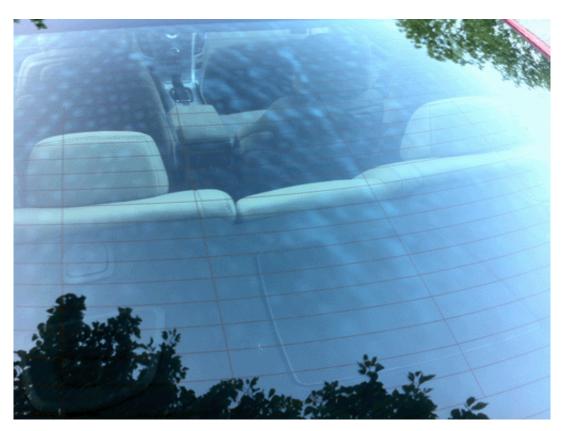
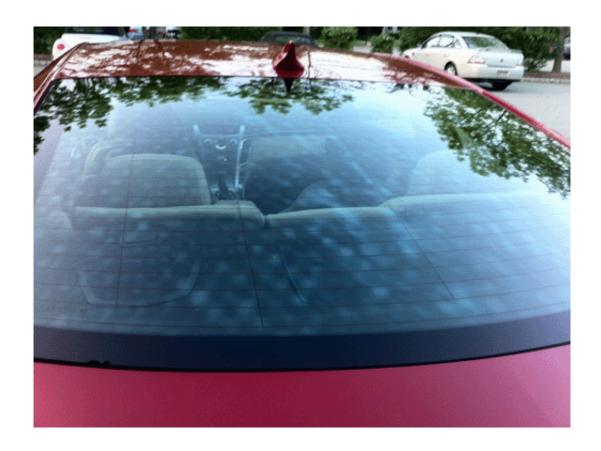
Some customers may comment on spots showing on the rear and side windows when the vehicle is in the sunlight. When wearing polarized glasses/sunglasses, these spots may be more magnified.

The spots are due to the manufacturing process and are "quench marks" in the glass. Quench marks are an unintentional side effect of the tempering process.

Technicians should explain to the customer that this is a normal condition and part of the manufacturing process for tempered glass. Do not replace the window(s) for this condition.

**Note:** This will not be seen on front windshields or laminated side glass.
