1977 Corvette: Service Bulletin: Anti-Theft Alarm System Interim Modifications

Subject: Anti-Theft Alarm System Interim Modifications

Model and Year: 1977 Corvette

Bulletin No: 77-I-38

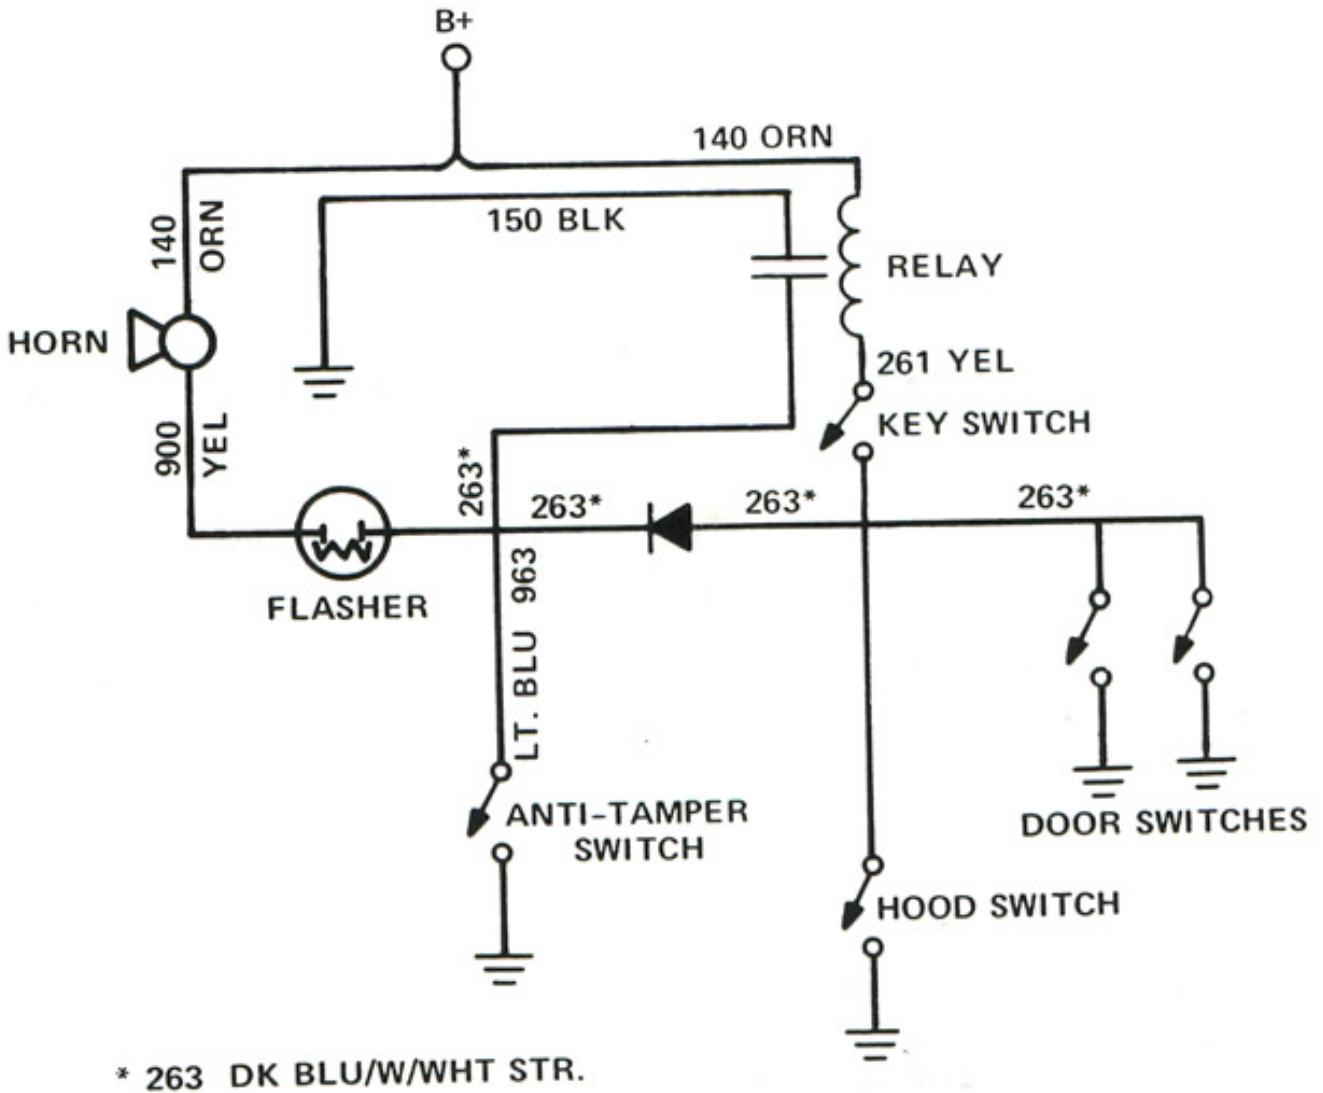
FIGURE 4

- The actuating switch for the system is no longer located on the left front fender. It has been incorporated into the left front door lock and must be activated by locking this door with the key from outside of the vehicle (Figure 1). This is the only way the alarm can be set. Turning the inside door knob to the locked position when exiting the vehicle will not activate the alarm system.
- The anti-theft alarm system horn has been moved from the left rear inner fender to the far left side of the engine compartment dash panel. (Figure 2).
- The anti-theft alarm system flasher assembly is now located on the console trim plate (Figure 3), rather than the rear compartment underbody panel.
- The new anti-theft alarm system wiring diagram is illustrated in Figure 4.

NEW 77½ CORVETTE THEFT DETERRENT CIRCUIT
