# 1977 Corvette: Service Bulletin: Anti-Theft Alarm System Interim Modifications

**Model and Year:** 1977 Corvette

**Bulletin No:** 77-I-38

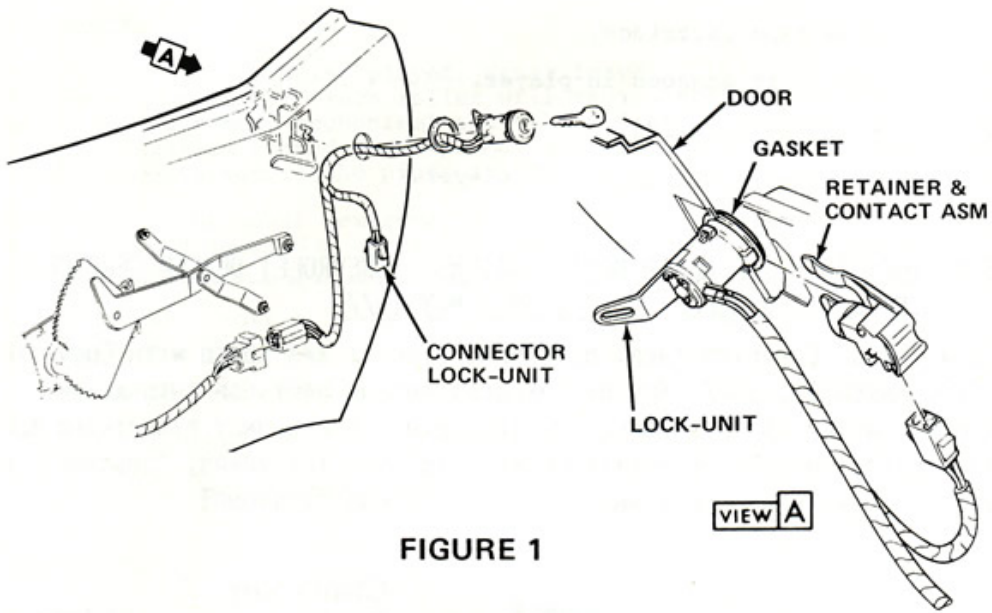
FIGURE 1

- The actuating switch for the system is no longer located on the left front fender. It has been incorporated into the left front door lock and must be activated by locking this door with the key from outside of the vehicle (Figure 1). This is the only way the alarm can be set. Turning the inside door knob to the locked position when exiting the vehicle will not activate the alarm system.
- The anti-theft alarm system horn has been moved from the left rear inner fender to the far left side of the engine compartment dash panel. (Figure 2).
- The anti-theft alarm system flasher assembly is now located on the console trim plate (Figure 3), rather than the rear compartment underbody panel.
- The new anti-theft alarm system wiring diagram is illustrated in Figure 4.

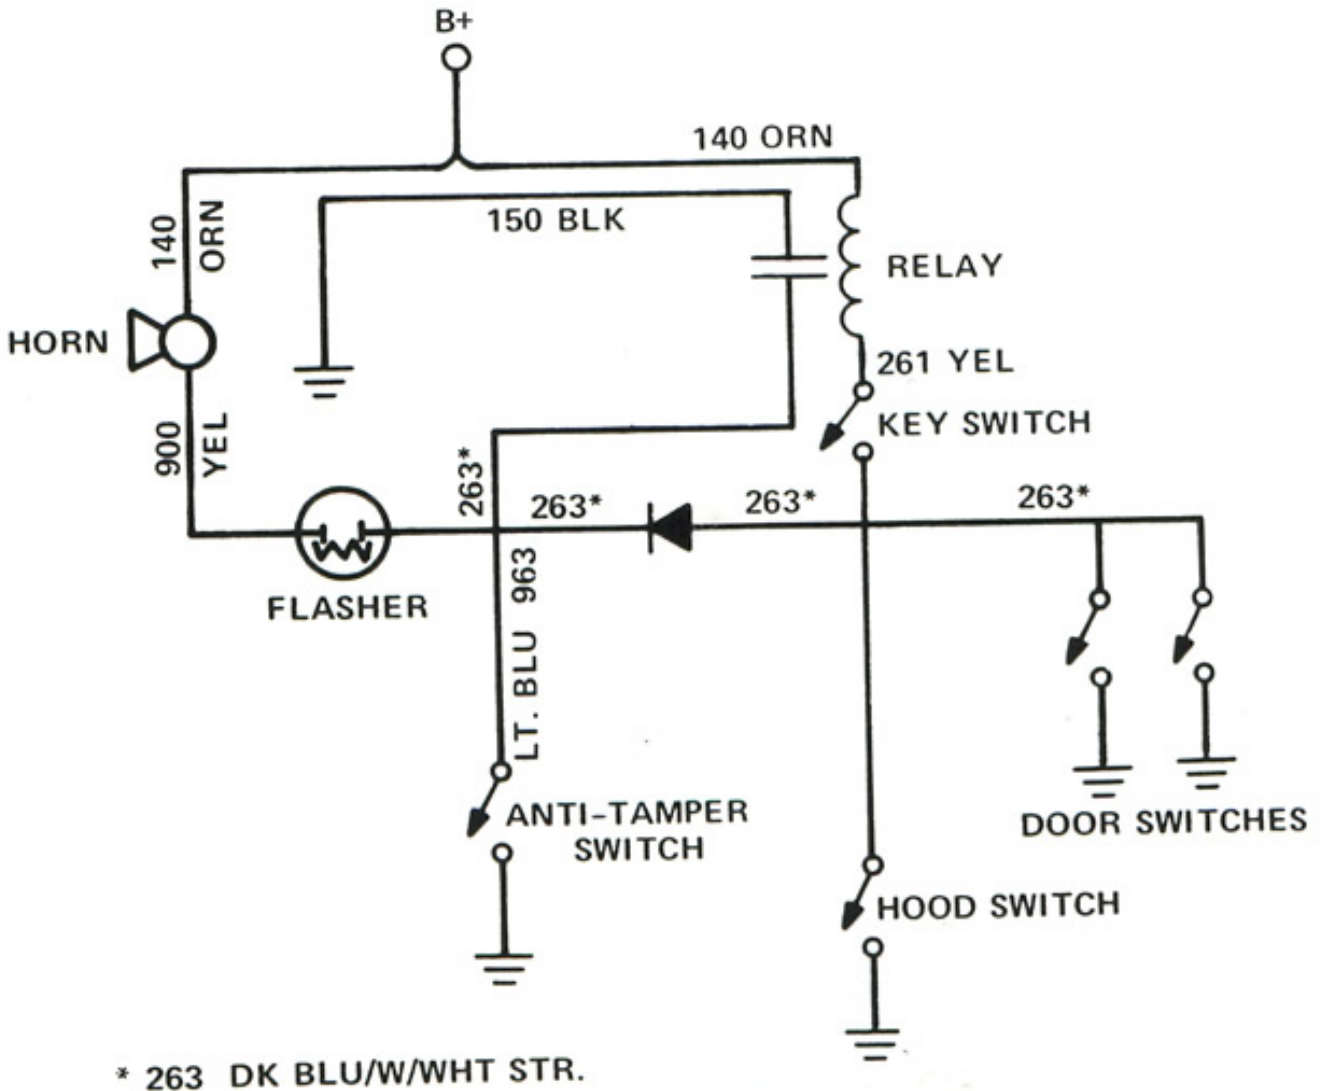
**FIGURE 4**

## NEW 77½ CORVETTE THEFT DETERRENT CIRCUIT
