# 2015 Corvette Z06: GM TechLink: Brake Pad Wear Sensor Harness

**Subject:** Brake Pad Wear Sensor Harness

**Model and Year:** 2014 - 2015 Camaro Z/28 and 2015 Corvette Stingray Z06 models

**Date:** January 22, 2015

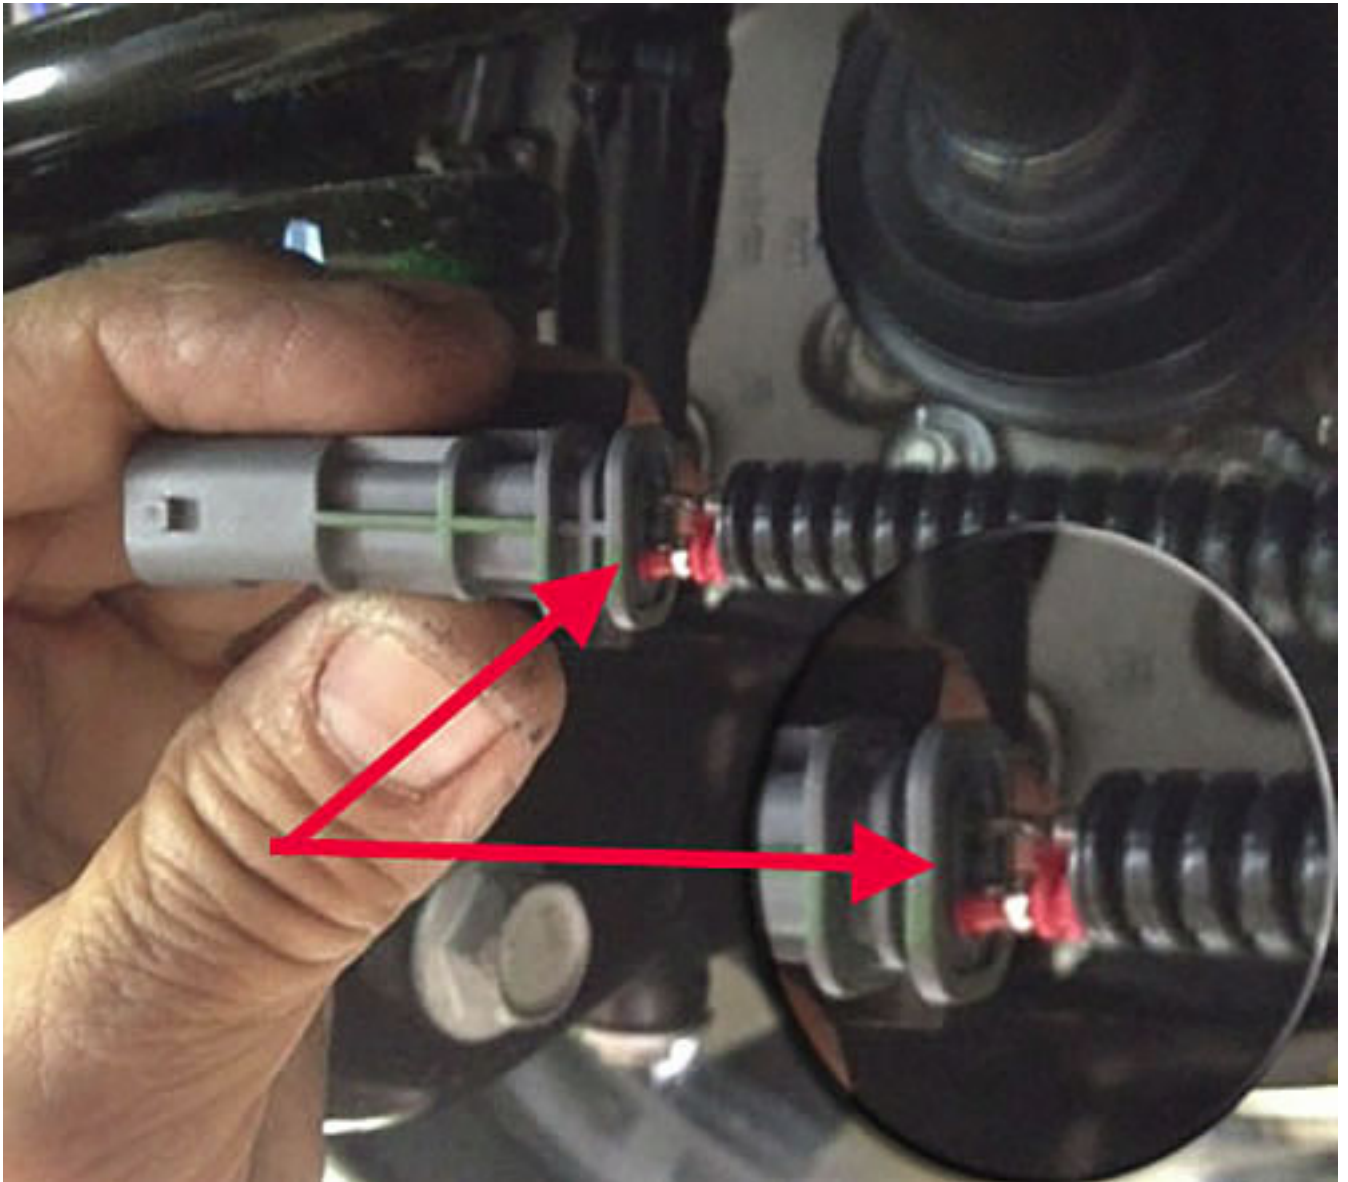
**Fig. 10**

If the message is displayed, check the brake pads to see if they are worn, but if they are not, closely inspect the brake pad wear sensor harnesses for any damage. In some cases, the sensor harness may be coming in contact with a tire, causing the wiring/terminals to be pulled out of the plastic connector. (Fig. 10) As a result, this condition causes the message to be displayed on the DIC.

If any damage is found to the brake pad wear sensor wiring, the harness should be replaced. If the terminals are pulled from the connector, either secure the terminals back into the connector or, if repairs are not possible due to the extent of the damage, replace the terminals as required.

To prevent any damage to the sensor wiring in the future, secure the sensor harness to the brake hose with a zip tie.
