2015 - 2017 Corvette Z06: Service Bulletin: #PIP5395B: Ticking Rattle Or Buzz Noise Heard The Best In The Passenger Compartment - (Mar 20, 2017)

#PIP5395B: Ticking Rattle Or Buzz Noise Heard The Best In The Passenger Compartment - (Mar 20, 2017)

Condition/Concern

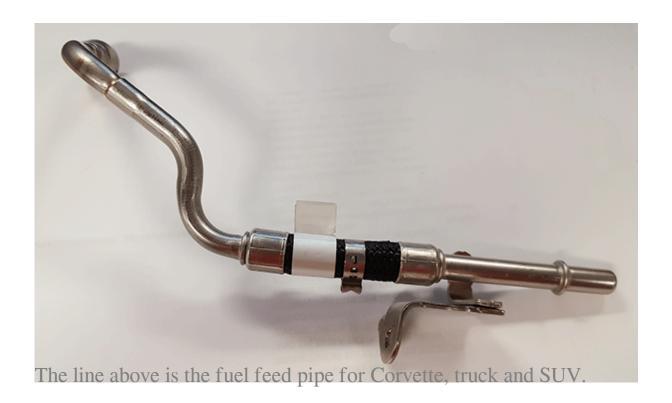
There are two different fuel line types that contain this check valve and vary by model.

This line connects the chassis fuel line to the high pressure fuel pump.

The fuel feed line between the high pressure fuel pump and chassis fuel line could be the cause allowing high pressure pulsation back to the low side of the fuel system. There is not a good way to test the check valve, the line will need to be replaced.

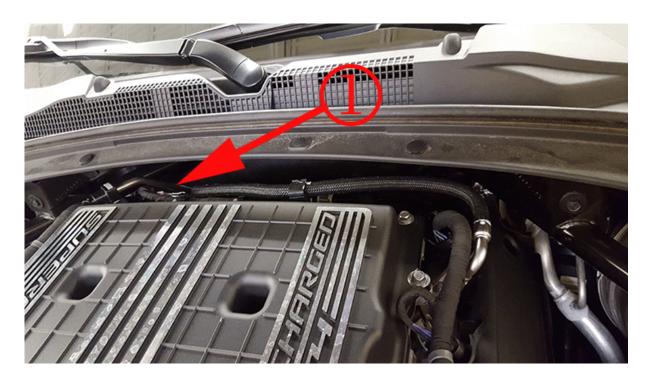
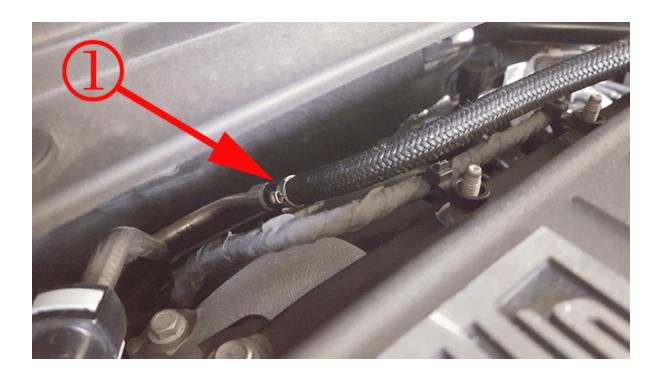
These pictures above shows the chassis fuel feed pipe for the LT4 supercharged ZL1 Camaro.

On LT1 Camaro and LT4 CTS-V this line would have a jumper line with quick disconnects at both ends.

One end will connect to the chassis line and the other to the high pressure pump feed line.
