# 2019 Corvette ZR1: Rear Spoiler Adjustment

May 30, 2019 - GM TechLink

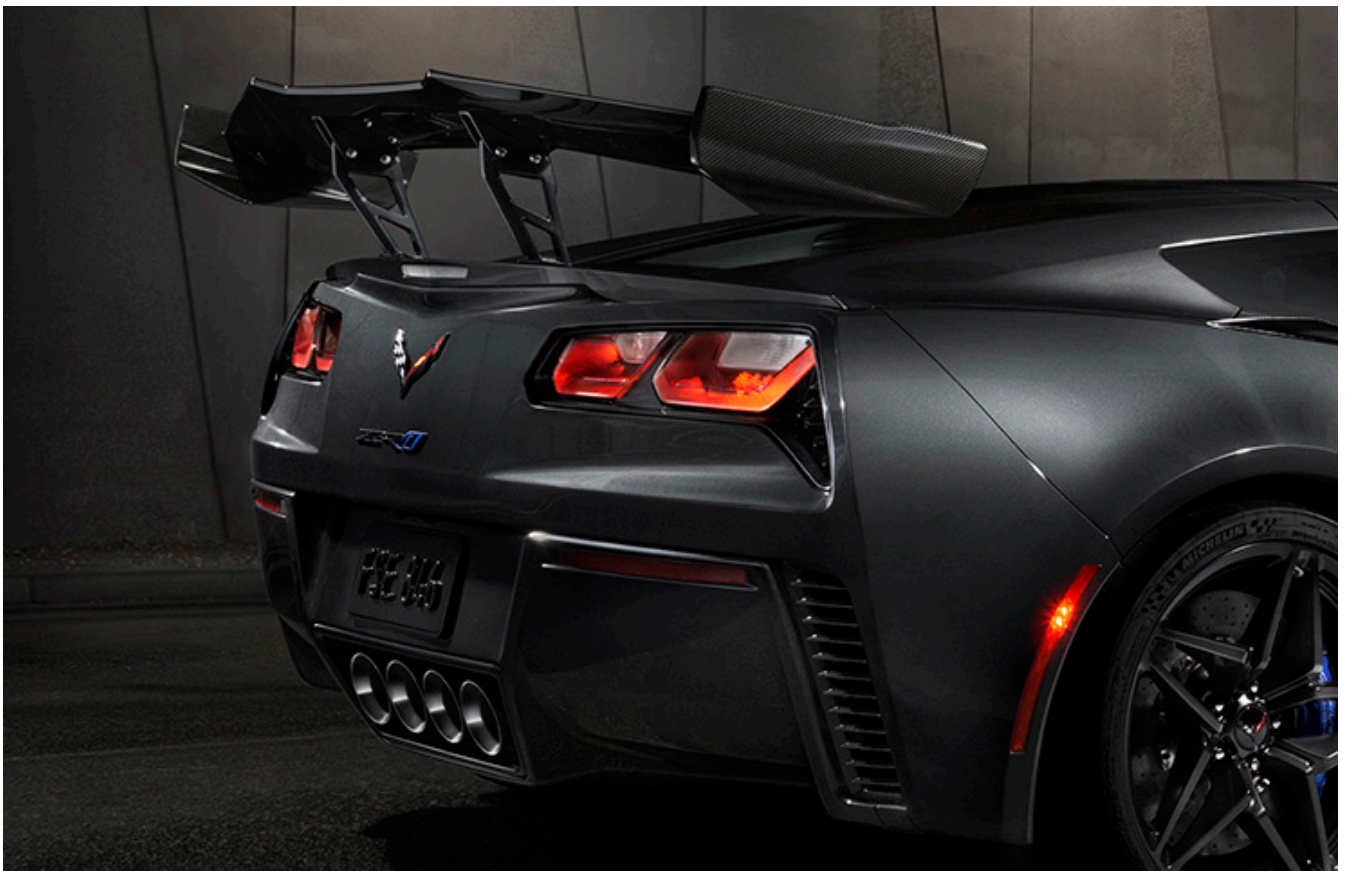
**Fig. 18**

The rear spoiler of the 2019 Corvette ZR1 (Fig. 18) is installed at the dealership during the Pre-Delivery Inspection (PDI). After installation of the rear spoiler, it may be noticeable that the spoiler has a crooked appearance. If this condition is evident, the Rear End Secondary Spoiler Bracket may be out of adjustment.

**TIP:** The rear spoiler (in both street and track configurations) is attached to the vehicle using unique fasteners. The vehicle is not shipped with the **special bit that is needed to attach the spoiler** to the vehicle. Obtain the appropriate bit to complete the installation. Refer to the Special Inspection Items box on the PDI form.
