# 2020 Corvette: GM TechLink: Loose Carbon Patch in Air Cleaner Housing

## 2020 Corvette: Loose Carbon Patch in Air Cleaner Housing

GM TechLink  
April 30, 2020

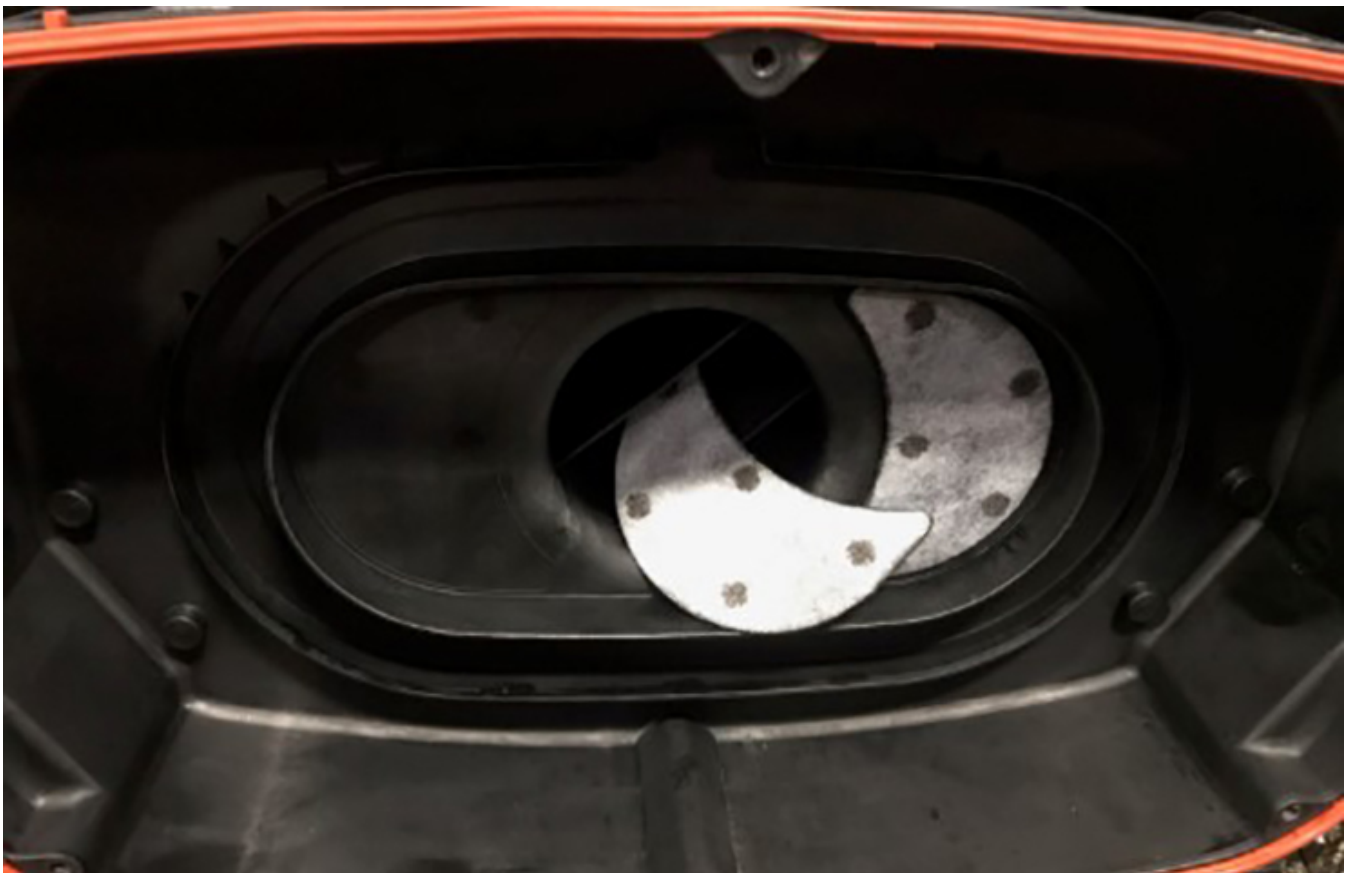
**Fig. 11**

A loose carbon patch in the air cleaner housing may be restricting air flow across the Mass Airflow (MAF) sensor on some 2020 Corvette models. (Fig. 11) DTCs P0101 (Mass Airflow Sensor Performance), P0171 (Fuel Trim System Lean) and P0174 (Fuel Trim System Lean Bank 2) may be set in the Engine Control Module (ECM).

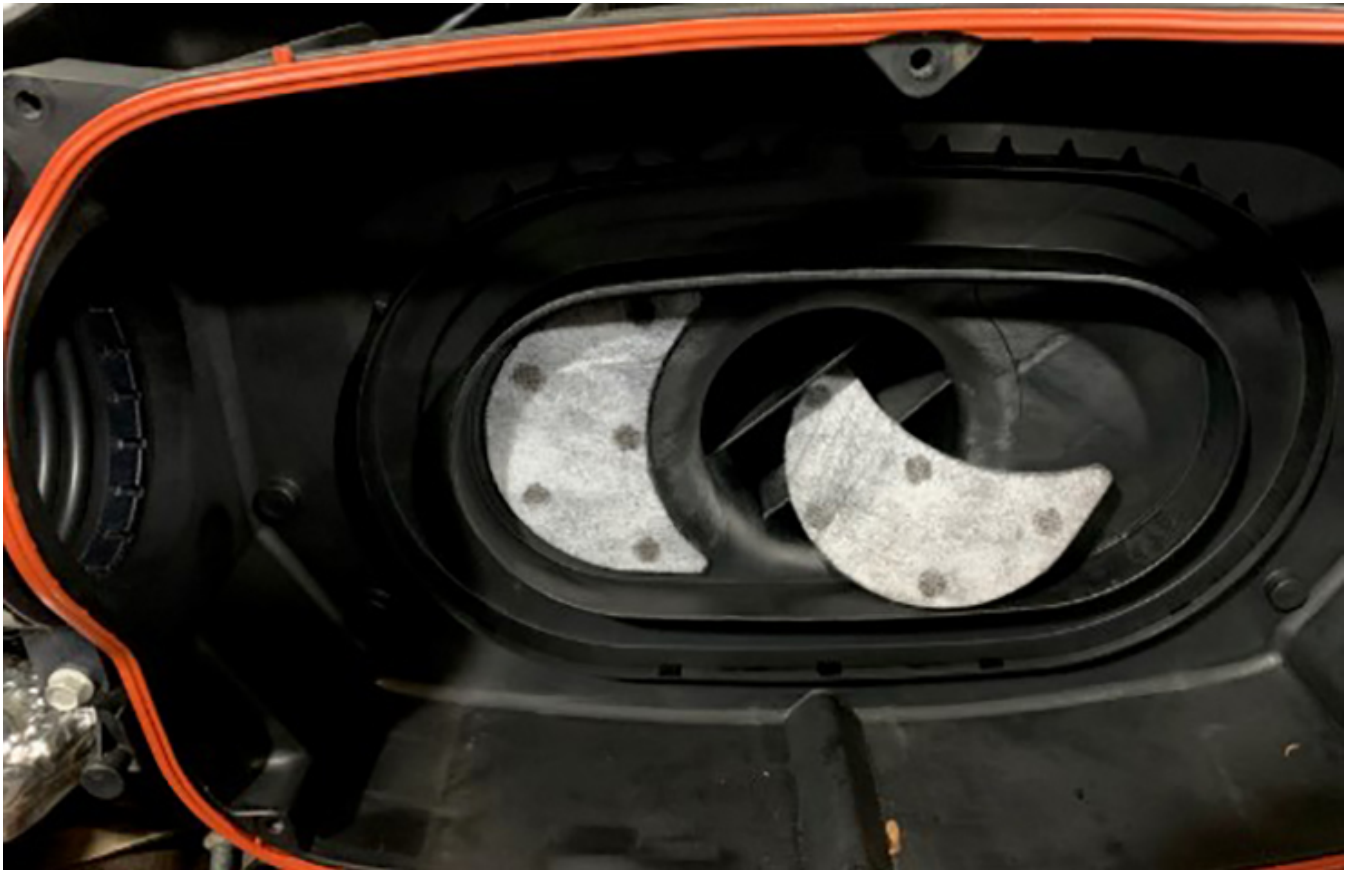
**Fig. 12**

If any of these DTCs are set, remove the air filter and inspect the carbon patches to determine if they are out of place. (Fig. 12)
