# 1984 - 2021 Corvette: Service Bulletin: #PI0754D: Rear and Side Tempered Glass Spots (Quench Marks) - (Nov 6, 2020)

**Subject:** Rear and Side Tempered Glass Spots (Quench Marks)

**Models:** 2021 and Prior GM Passenger Cars and Trucks

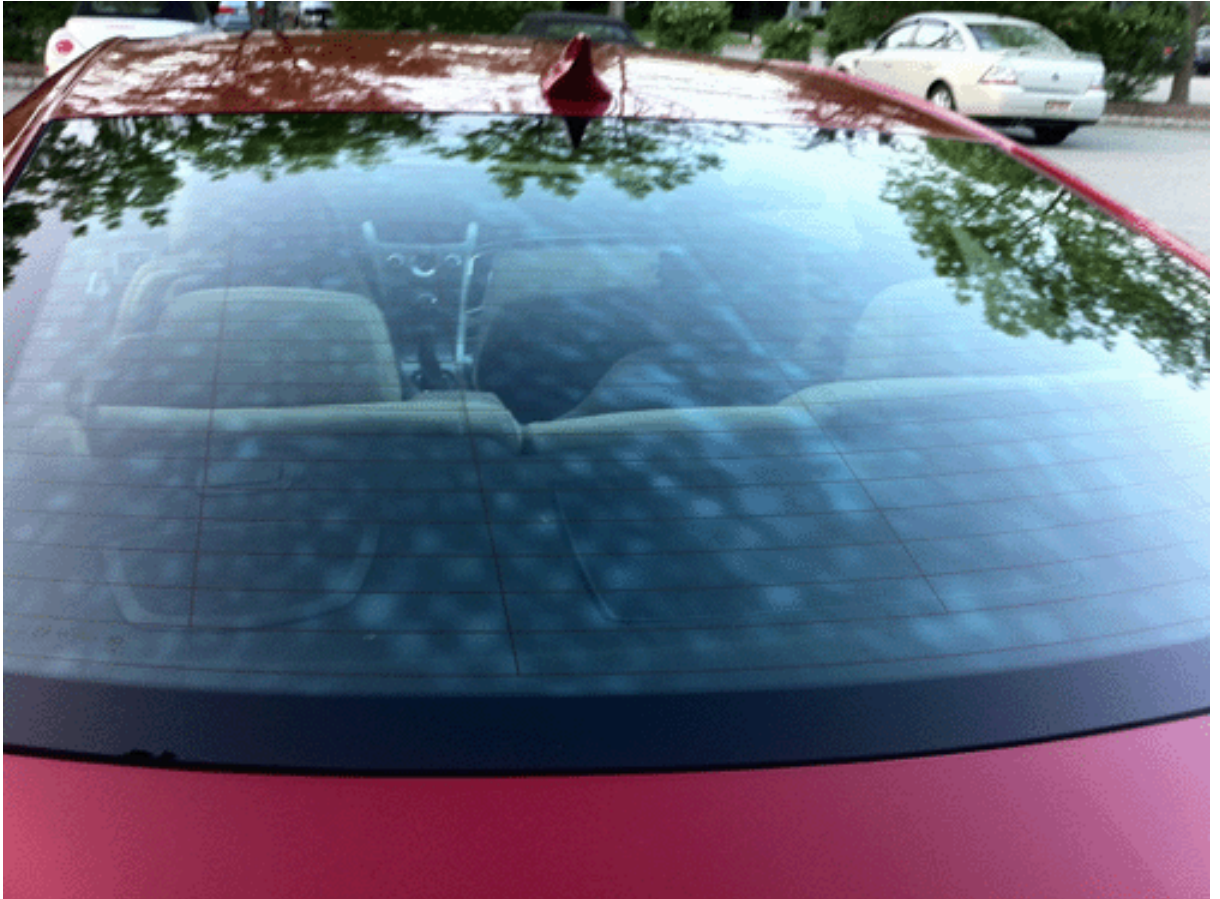
Some customers may comment on spots showing on the rear and side windows when the vehicle is in the sunlight. When wearing polarized glasses/sunglasses, these spots may be more magnified.

The spots are due to the manufacturing process and are “quench marks” in the glass. Quench marks are an unintentional side effect of the tempering process.

Technicians should explain to the customer that this is a normal condition and part of the manufacturing process for tempered glass. Do not replace the window(s) for this condition.

**Note:** This will not be seen on front windshields or laminated side glass.
