2020 - 2021 Corvette: Service Bulletin: #PIC6429: Addressing Customer Concerns on Brake Noises - (Jan 20, 2021)

Subject: Addressing Customer Concerns on
Brake Noises

J55 brake system (included with the Z51 performance package)

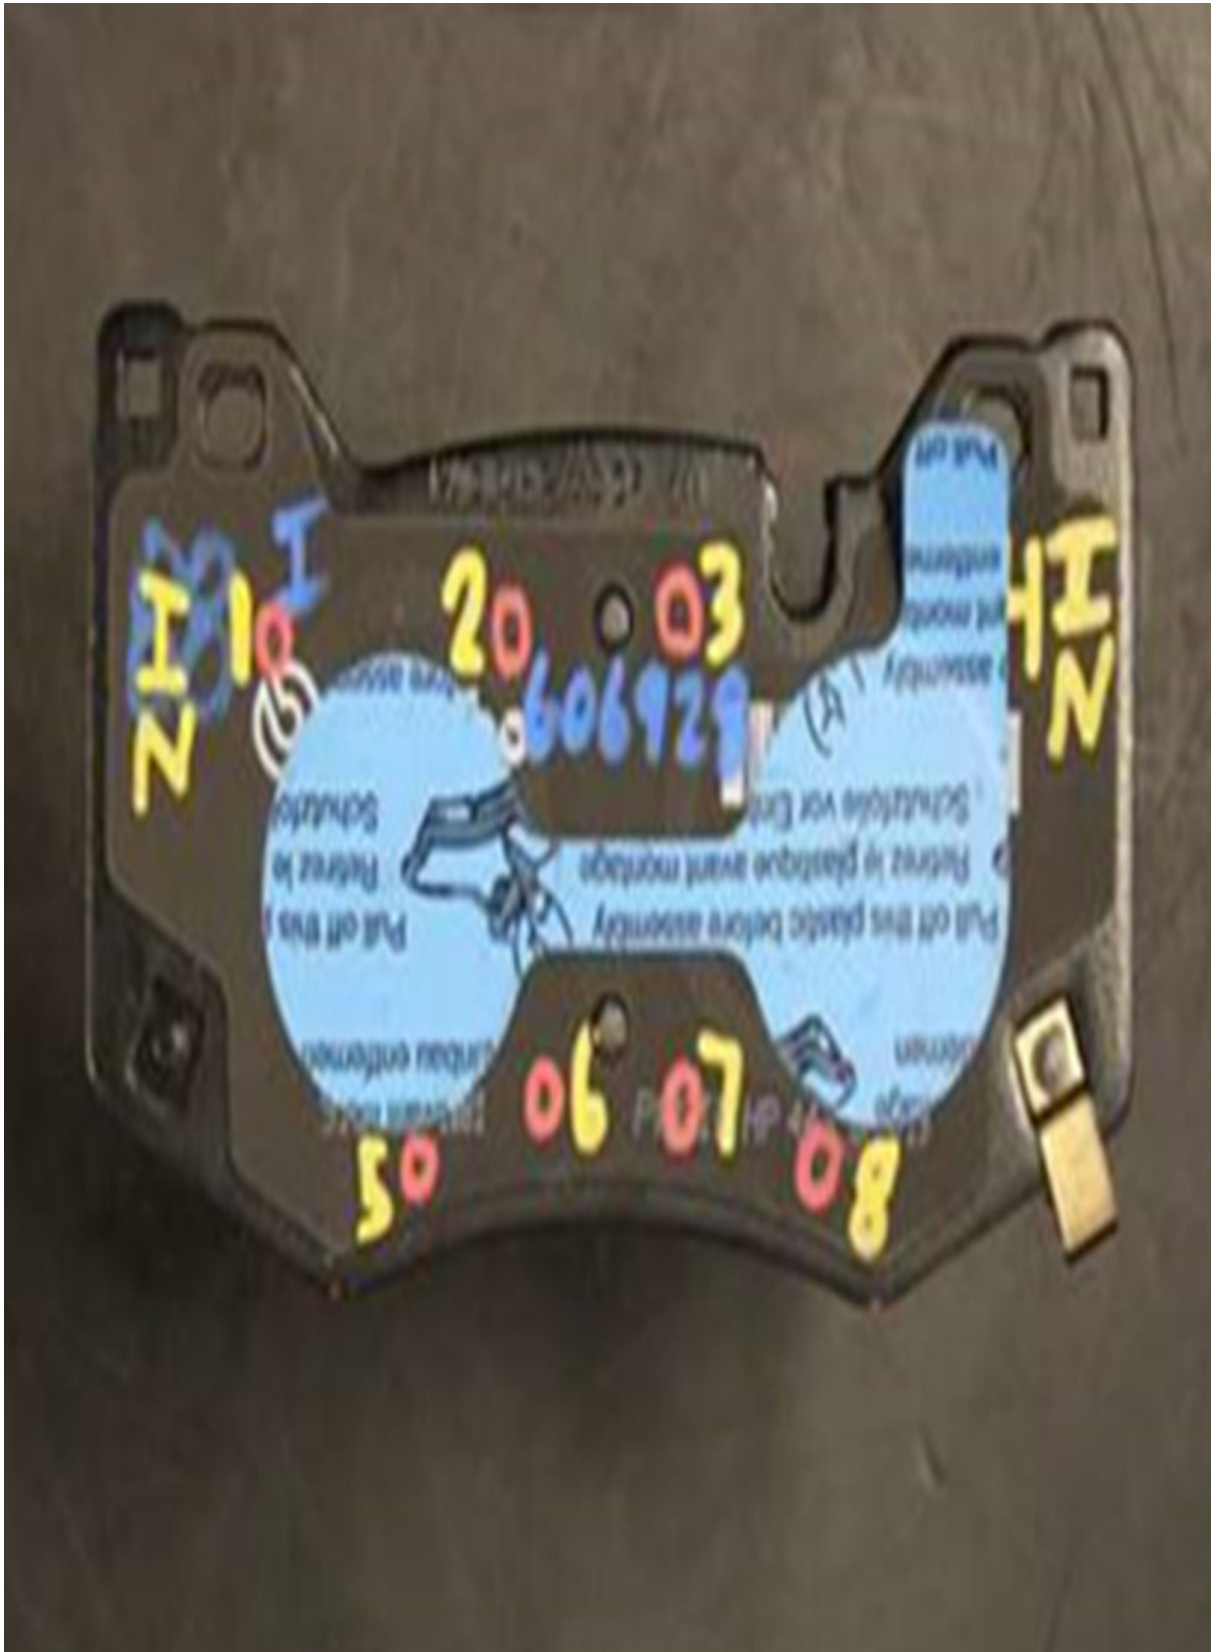
If the customer describes a brake noise coming from the vehicle, perform bulletin 17-NA-040 as described. When removing the front brake pads on a Z51-equipped vehicle, the servicing technician should notice that there is a piece of double-sided tape that secures the front brake pads firmly to the caliper pistons. See the photo below as an example. The blue area is this peel-and-stick double sided tape.

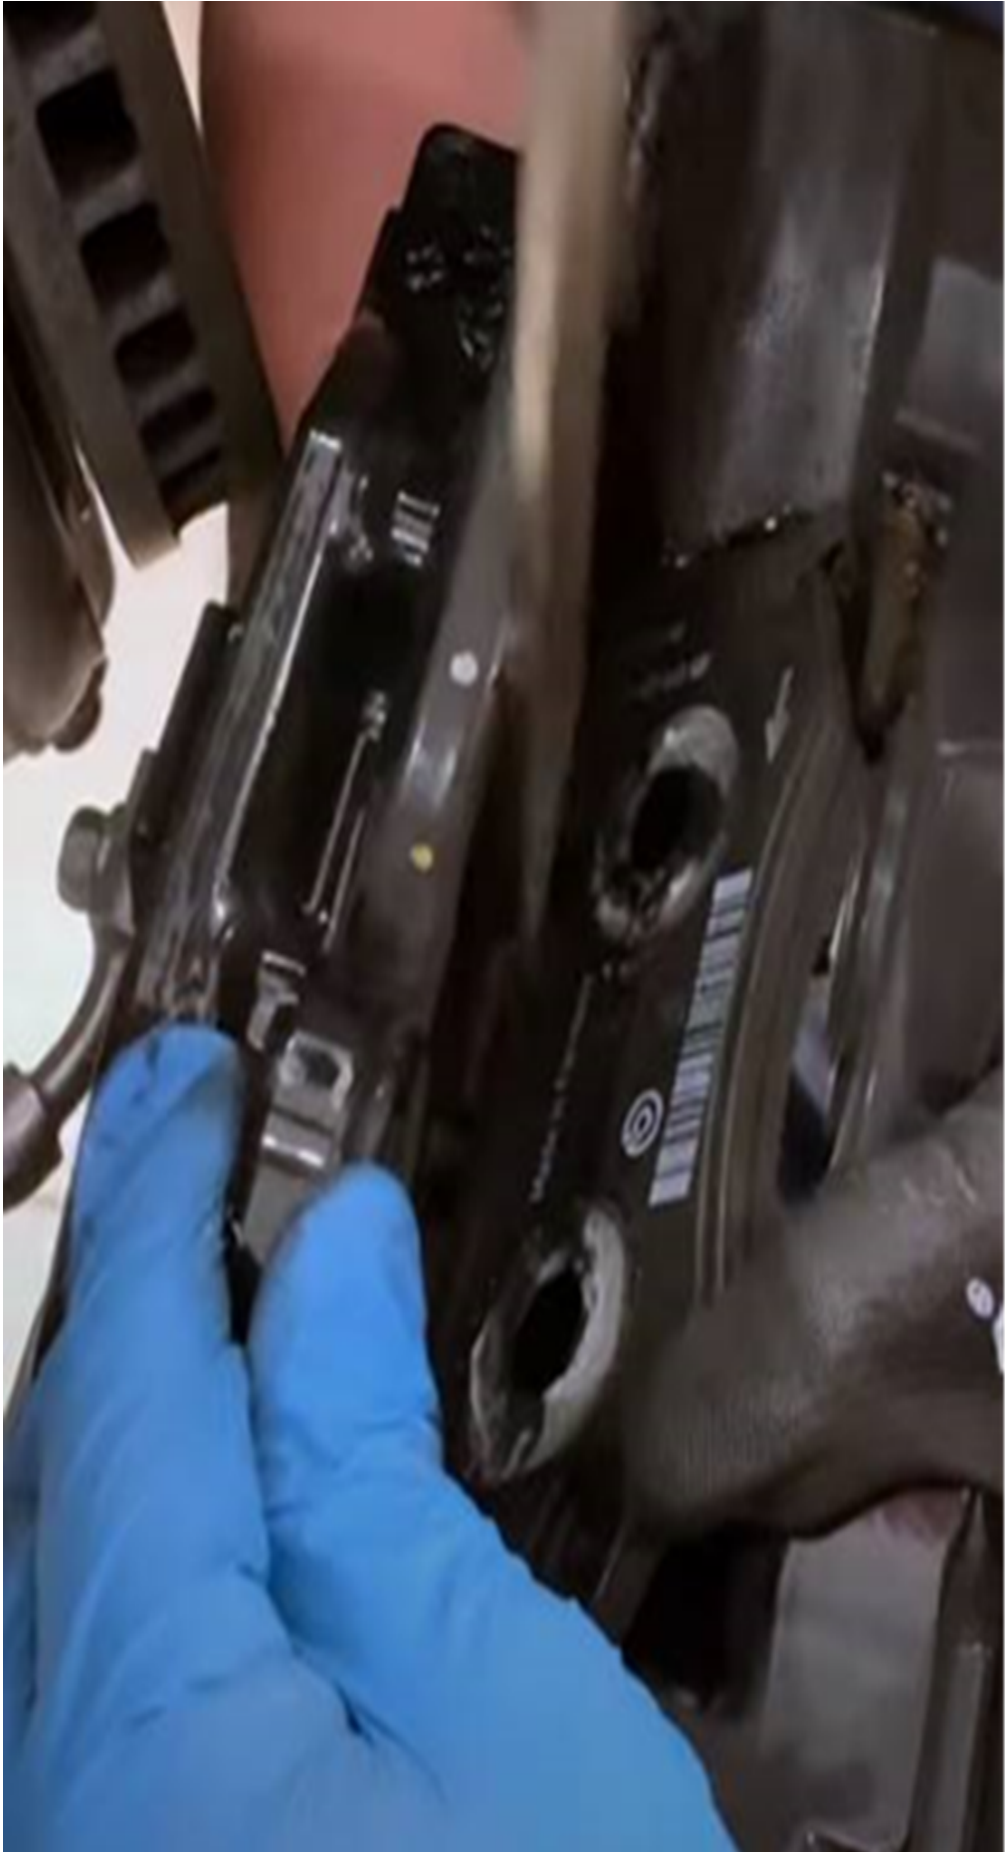
To apply the paste correctly, the pads must be removed from the calipers. See the photo below for an example of what the front brake pads look like once they have been separated from the caliper pistons.

This is normal when the front pads have been removed. When this has been done, remove as much of the remaining tape residue as possible. Then, apply the copper paste as directed in the bulletin. Once the copper paste has been applied correctly to the front brake pads, simply reinstall them into the calipers. There is no need to replace the front brake pads during this service because of the double-sided tape.

Important: At this point in reassembly, many technicians have a tendency to want to chamfer the edges of the brake pads slightly, in the hopes that this will eliminate or prevent future noises from occurring. This is not something that should be done, despite any direction to the contrary. "Taking the edge off" or chamfering the brake pads will not provide any noise benefit to the customer and it may actually create other issues with the brake system.
