2020 - 2021 Corvette - Service Update Bulletin: #N212327740: Service Update - HVAC Condensate Drain Hose Not Fully Installed - (Mar 10, 2021)

Subject: N212327740 — HVAC Condensate Drain
Hose Not Fully Installed

Models: 2020 – 2021 Chevrolet Corvette

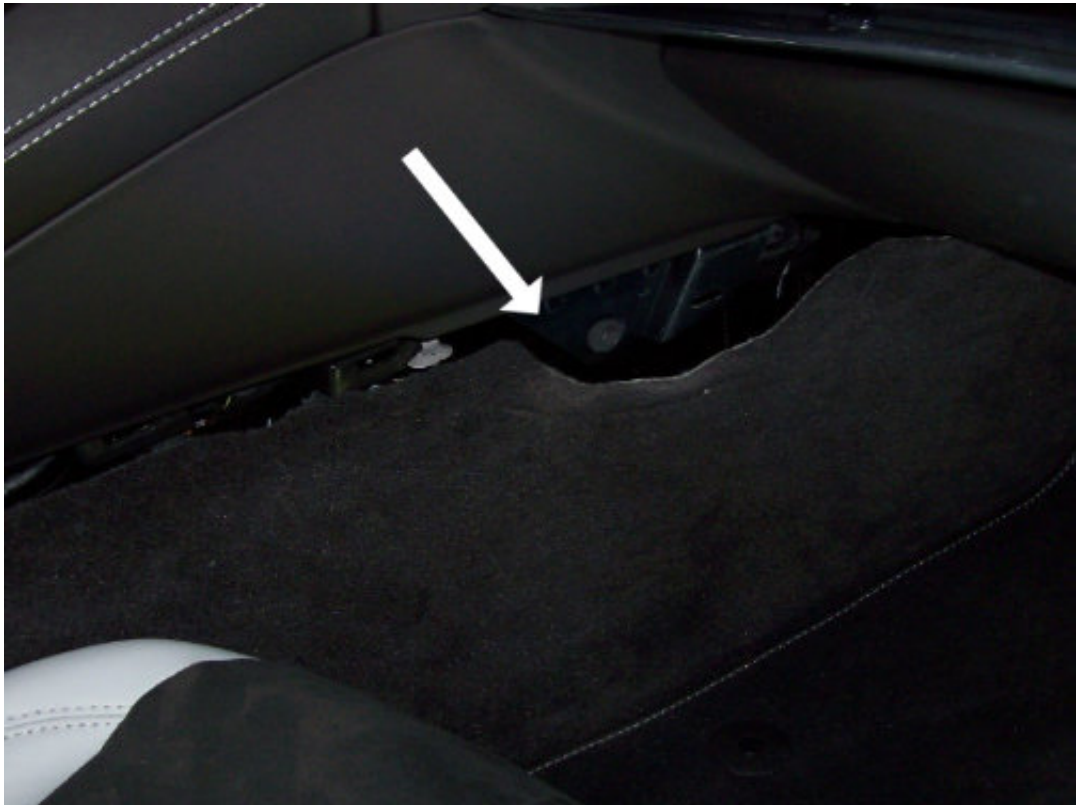
2. Pull back the carpet in the location shown to gain access to the A/C Evaporator Drain Tube.

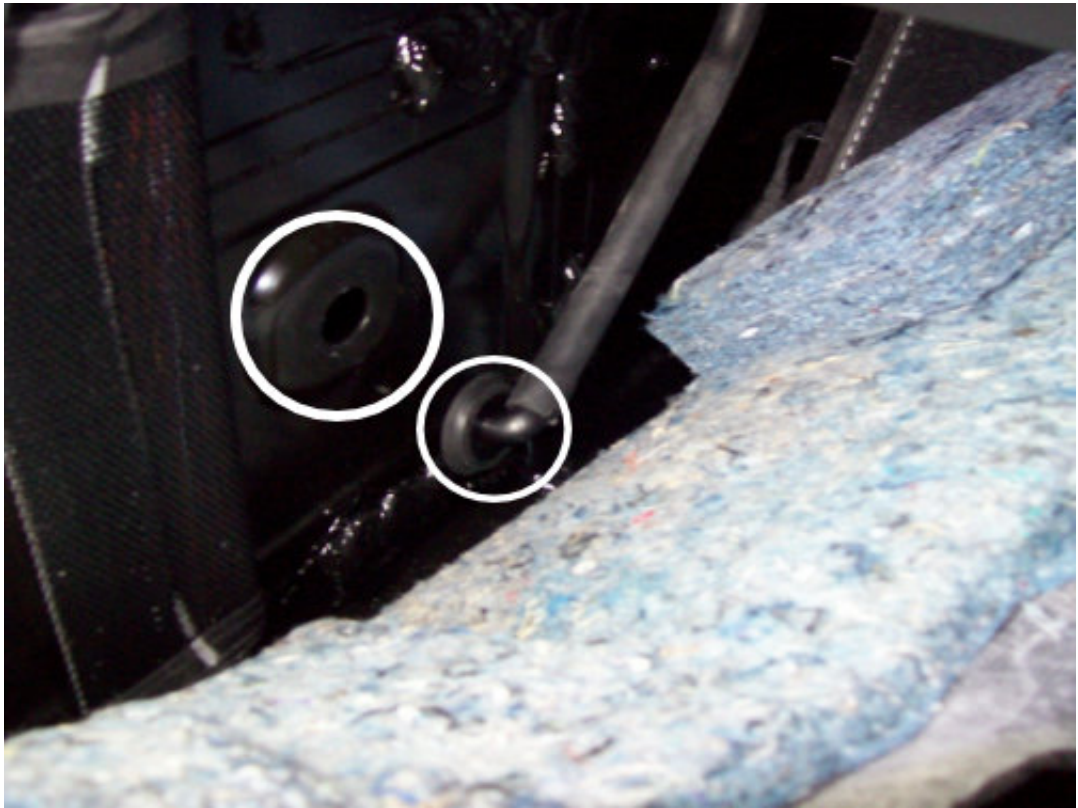
3. The drain tube may be partially or fully disconnected from the body sheet metal as shown.
 - If the drain tube end is fully disconnected, reinsert the drain tube end into the body sheet metal and press firmly to be sure it is securely fastened.
 - If the drain tube end appears to be correctly seated in the body sheet metal, press firmly on it to confirm that it is securely fastened.
- Shift the carpet back to the original location.
- Reinstall the Front Floor Rear Console Side Trim Panel – Right Side. Refer to *Front Floor Rear Console Side Trim Panel – Right Side* in SI.

Correction Dealers are to fully install the HVAC condensate drain hose.
