# 2020 - 2021 Corvette - Service Update Bulletin: #N212327740: Service Update - HVAC Condensate Drain Hose Not Fully Installed - (Mar 10, 2021)

**Subject:** N212327740 — HVAC Condensate  
Drain Hose Not Fully Installed

**Models:** 2020 – 2021 Chevrolet Corvette

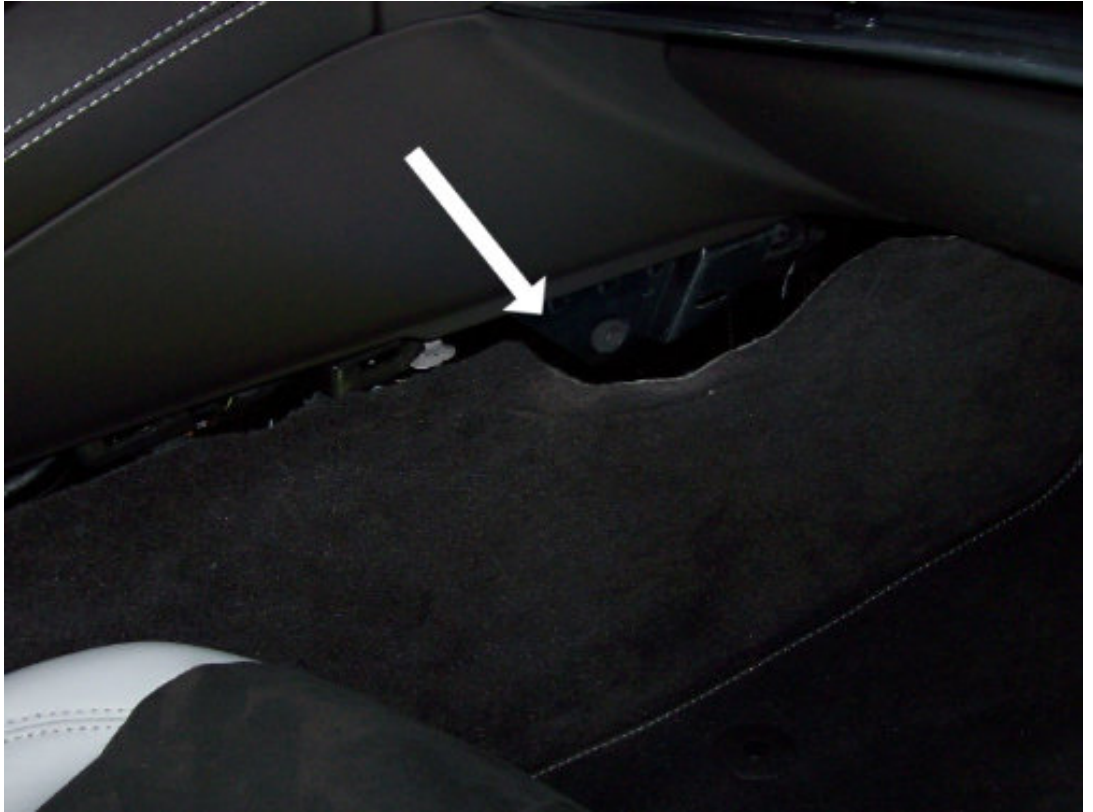
1. Remove the Front Floor Rear Console Side Trim Panel – Right Side. Refer to *Front Floor Rear Console Side Trim Panel – Right Side* in SI.

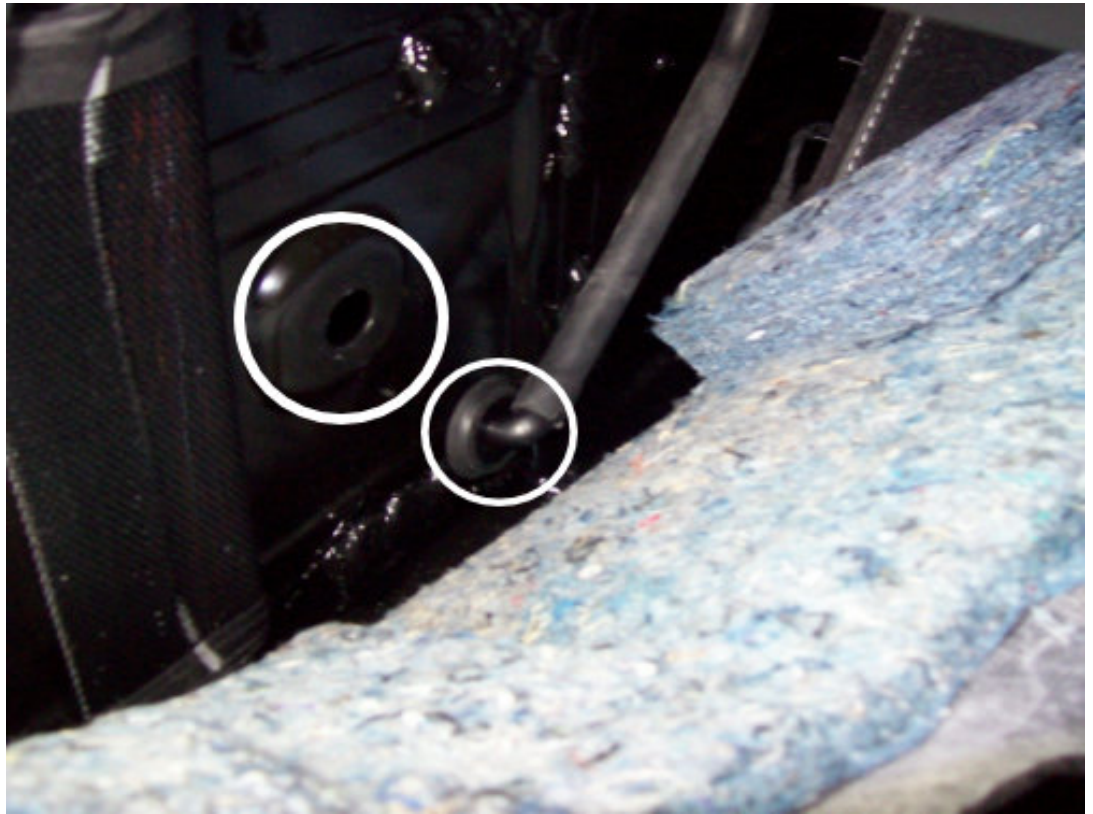
2. Pull back the carpet in the location shown to gain access to the A/C Evaporator Drain Tube.

3. The drain tube may be partially or fully disconnected from the body sheet metal as shown.
  - If the drain tube end is fully disconnected, reinsert the drain tube end into the body sheet metal and press firmly to be sure it is securely fastened.
  - If the drain tube end appears to be correctly seated in the body sheet metal, press firmly on it to confirm that it is securely fastened.
- Shift the carpet back to the original location.
- Reinstall the Front Floor Rear Console Side Trim Panel – Right Side. Refer to *Front Floor Rear Console Side Trim Panel – Right Side* in SI.
