# 1997 - 1998 Corvette: Service Bulletin: Loose Lower Front Fascia Valance Panels

**Number:** 73-15-12A

**SUBJECT: LOOSE LOWER FRONT FASCIA VALANCE PANELS (INSTALL ADDITIONAL ADDITIONAL WASHERS)**

**MODELS:** 1997-98 CHEVROLET CORVETTE - BUILT PRIOR TO VIN BREAKPOINT W5127967

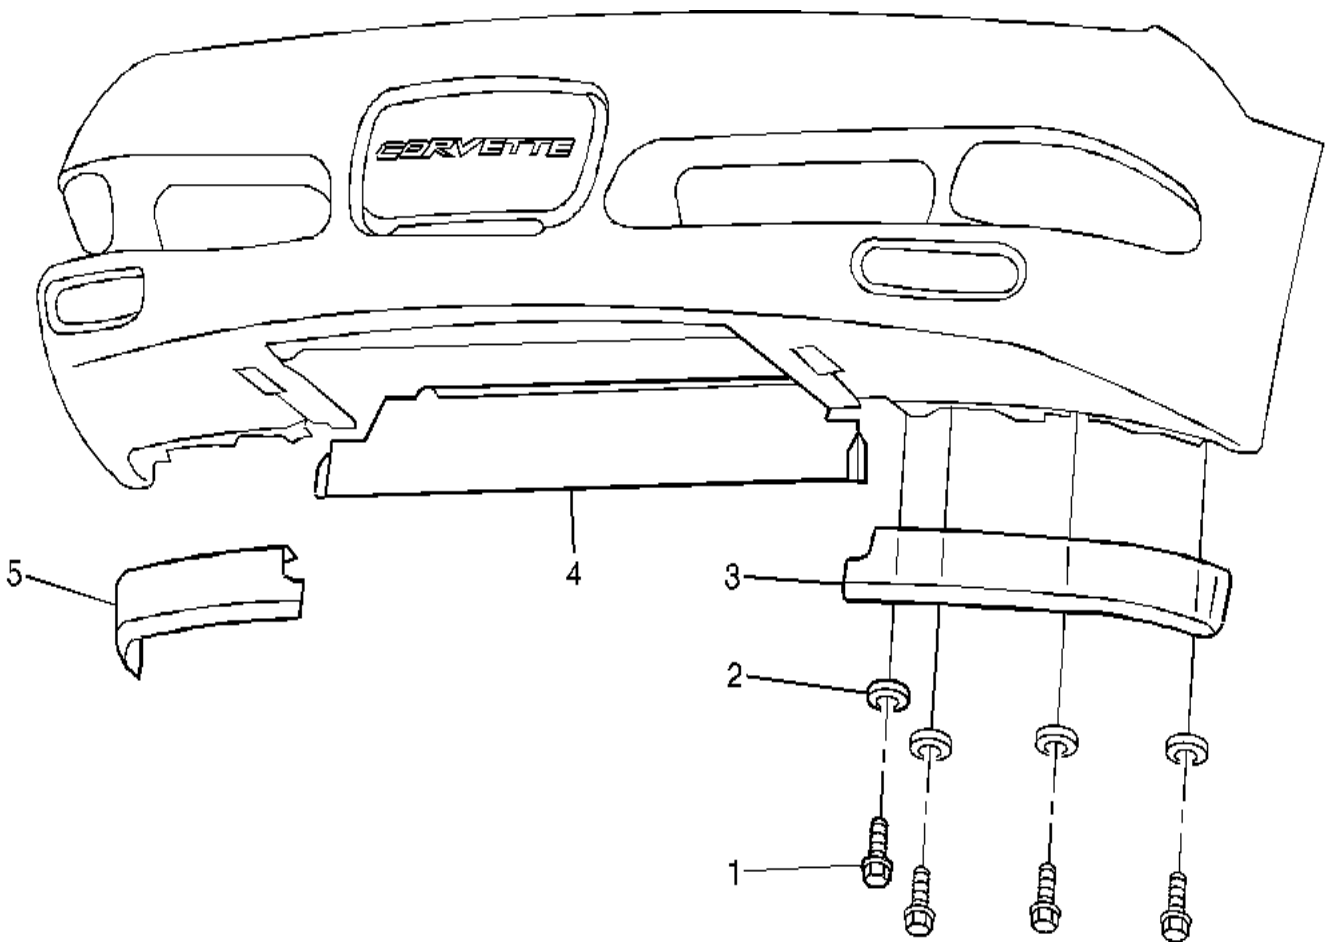
**Figure 1**

SOME OWNERS MAY COMMENT THAT THE LOWER FRONT FASCIA VALANCE PANELS APPEAR LOOSE.

THE ORIGINAL WASHERS ON THE BOLTS/SCREWS THAT ATTACH THE LOWER VALANCE PANELS TO THE FRONT FASCIA MAY HAVE WORKED THEIR WAY THROUGH THE HOLES IN THE VALANCE PANELS.

ADD ONE ADDITIONAL LARGER FLAT WASHER, P/N 11500365, 25 MM O.D. BY 6.3 MM I.D. BY 2.5 MM THICK (1 IN. O.D. BY 1/4 IN. I.D. BY 3/32 IN. THICK) TO EACH OF THE EIGHT BOLTS/SCREWS (FOUR PER VALANCE PANEL) THAT ATTACH BOTH LOWER VALANCE PANELS TO THE FRONT FASCIA (SEE FIGURE 1). TIGHTEN BOLTS TO 7 N.M (62 LB IN).
