1956 Corvette Service Bulletin: Clutch Disc - Springs - Periodic Vibration

Subject: Clutch Disc - Springs - Periodic Vibration

Model and Year: 1956 Passenger Car and Truck

Bulletin No: DR #266

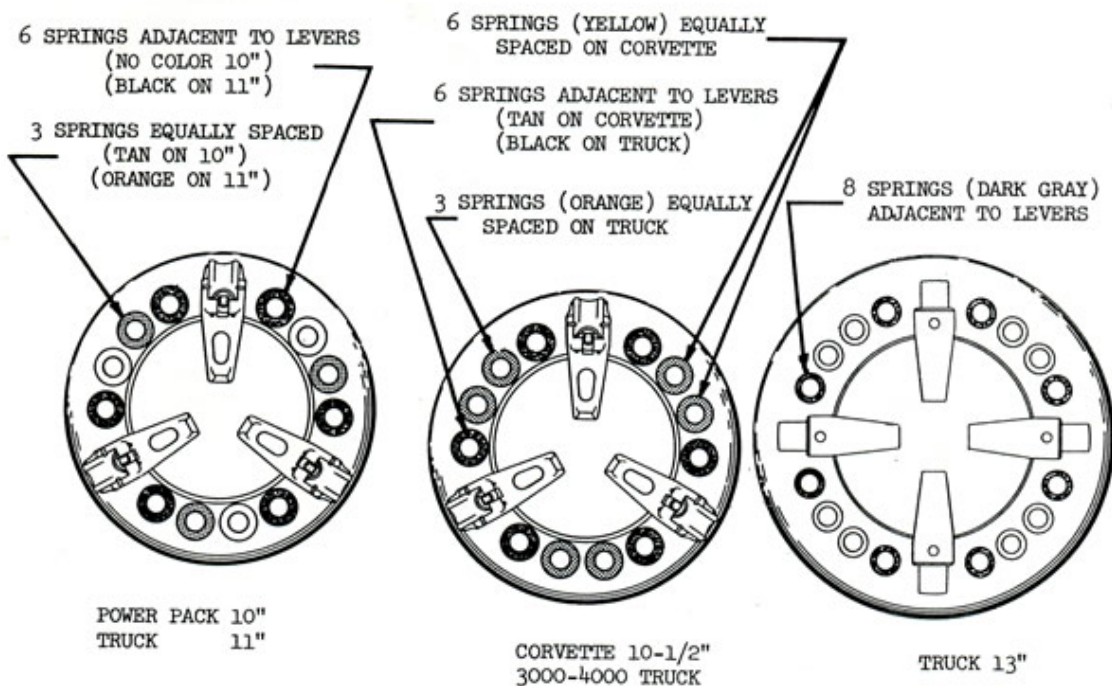
* See illustration on page 4 for location of the various coil springs in the pressure plate.

In some cases early Power Pack Clutches, coil spring type (6 red and 3 lavender coil springs) were found to be low in capacity. Where this condition exists, they should be changed to "6 No Color" and "3 Tan" as covered in chart. For extreme use on high performance units "9 No Color" springs or Corvette clutch cover and pressure plate assembly is recommended, although a considerably higher pedal effort will result form use of such assemblies.
