2016 Corvette: Service Bulletin: Delayed Engagement After Sitting With Engine Off

#16-NA-014: Delayed Engagement After Sitting With Engine Off - (Jan 21, 2016)

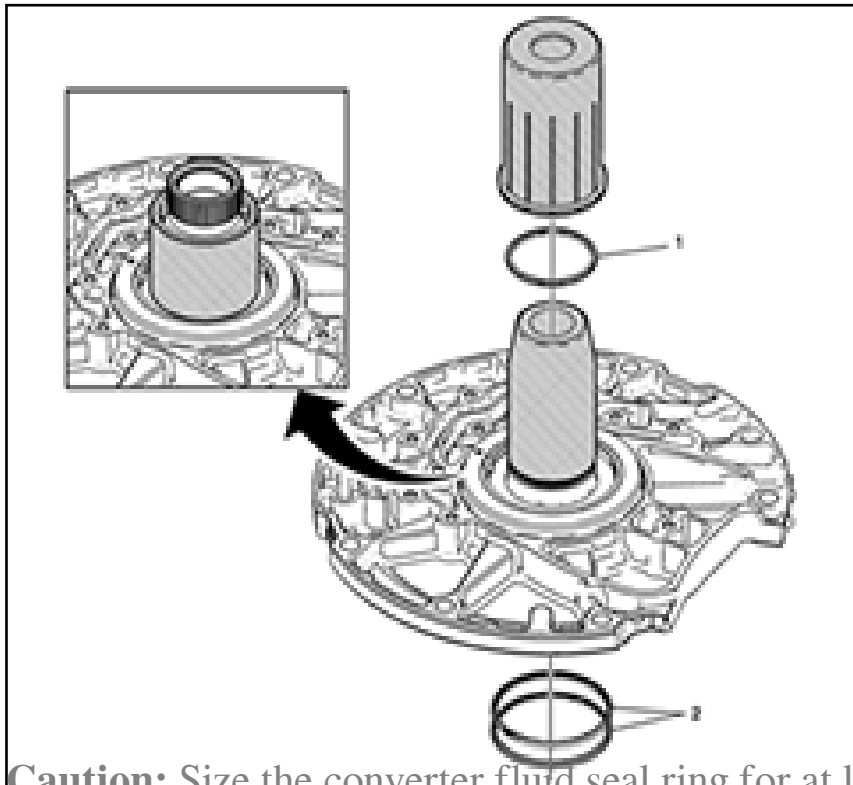
Note: The new stator shaft support assembly has a second check ball (1) added (see illustrations).

Install a new stator shaft support assembly that includes an additional check ball. Follow the instructions below to replace the stator shaft support assembly.
